MAINE SOUTH  
**MEP CONDITION ASSESSMENT**

## MAINE SOUTH HIGH SCHOOL

## Mechanical Assessment

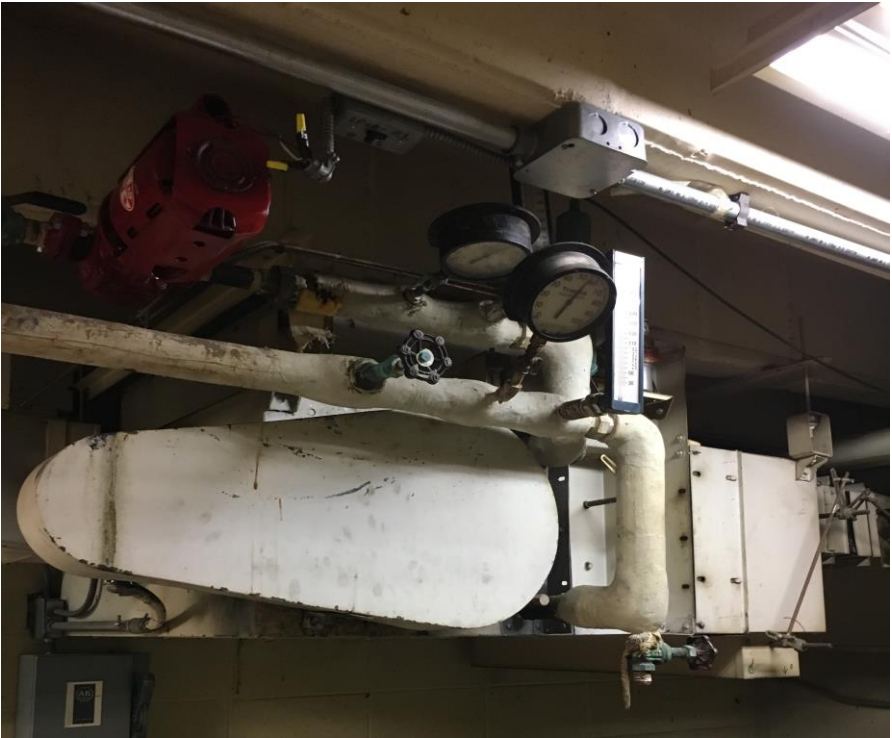
A-Wing Basement AHU

The A-Wing basement AHU was installed in 1968 and is in poor condition due to its age. It is recommended to replace this AHU with a like for like replacement. Please reference the AHU Cost Estimates for pricing information.

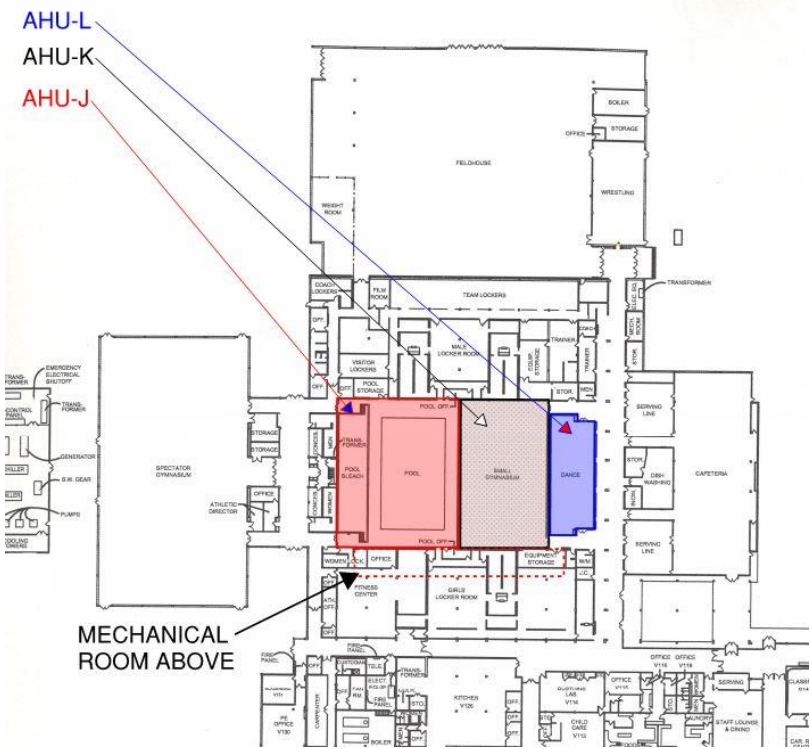
Pool, Small Gym, and Dance AHUs

AHU-J provides heating and ventilation to the pool area and is original the building from 1964. Like AHUs J and K, it is equipped with a hot water duct mounted coil, constant volume supply air, and is in a cramped mechanical space. This unit is incapable of providing dehumidification to the pool area since it does not have any means of cooling. Excessive moisture in air can, over time, provide an ideal environment for molds to grow which can cause health-risks and potential damage to the structure of interior walls. AHU-J is also significantly aged and has far exceeded the ASHRAE median equipment service life of thirty (30) years.

These AHUs supply constant volume air and are original to the building from 1964. They are equipped with hot water coils, and are in a tight and restrictive mechanical space above the areas which they serve. Due to age and condition and challenging the ASHRAE median equipment service life of thirty (30) years, they are recommended for upgrade.

It is recommended to update this unit to a variable flow, pool dehumidification unit. The advantages of a pool dehumidification unit include providing cool dry air during the summer and warm dry air during the winter. This is particularly important with a pool air handling unit since pool spaces have high humidity levels throughout the year. This unit would address issues relating to moisture content in the pool air and noticeably improve comfort. Please reference the AHU Cost Estimates for pricing information.

Due to the limited mechanical space available, it is recommended to replace these units with cooling only, variable volume packaged roof top units that are equipped with duct-mounted hot water heating coils. In comparison to the existing constant volume AHUs, the new variable volume roof top units would provide notable savings and increased comfort due to cooling capabilities. Please reference the AHU Cost Estimates for pricing details.

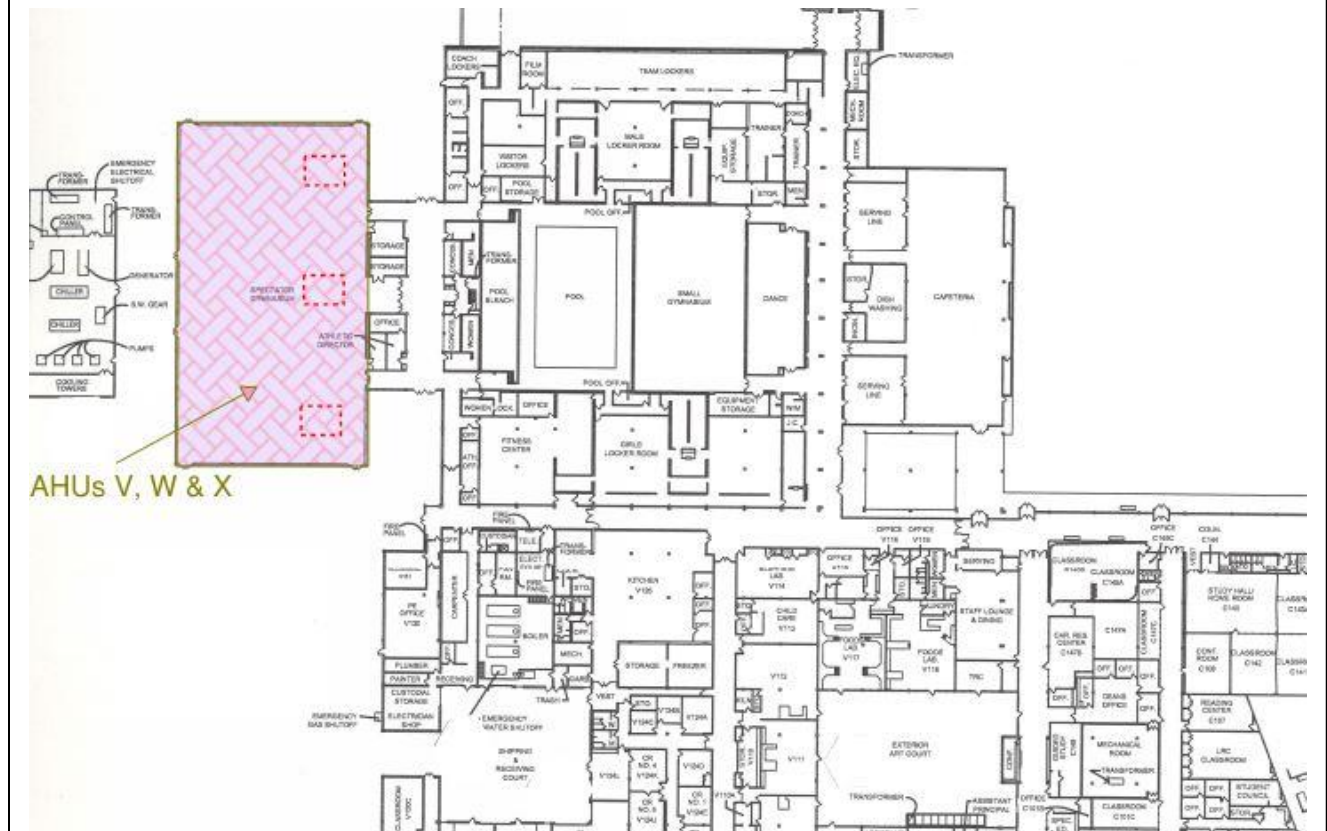
### Spectator Gym AHUs

The spectator gym AHUs are original to the building from 1964 and provide constant volume air with heating only via hot water coils. Since these units are hung from the ceiling, they are difficult to service. According to ASHRAE, the median service life of a packaged medium-duty air handling unit is 25 years. Impressively, these units have doubled the ASHRAE median equipment service life average; however, they are in a poor condition.

It is recommended to update these units with more accessible, variable speed, packaged roof top units equipped with hot water heating and cooling capabilities. With the transition to variable flow, improved serviceability, and cooling capabilities, considerable savings and comfort improvements would be achieved. Please reference the AHU Cost Estimates for pricing information.

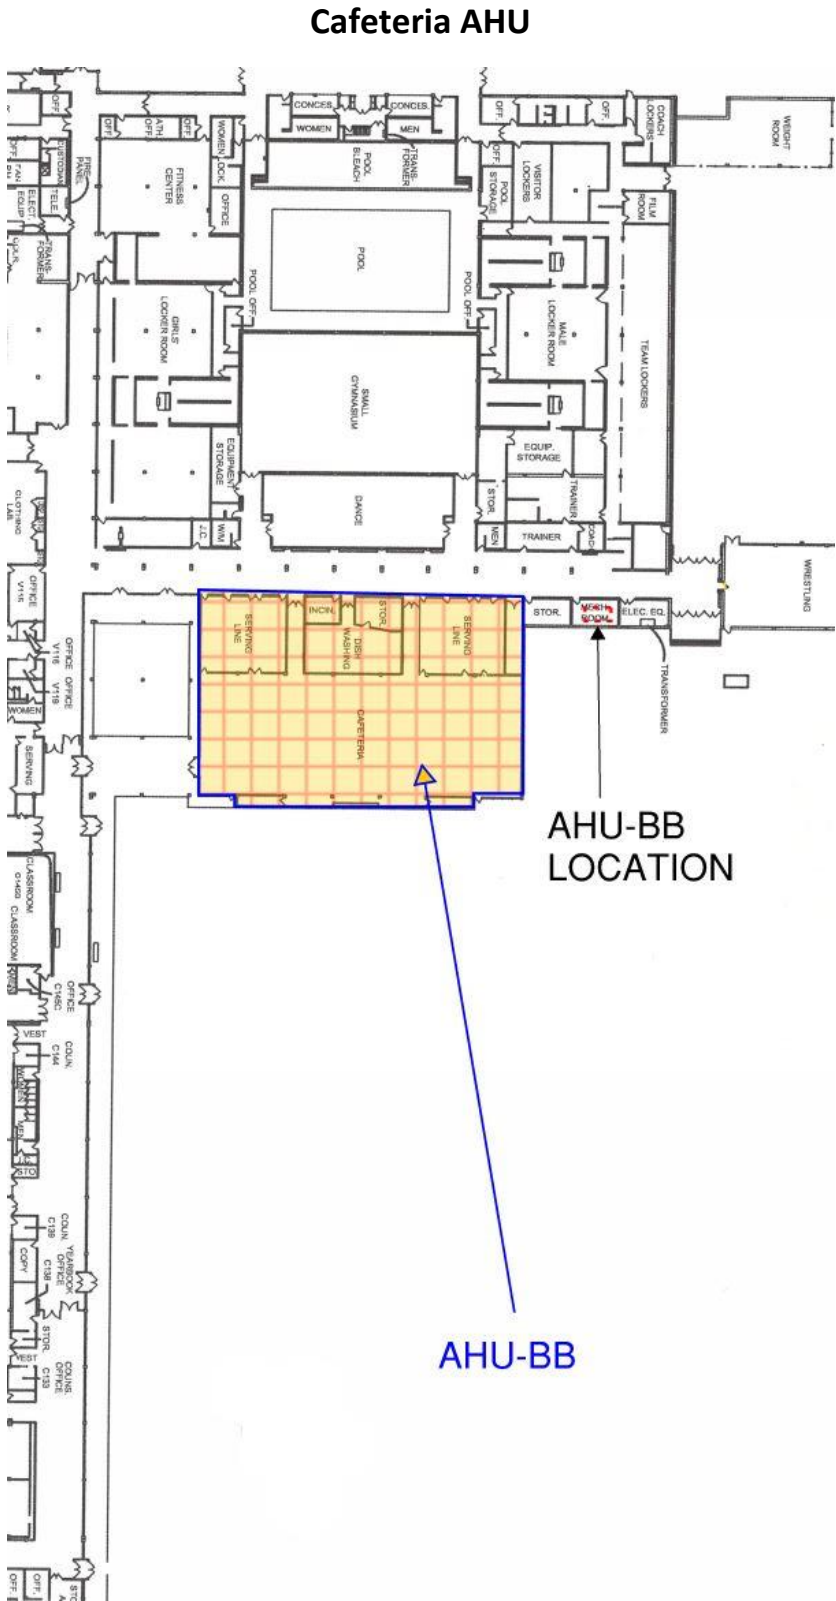
AHU-BB was installed in 1968 and is located in the mechanical room near the cafeteria. It conditions the cafeteria with 100% outside air at constant volume via one (1) hot water preheat coil, one (1) DX cooling coil with an associated condensing unit installed in 2002 on the roof, and three (3) hot water reheat coils placed in main duct branches. AHU-BB is equipped with face and bypass dampers. Consult the graphic on the right for its area of service and the table below for added specifications.

Cafeteria AHU-BB is original to the building from 1964. This unit delivers constant volume supply air and utilizes chilled water and hot water coils to condition the Cafeteria. AHU-BB has surpassed its ASHRAE median equipment service life of thirty (30) years and is substantially aged. Additionally, constant volume systems are considerably less energy efficient than today’s technology.

It is recommended to upgrade the AHU-BB with a new AHU that distributes variable volume supply directly to the zones of service. In this case, the air handler itself acts as a VAV box providing variable supply to only one or two spaces. With a variable volume system upgrade, fan supply air is dependent on the space requirements; when demand is low, the fan reduces its speed, which results in significant energy savings both from the perspective of fan energy as well as heating and cooling energy. Please reference the AHU Cost Estimates for pricing details.

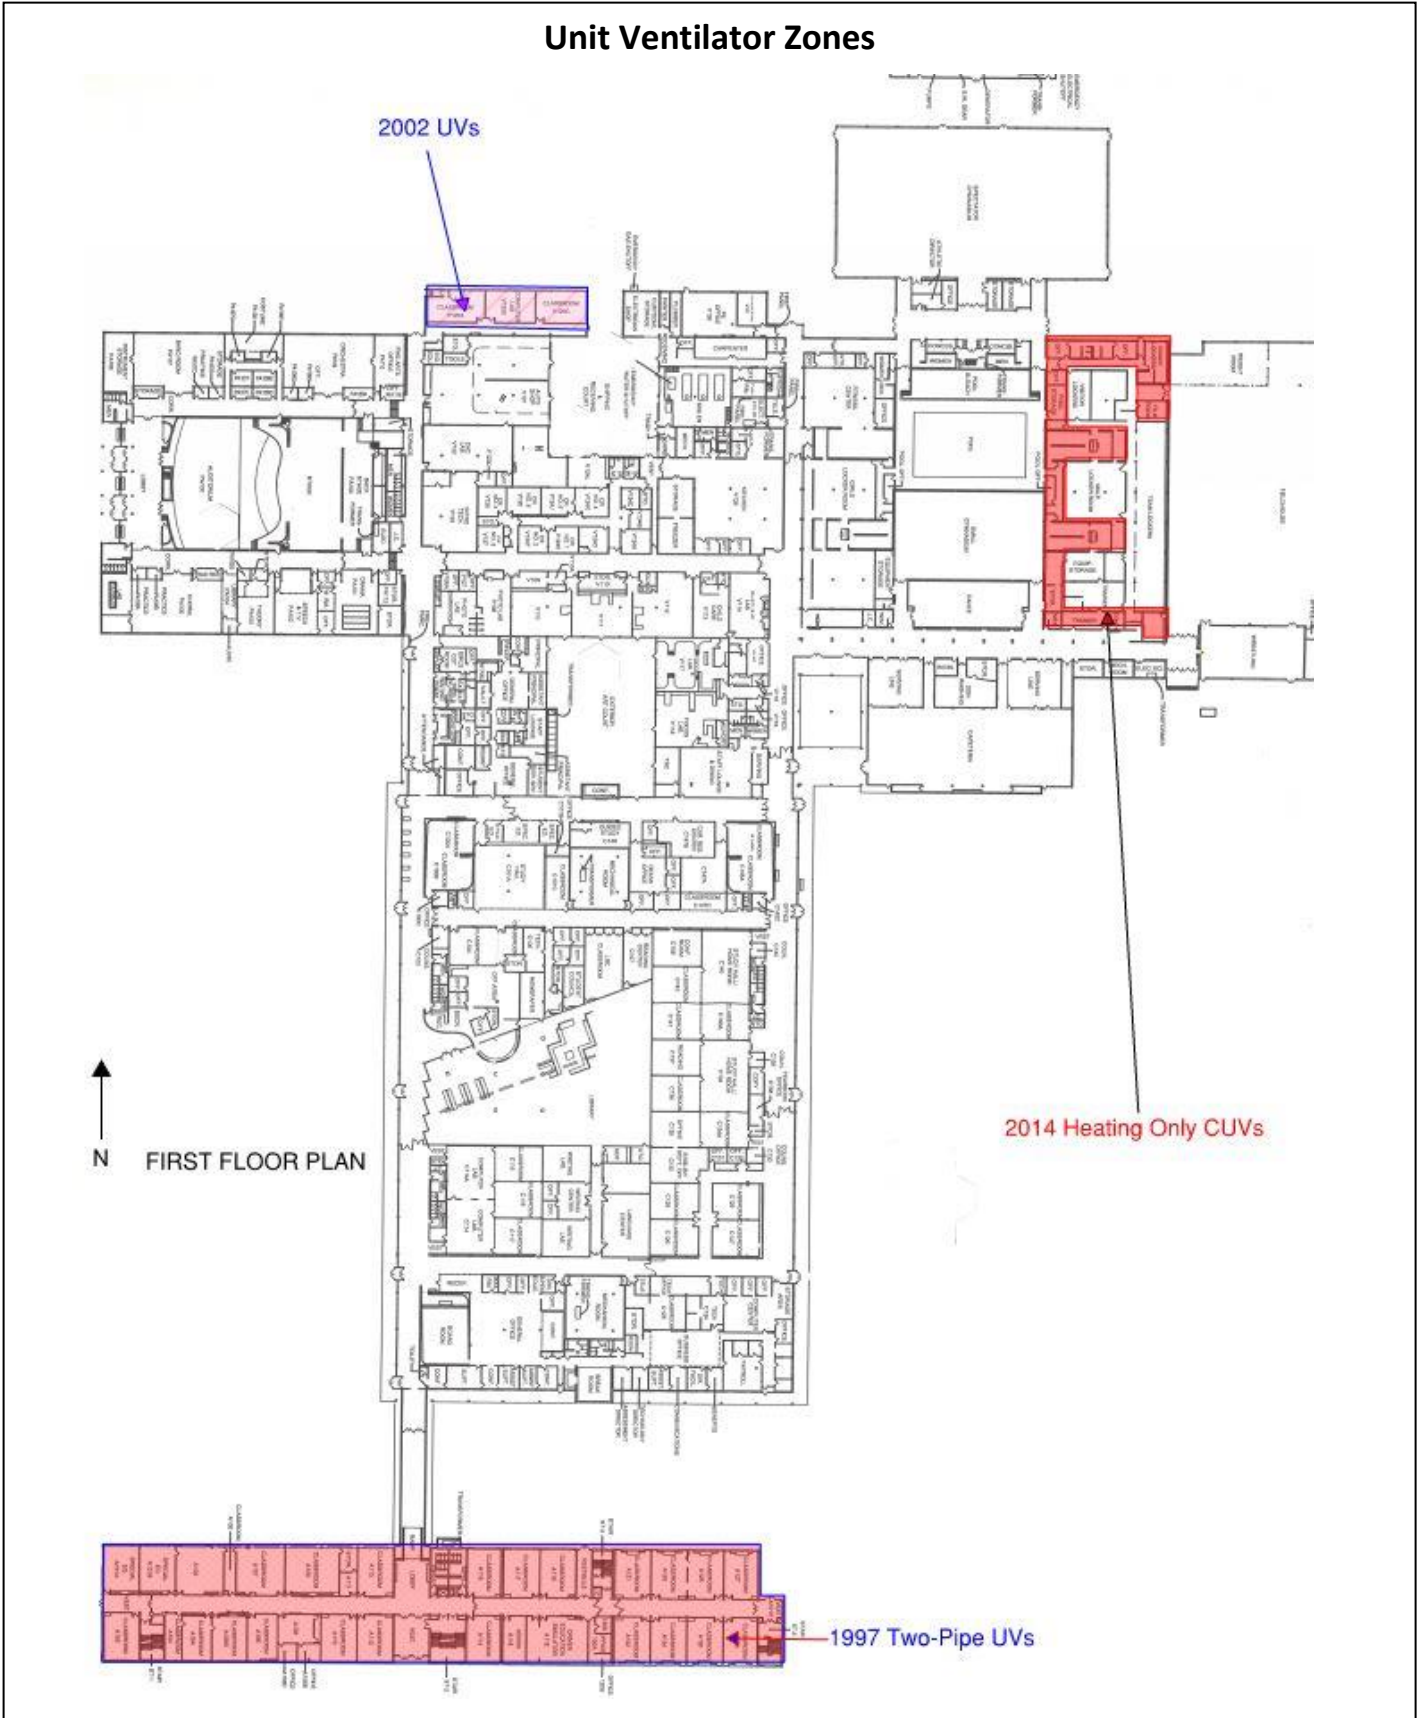
The A-Wing unit ventilators are from 1997 and are reportedly difficult to accurately control space temperatures. Noise can also be an issue, and some UVs allow for rain infiltration inside of the classrooms.

Two options are recommended for UV replacement: Option 1 is to replace the UVs with vertical air change UVs. This would provide increased comfort control, reliability and efficiency. Option 2 is to install a variable flow, dedicated outdoor air unit (DOAS) on the roof that serves local fan coil units with hot water heating and chilled water cooling coils. This system provides optimum temperature control and yields long term energy savings due to its variable volume supply. Please reference the UV Cost Estimates section for pricing details per option.

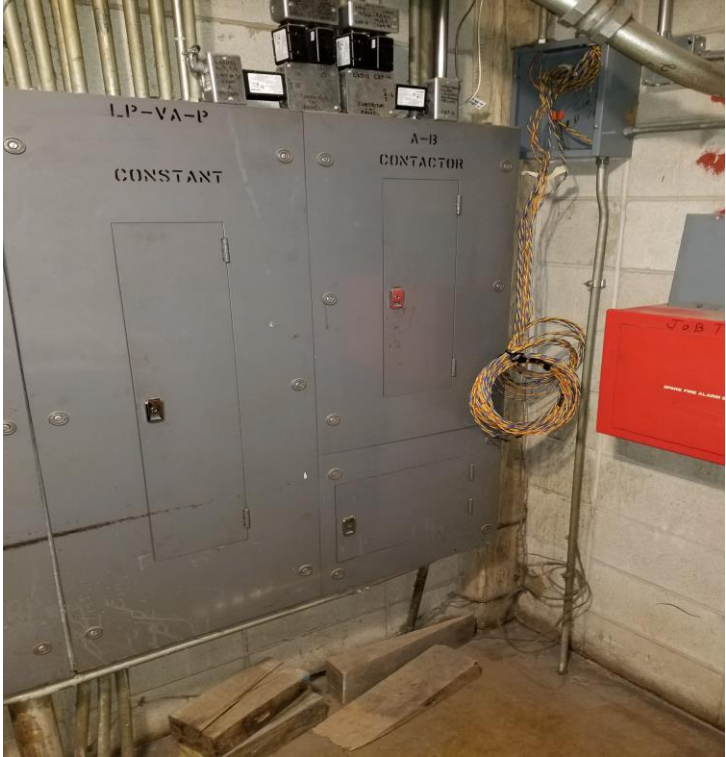
### VA-2 Distribution Panels

The panelboards fed from substation VA-2 are also original to the building and are due for a replacement. The panels may be furnished by either a reputable manufacturer, or a custom switchboard manufacturer. The existing panel feeders and branch circuits may remain as existing.

Any panelboards fed via cloth-insulated wiring should be re-fed with equivalent thermoplastic-insulated wire as replacements occur.

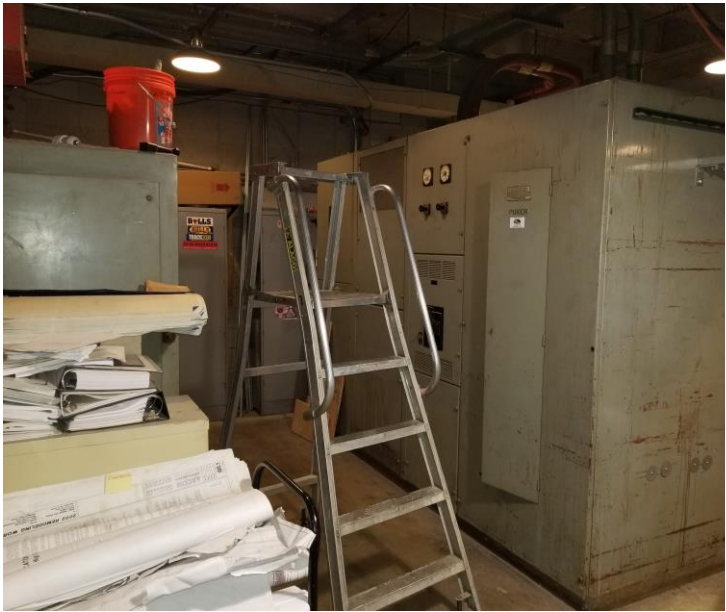
Substation VA-2 is original to the building from 1964. The unit is significantly aged and was manufactured by a company that no longer formally exists. Due to the inherent reliability issues of the unit being beyond its expected lifespan along with the difficulty of obtaining relevant parts, it is recommended to replace this substation in the coming years. If the substation is fed by cloth-insulated wiring, it should be replaced with an equivalent thermoplastic-insulated wire during the substation replacement.

We recommend to exercise the existing 4160V switches to verify proper operation and reduce risk of becoming stuck in a certain position at an inopportune time. Additionally, we recommend annual thermal inspections of the substation, switches, distribution panels, and other equipment in order to more easily identify problematic areas of unwanted heat buildup in the system.

A like-for-like replacement can be implemented by custom switchboard manufacturers, replacing the primary switch, 500 KVA transformer, circuit breakers, and distribution board in a package of the same size as the existing. The incoming and outgoing feeders may remain as they currently are.

OSHA 2015 regulations require the application of an arc flash label that provides information on arc flash protection boundary, incident energy, working distance, PPE class, and available short circuit information. It is recommended to perform an arc flash and coordination study at the same time the switchboards are replaced.

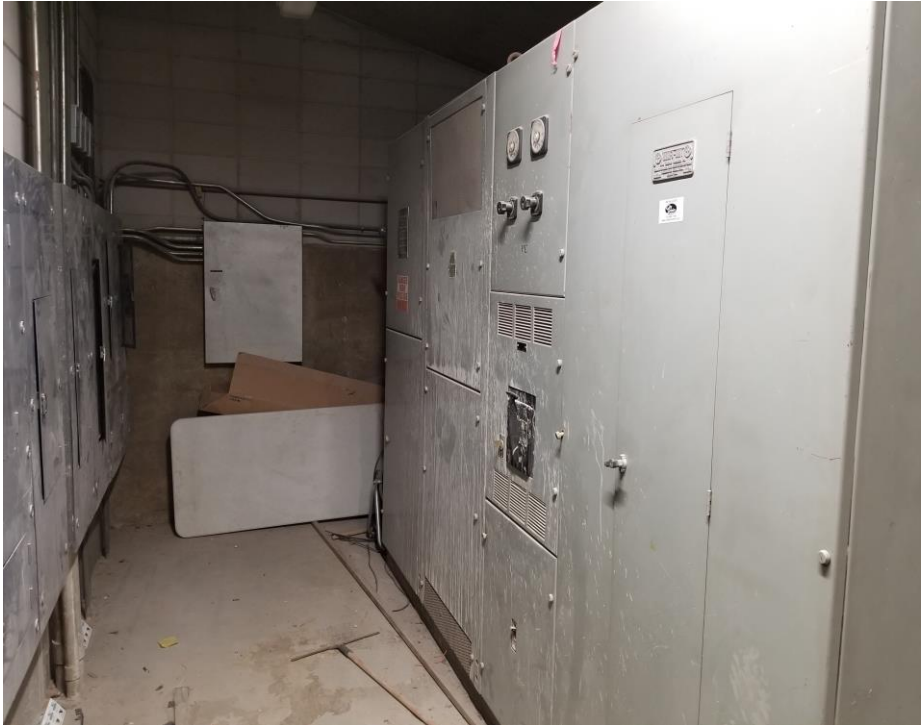
### Substation PE and Distribution Panels

Substation PE is original to the building from 1964. The unit is significantly aged and was manufactured by a company that no longer formally exists. Due to the inherent reliability issues of the unit being beyond its expected lifespan along with the difficulty of obtaining relevant parts, it is recommended to replace this substation in the coming years. If the substation is fed by cloth-insulated wiring, it should be replaced with an equivalent thermoplastic-insulated wire during the substation replacement.

The panelboards fed from substation PE are also original to the building and are due for a replacement. The panels may be furnished by either a reputable manufacturer, or a custom switchboard manufacturer. The existing panel feeders and branch circuits may remain as existing.

We recommend to exercise the existing 4160V switches to verify proper operation and reduce risk of becoming stuck in a certain position at an inopportune time. Additionally, we recommend annual thermal inspections of the substation, switches, distribution panels, and other equipment in order to more easily identify problematic areas of unwanted heat buildup in the system.

A like-for-like replacement can be implemented by custom switchboard manufacturers, replacing the primary switch, 500 KVA transformer, circuit breakers, and distribution board in a package of the same size as the existing. The incoming and outgoing feeders may remain as they currently are.

OSHA 2015 regulations require the application of an arc flash label that provides information on arc flash protection boundary, incident energy, working distance, PPE class, and available short circuit information. It is recommended to perform an arc flash and coordination study at the same time the switchboards are replaced.

Any panelboards fed via cloth-insulated wiring should be re-fed with equivalent thermoplastic-insulated wire as replacements occur.
