MECHANICAL, ELECTRICAL, PLUMBING, AND FIRE PROTECTION CONDITIONS

MAINE EAST HIGH SCHOOL

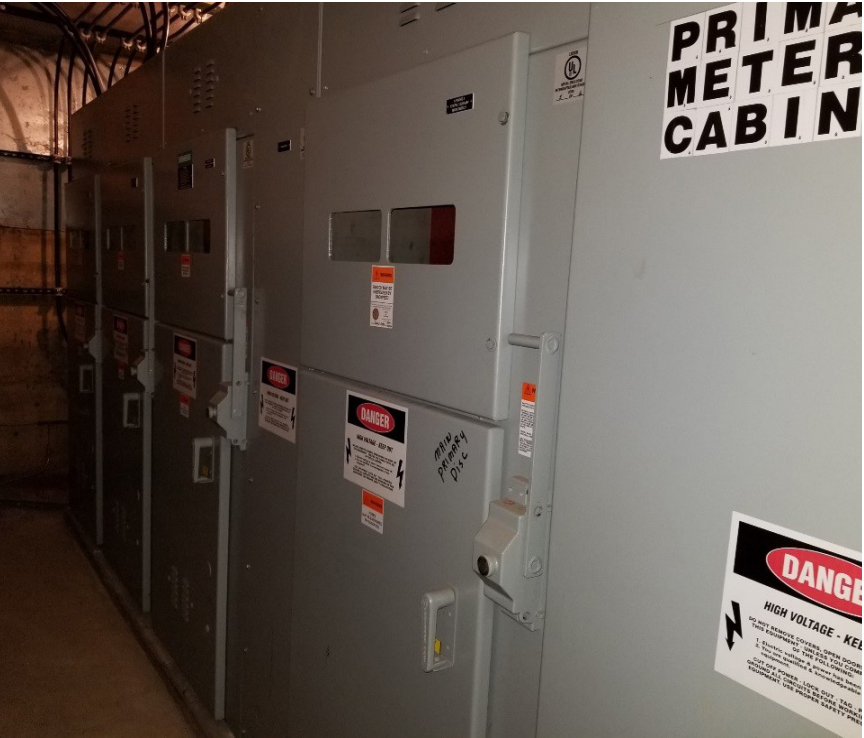
ComEd Vault Switchgear

The vault switchgear is in good condition, and has been relatively recently installed. Therefore, no adjustments are required for this portion of the distribution system.

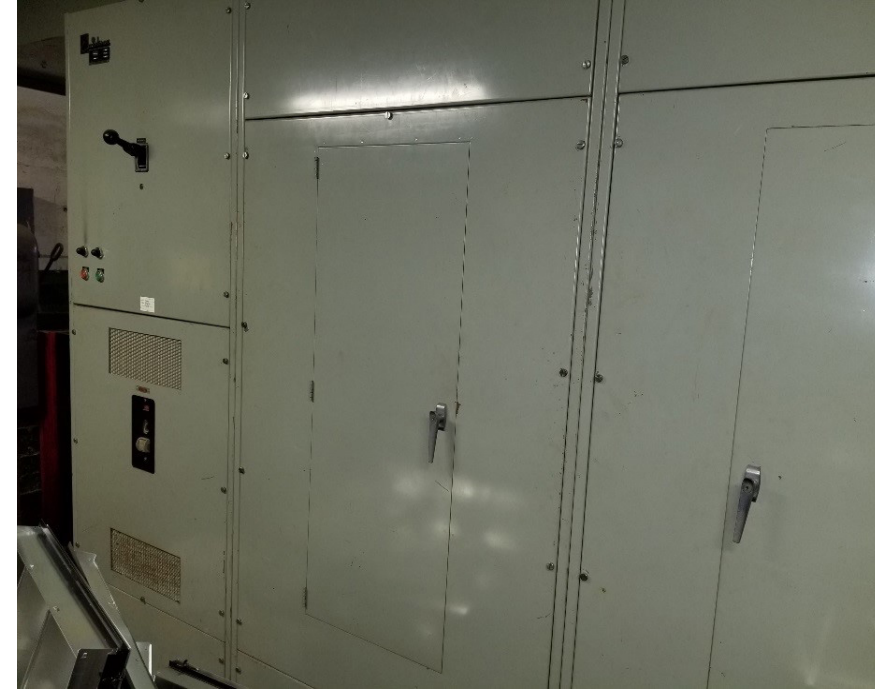
Basement Electrical Room Switchboard

The distribution switchboard in the basement electrical room is fed from a step-down transformer outside the building. The switchboard is rated for 1200A at 120/208V, 3-phase.

Some distribution equipment can be found in this room outside of the switchboard, mounted along the walls. While some of the oldest pieces of equipment are no longer functional, there are a few live-front enclosures that still see active use, such as fuse panels for lighting.

We strongly recommend the replacement of all existing live-front equipment as soon as possible. Virtually all such equipment can be replaced by a dead-front equivalent, providing much greater safety to maintenance personnel and anyone else who may need to access the equipment.

We recommend to exercise the existing switchboard breakers to verify proper operation and reduce risk of becoming stuck in a certain position at an inopportune time. Additionally, we recommend annual thermal inspections of the switchboard, distribution panels, and other equipment in order to more easily identify problematic areas of unwanted heat buildup in the system.

The switchboard room currently has several items scattered about the floor, obstructing access to most of the room's electrical equipment. It is recommended to find suitable storage for these items and maintain a minimum 36 inch front clearance for all electrical equipment.

OSHA 2015 regulations require the application of an arc flash label that provides information on arc flash protection boundary, incident energy, working distance, PPE class, and available short circuit information for all electrical equipment. It is recommended to perform an arc flash study and apply the labels in a timely manner to comply.

It is recommended to inspect the switchboard and all outgoing feeder cables for cloth-insulated wire. Should cloth wire be encountered, it is best to replace it quickly with a thermoplastic equivalent. Doing so reduces risks associated with older insulation such as excessive heat, brittleness, and potential exposure to asbestos.

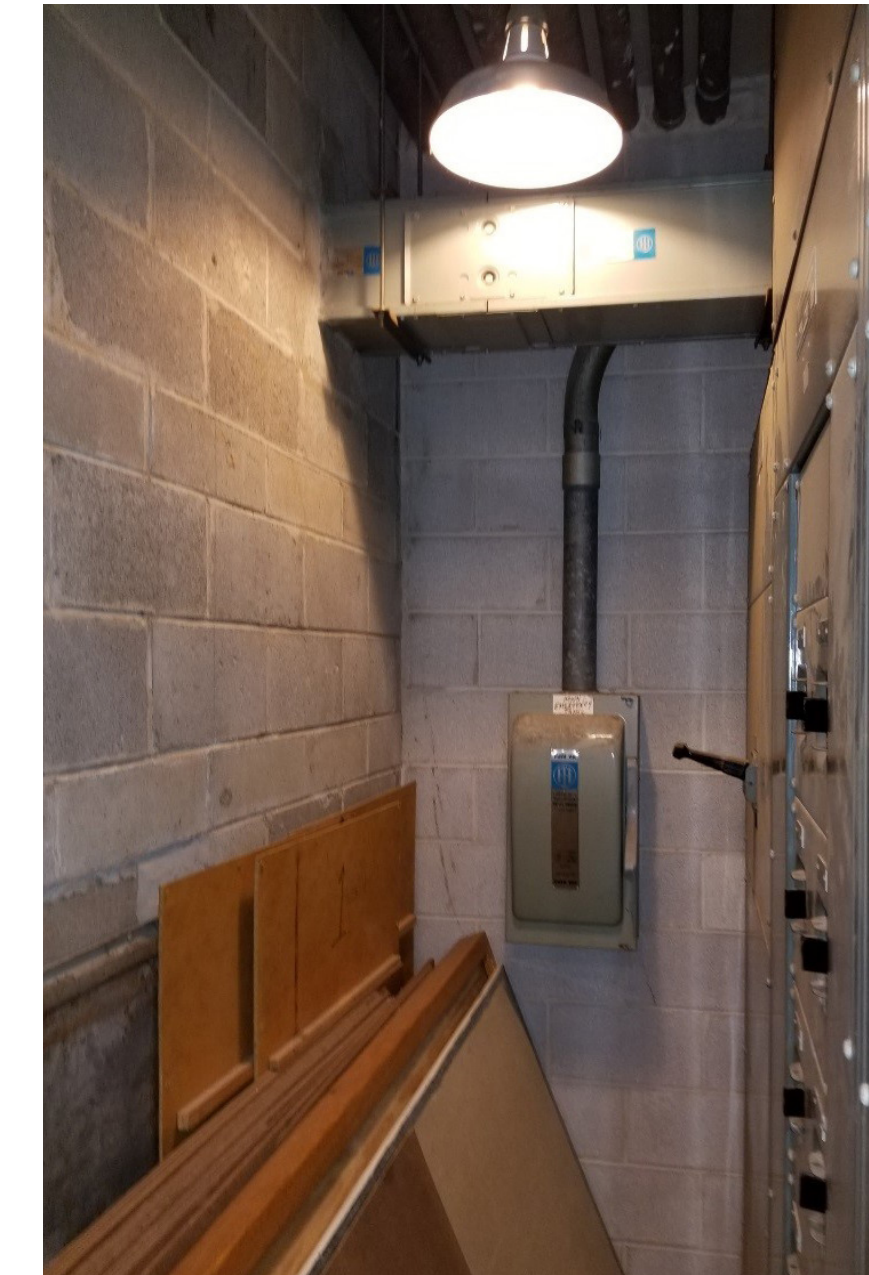
Switchboard and Disconnect Switch

The distribution switchboard in the first floor electrical room south of the bookstore is fed from three single-phase transformers in the room directly north, accessible from First Floor Electrical Room #2. The switchboard is rated for 2000A at 120/208V, 3-phase.

The first section of this switchboard contains the 'main' circuit breaker for all the distribution breakers in the next two board sections. Most of the circuit breakers in the switchboard appear to feed a lighting panel, based on the labeling. The entire switchboard was manufactured by I-T-E circuit breaker company. The switchboard is fairly old, however it still appears to be in acceptable condition for use.

We recommend to exercise the existing switchboard breakers to verify proper operation and reduce risk of becoming stuck in a certain position at an inopportune time. Additionally, we recommend annual thermal inspections of the switchboard, distribution panels, and other equipment in order to more easily identify problematic areas of unwanted heat buildup in the system.

The switchboard room currently has several items obstructing access to most of the room's electrical equipment. It is recommended to find suitable storage for these items and maintain a minimum 36 inch front clearance for all electrical equipment.

OSHA 2015 regulations require the application of an arc flash label that provides information on arc flash protection boundary, incident energy, working distance, PPE class, and available short circuit information. It is recommended to perform an arc flash study and apply the labels in a timely manner to comply.

It is recommended to inspect the switchboard and all outgoing feeder cables for cloth-insulated wire. Should cloth wire be encountered, it is best to replace it quickly with a thermoplastic equivalent. Doing so reduces risks associated with older insulation such as excessive heat, brittleness, and potential exposure to asbestos.

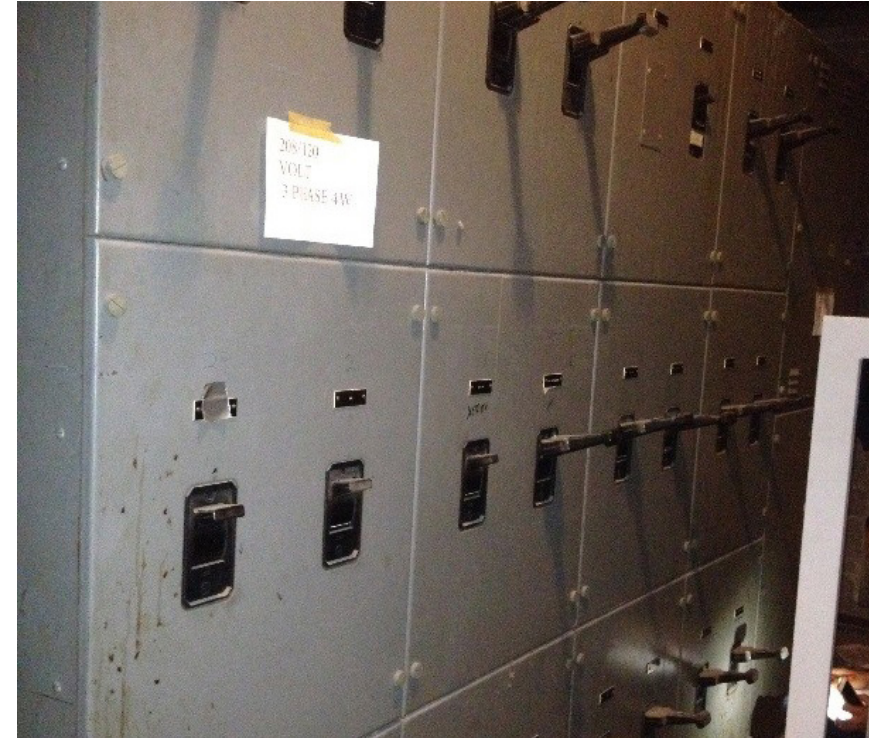
Switchboard – First Floor Electrical Room #2

The distribution switchboard in the first floor electrical room west of the bookstore is fed from three single-phase step-down transformers in a room immediately east. The switchboard is rated for 120/208V, 3-phase. At the time of survey, we were unable to verify the current rating of the main breaker or switchboard bus.

The first four sections of this switchboard contain (23) power distribution breakers, which generally feed smaller power distribution boards or branch circuit panels. The fifth section contains the main circuit breaker for the board and the incoming feeder wires from the transformers. The switchboard was manufactured by I-T-E circuit breaker company. The switchboard appears to be in less satisfactory condition than other such units in the school.

This switchboard is at or past its expected lifespan and does not appear to be in as good a condition as the other switchboards encountered in the facility. Due to the inherent reliability issues of the unit being beyond its expected lifespan along with the difficulty of obtaining relevant parts, it is recommended to replace this substation in the coming years.

We recommend to exercise the existing switchboard breakers to verify proper operation and reduce risk of becoming stuck in a certain position at an inopportune time. Additionally, we recommend annual thermal inspections of the switchboard, distribution panels, and other equipment in order to more easily identify problematic areas of unwanted heat buildup in the system.

The switchboard room currently has several items obstructing access to most of the room's electrical equipment. It is recommended to find suitable storage for these items and maintain a 36 inch minimum front clearance for all electrical equipment.

During the replacement process, it is recommended to inspect the switchboard and all outgoing feeder cables for cloth-insulated wire. Should cloth wire be encountered, it is best to replace it quickly with a thermoplastic equivalent. Doing so reduces risks associated with older insulation such as excessive heat, brittleness, and potential exposure to asbestos.

When the new switchboard is in place, OSHA 2015 regulations require the application of an arc flash label that provides information on arc flash protection boundary, incident energy, working distance, PPE class, and available short circuit information. It is recommended to perform an arc flash study and apply the labels in a timely manner to comply.

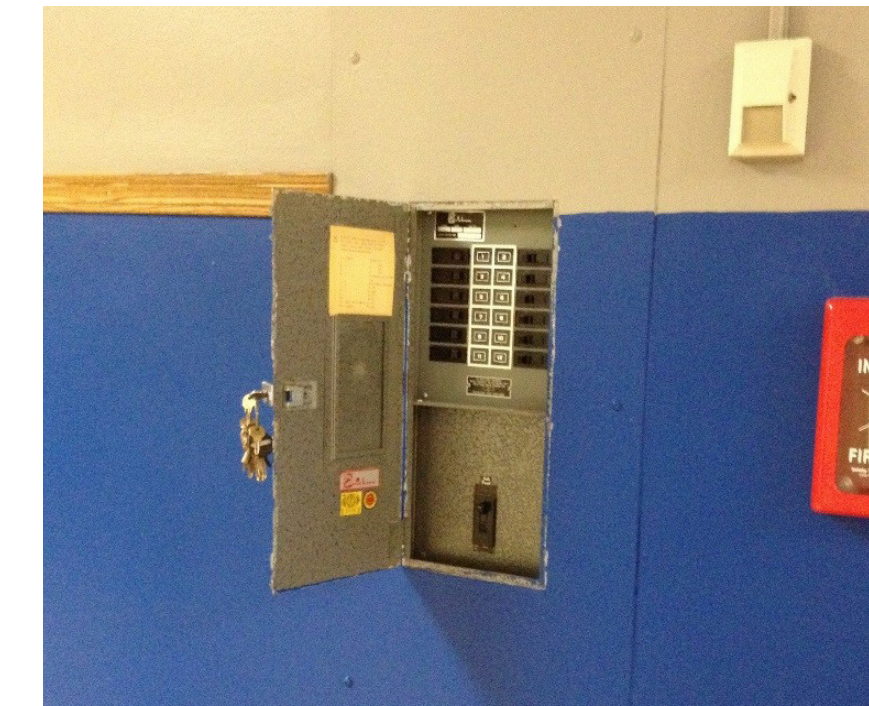
Panel Recessed in Corridor

The school's load centers are distributed throughout the school, only a few are located in the switchboard rooms where the main power distribution resides. The condition of the panels are varied, many having been replaced over the course of the facility's history from live-front fuse panels to newer units from Square-D, I-T-E, and Erickson, though a few live-front units still remain. Almost all panelboards are three-phase units, with supply voltages that are either 120/208V or 277/480V throughout the school. Many panelboards are recessed-type, found in the facility corridors

We recommend annual thermal inspections of the distribution panels in order to more easily identify problematic areas of unwanted heat buildup in the system.

It is recommended to replace all older panelboards in a given area as the spaces are renovated in the future with new units. If possible, it would be beneficial to install the new panelboards with additional spare circuit capacity for future use.

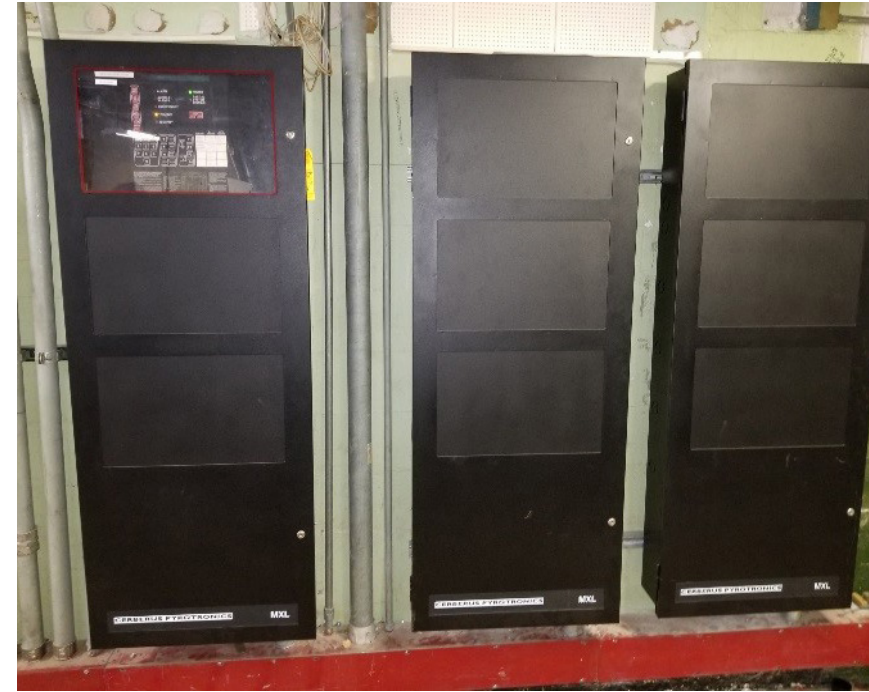
Fire Alarm Control Panel

The building contains a Siemens fire alarm system with a Cerberus Pyrotronics ‘MXL’ main fire alarm control panel, consisting of audio, visual, heat detector, smoke detector, duct smoke detectors, and pull station devices. The system is outdated and does not meet present code in certain areas.

The requirement of addressable devices requires the installation of new expansion cards in the existing fire alarm panel. There is not enough space in the existing fire alarm panel to install new cards, and due to the magnitude of new code requirements, it is recommended to install a completely new system that meets all requirements.

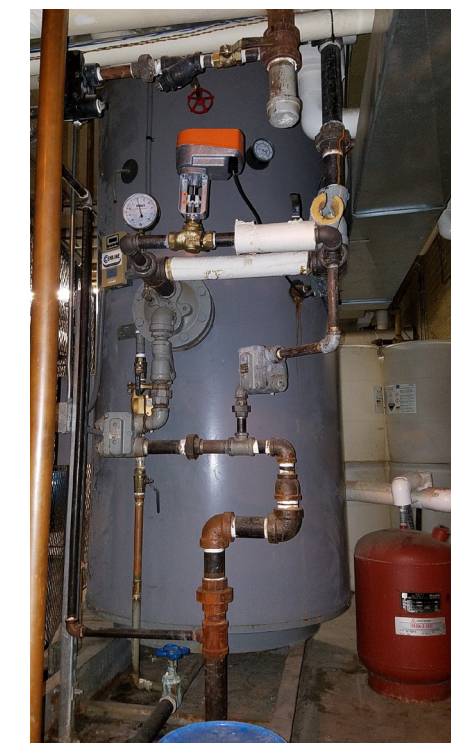
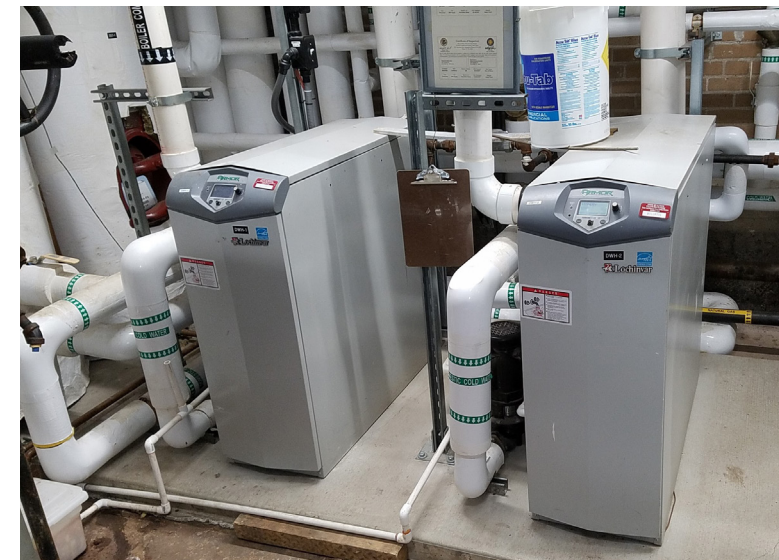
Domestic Hot Water Plants

The domestic hot water plant in the main building basement mechanical room is comprised of one (1) 500-gallon water heater with steam driven heat exchanger. The water heater and localized piping were replaced in 2002. This plant serves approximately half of the building's domestic hot water load. The pictures on the right show the equipment and location of the domestic hot water plant.

The domestic hot water plant in the pool equipment room is comprised of two (2) 800-MBH high-efficiency gas-fired domestic water heaters and one (1) 500-gallon hot water storage tank. The water heaters and storage tank and localized piping were replaced in 2016. This plant serves approximately half of the building's domestic hot water load, including the cafeteria conveyor dishwasher. The pictures on the right show the equipment and location of the domestic hot water plant.

Due to average life expectancy, the water heater system should be planned to be replaced in six (6) to ten (10) year range.

However, note that if mechanical absorption chillers are replaced, then the steam-driven water heater plant would be impacted and recommended to be replaced with that mechanical scope. Separate chiller report study is being prepared.

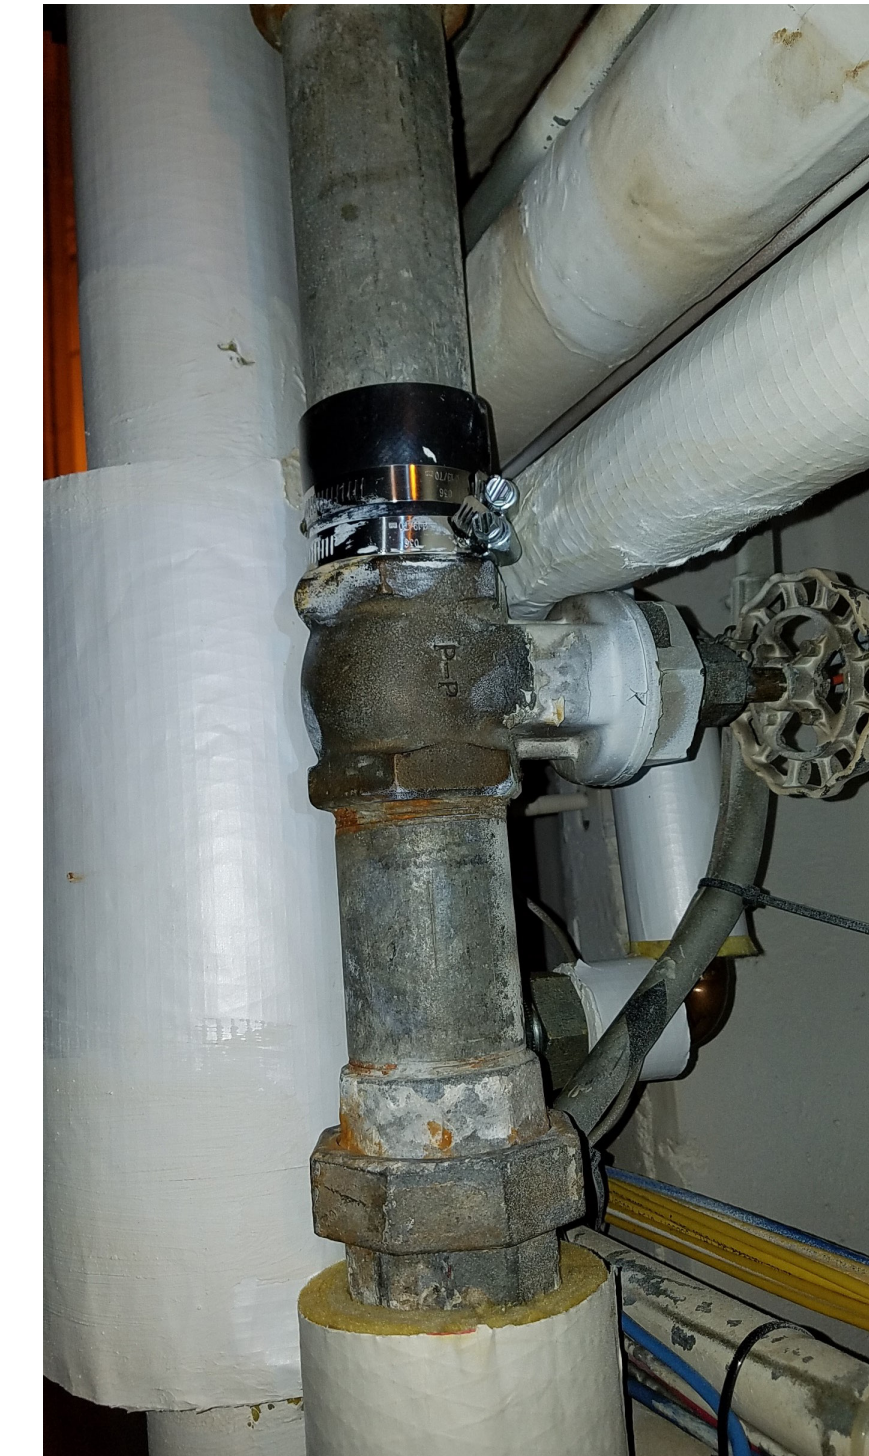
Sample of Failed Existing Galvanized Piping

The existing original domestic cold and hot water piping is galvanized piping in various levels of failure. Galvanized piping in domestic water systems corrodes overtime and generates corrosion and rust debris. Corroded pipe walls and pipe debris settle in piping creating restrictions and impacting function of isolation valves, balancing valves, check valves, faucet aerators, shower-head flow restrictors, etc. The debris materials settle at horizontal sections of pipe and piping at/near fixtures because the pipe diameter is smaller and the debris carried with water flow.

Pipe fails via mechanisms such as pitting, pin-hole leaks, and loss of pipe thickness at threaded fittings. Also, failure of threaded fittings can result in significant leak and release a high flow rate via open pipe fitting. The threading process itself cuts away pipe wall and significantly reduces pipe wall thickness and then further corrosion over time occurs.

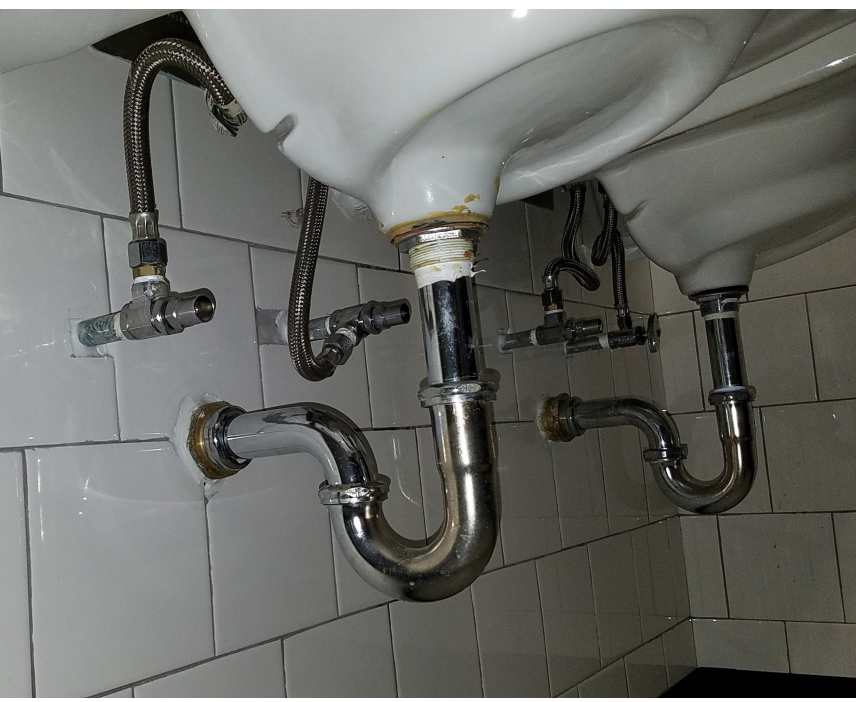
Existing Lavatories without TMV's

Thermostatic mixing valves are intended to limit hot temperature downstream of the valve. Per Code for this project, lavatories and showers require a thermostatic mixing valve either upstream of a group of fixtures or at each fixture.
