MECHANICAL, ELECTRICAL, PLUMBING, AND FIRE PROTECTION CONDITIONS

MAINE SOUTH HIGH SCHOOL

This report section will overview the existing cooling and heating systems at Maine West High School. The sections will include: building cooling plant, building heating plant, mechanical ventilation systems, unit ventilators, roof top units and recommendations.

This report section will review the existing electrical systems at Maine West High School.

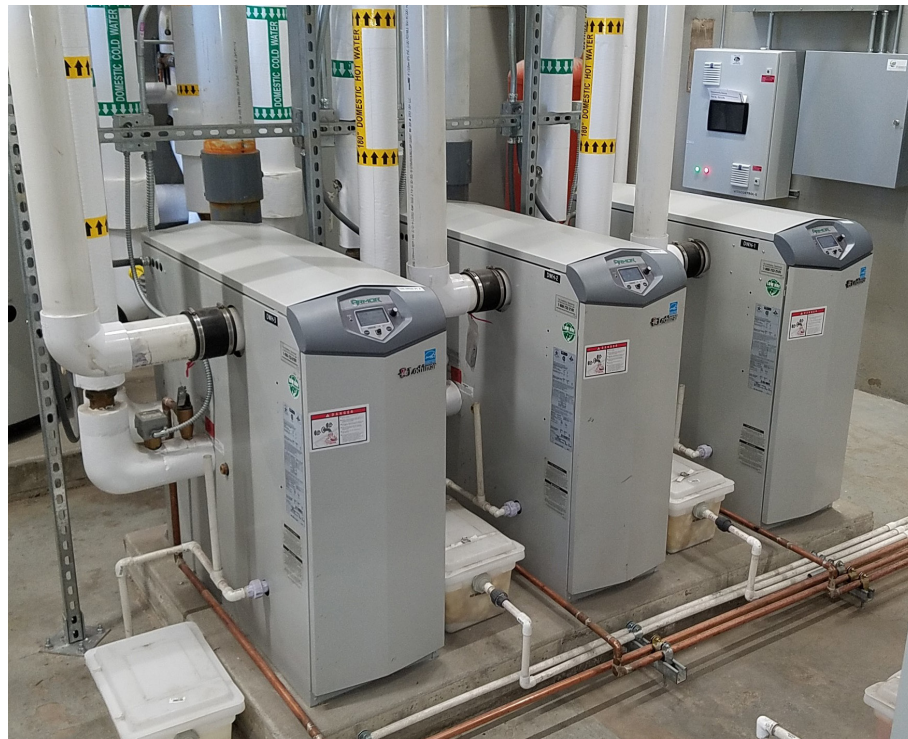
Domestic Hot Water Plant

The domestic hot water plant in the main building mechanical boiler room is comprised of three (3) 800-MBH high-efficiency gas-fired domestic water heaters and two (2) 500-gallon hot water storage tank. The water heaters and storage tank and localized piping were replaced in 2017. This plant serves entire building's domestic hot water load, including the cafeteria conveyor dishwasher. The pictures on the right show the equip ment and location of the domestic hot water plant.

No alterations are recommended for this equipment within the scope of this report.

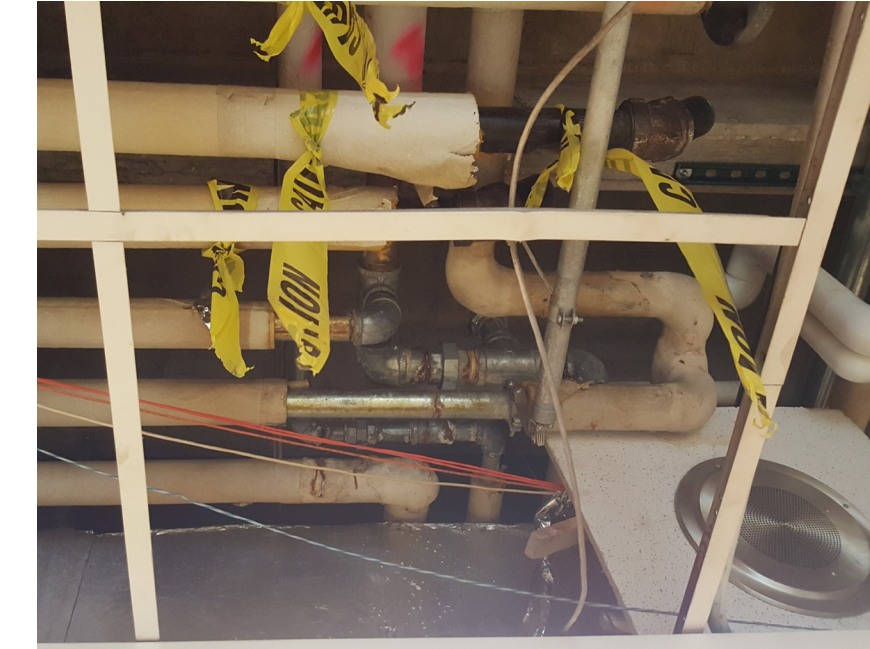
Sample of Existing Galvanized Piping

The existing original domestic water is galvanized piping. The existing original isolation valves are stem-operated valves. Hot water return piping is without adequate balancing.

The existing original domestic cold and hot water piping is galvanized piping in various levels of failure. Galvanized piping in domestic water systems corrodes overtime and generates corrosion and rust debris. Corroded pipe walls and pipe debris settle in piping creating restrictions and impacting function of isolation valves, balancing valves, check valves, faucet aerators, shower-head flow restrictors, etc. The debris materials settle at horizontal sections of pipe and piping at/near fixtures because the pipe diameter is smaller and the debris carried with water flow.

Pipe fails via mechanisms such as pitting, pin-hole leaks, and loss of pipe thickness at threaded fittings. Also, failure of threaded fittings can result in significant leak and release a high flow rate via open pipe fitting. The threading process itself cuts away pipe wall and significantly reduces pipe wall thickness and then further corrosion over time occurs.

Due to the fact that the piping is a) galvanized, b) corroding and generating rust/debris, especially on a water shut-downs, c) isolation valves failed/failing, d) check valves fowled/failed/failing or not present, e) balancing valves fowled/failed/failing or not present, and f) the resultant impact on the ability to balance the hot water recirculation the domestic cold water and hot water piping is recommended to be replaced. If replacement is necessary to be phased, the immediate focus should be on replacement of common horizontal piping, isolation valves, check valves, and balancing valves.

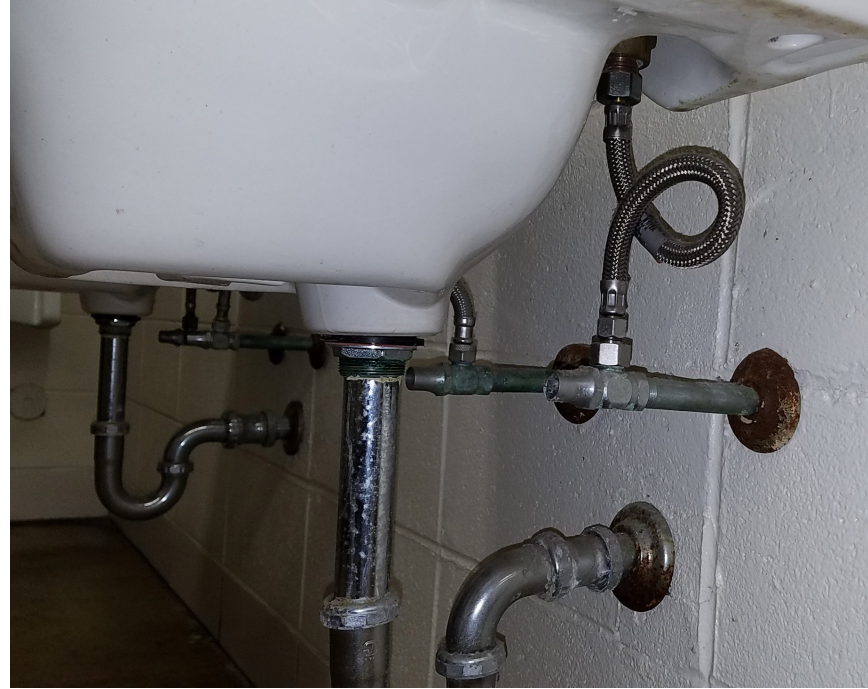
Existing Lavatories without TMV's

Thermostatic mixing valves are intended to limit hot temperature downstream of the valve. Per Code for this project, lavatories and showers require a thermostatic mixing valve either upstream of a group of fixtures or at each fixture.

Existing thermostatic mixing valves in need of repair shall be repaired/replaced as part of necessary regular maintenance program.

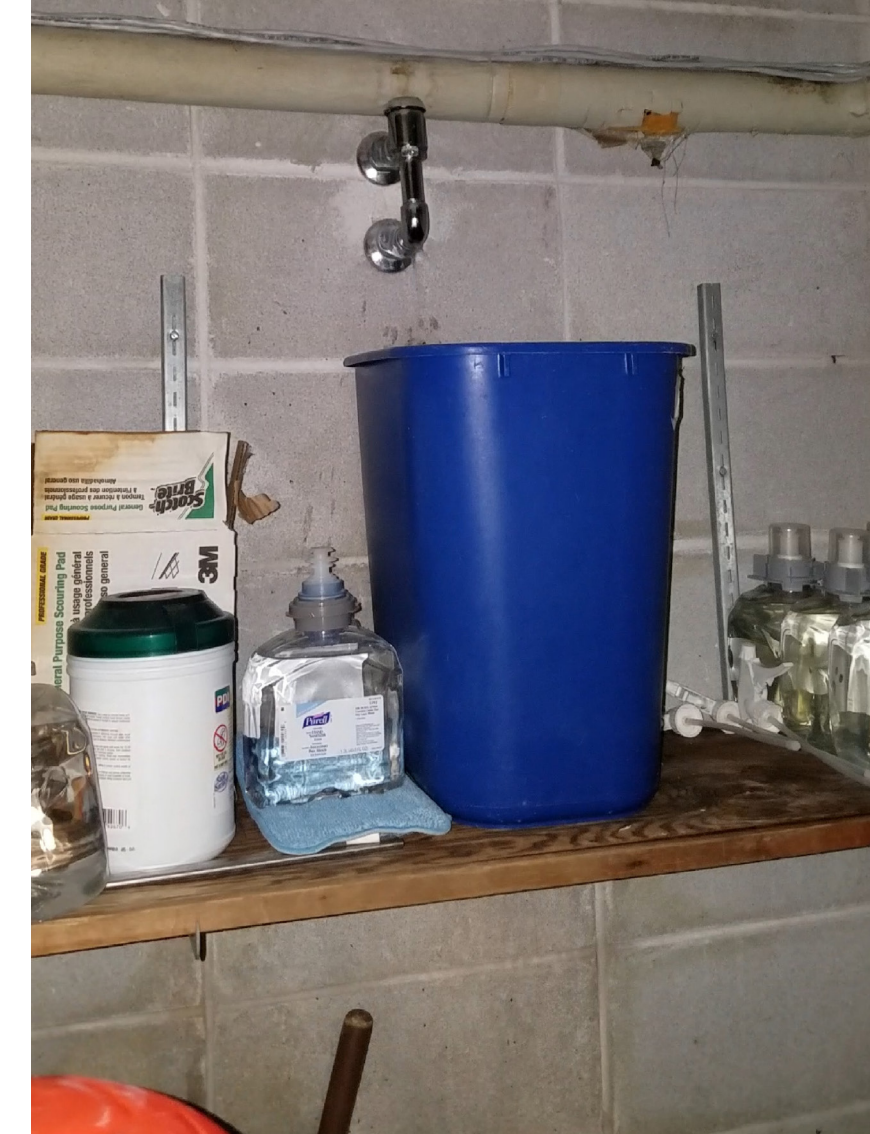
Failed Vacuum Breaker

A failed mop basin vacuum breaker at third floor (east side) of academic wing was observed.

For backflow prevention purposes and to protect the domestic water distribution system, failing/failed or deficient backflow preventers are required to be replaced for proper function of backflow protection.

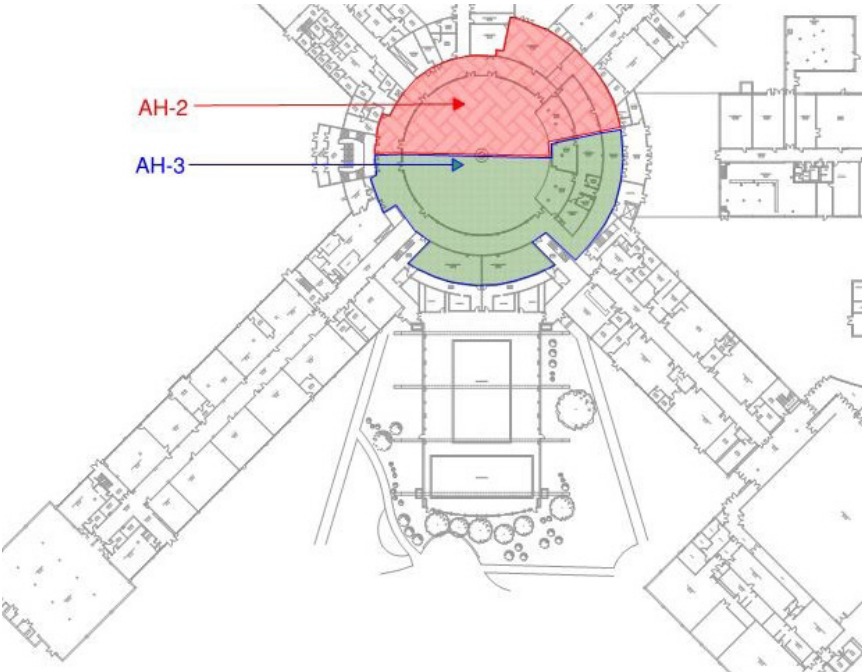
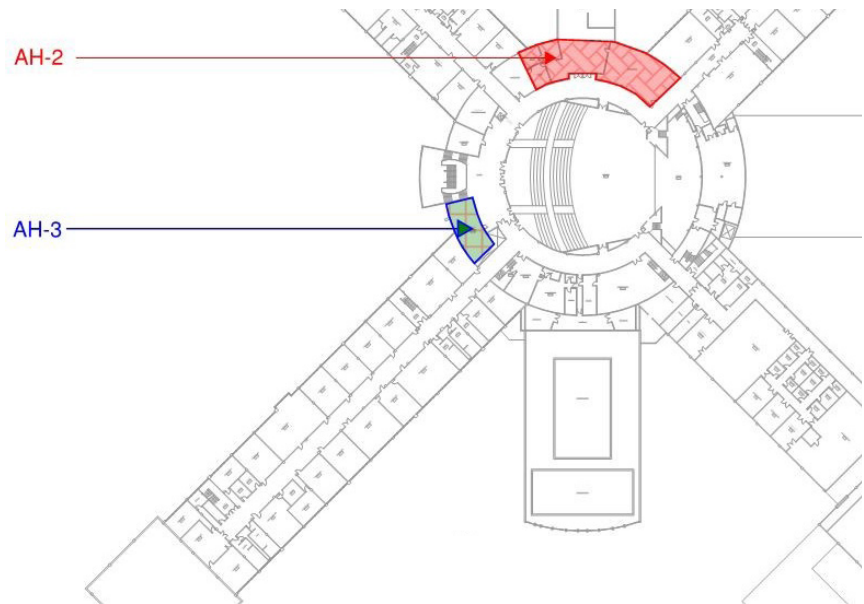
Cafeteria AHUs

Both cafeteria units have associated return fans that are original to the building and in poor condition. Due to their age, replacement parts can be costly and challenging to find.

It is recommended to replace the exhaust/return fans with a “like for like” replacement. This upgrade would provide increased reliability and efficiency due to new motor technologies. For additional details, please reference the Exhaust/Return Fan Cost Estimates section.

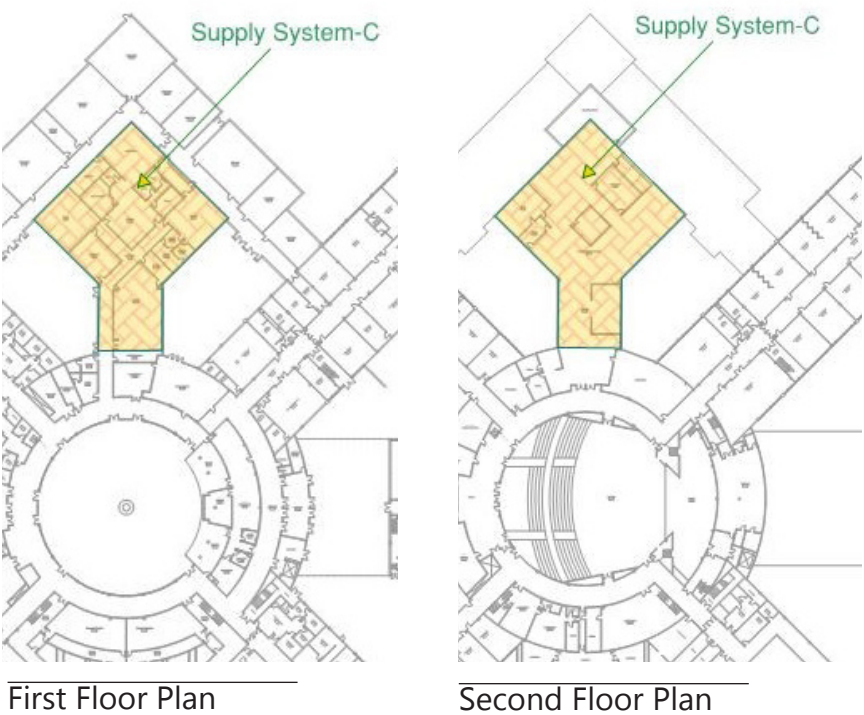
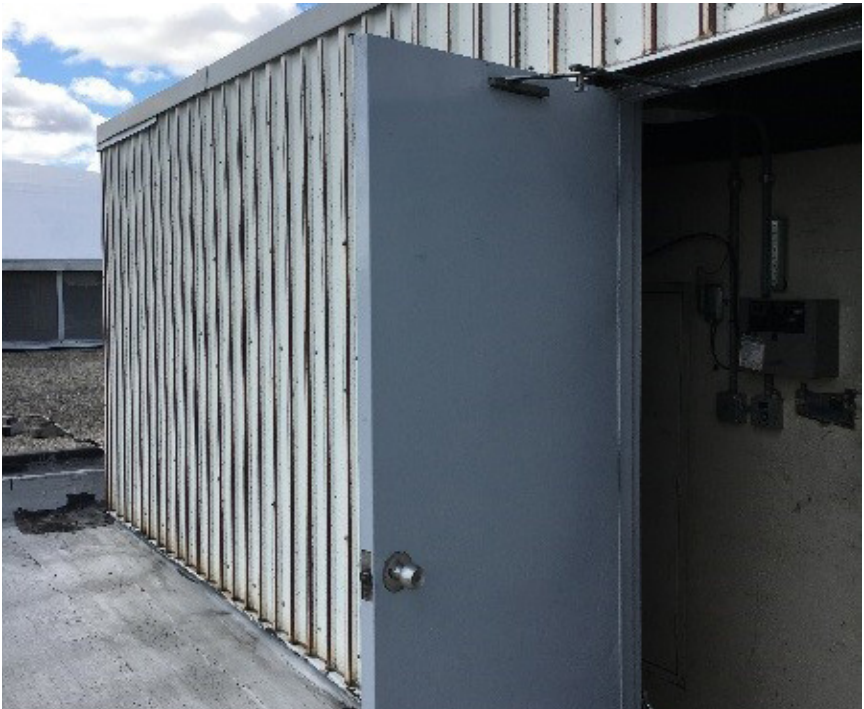
L-Wing AHU: Supply System-C

Supply System-C serves the 1st and 2nd floors of the L-Wing. This 1967 unit is located on the L-Wing roof inside of an enclosed mechanical room. Supply System-C is a constant volume, multi-zone unit that is controlled via pneumatics and is equipped with chilled water and hot water coils.

As mentioned previously, with a multi-zone system air passes through a “hot deck” and “cold deck” and then mixes to an appropriate discharge air temperature at the AHU before being delivered to a zone. Multi-zone systems are inefficient because simultaneous heating and cooling occurs at each air handler to serve the “hot deck” and “cold deck.” Additionally, constant volume systems are always running at full speed, even when the demand is low. Due to the units age there is a greater possibility of unit failure. There are two options for replacement:

OPTION 1 - Demolish the existing penthouse structure and to replace it with a variable volume RTU furnished with DX cooling, and gas heating.

OPTION 2 - Rebuild the penthouse and replace with a variable air volume AHU equipped with a chilled water coil and install terminal VAV boxes equipped with hot water reheat coils within the spaces. With both options, energy would be saved due to variable volume operation and the ability to provide heating or cooling based on space demands. Examine the AHU and RTU Cost Estimates section for further details regarding these recommended replacement options.

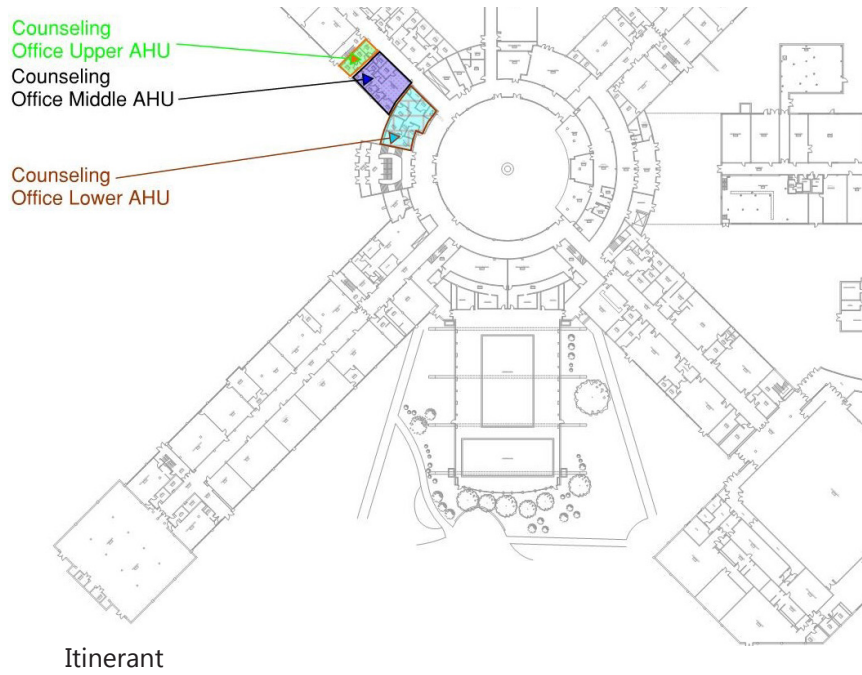
Counseling Office AHUs

According to conversations with building maintenance staff, the Upper and Middle AHUs are reportedly difficult to control, cause some areas to overheat/overcool, and do not supply an adequate amount of ventilation air. The unequal temperature distribution is partly due to the single zone perimeter finned tubed radiators that provide additional heat for spaces near windows. Furthermore, the ASHRAE median service life for a packaged medium-duty air handling unit is 25 years.

It is recommended to replace the aged Upper and Middle units with variable volume supply AHUs and DDC capabilities. Benefits from this upgrade include: increased comfort control, reliability improvements, and reduced operating costs. Please reference the AHU Cost Estimates section for pricing details.

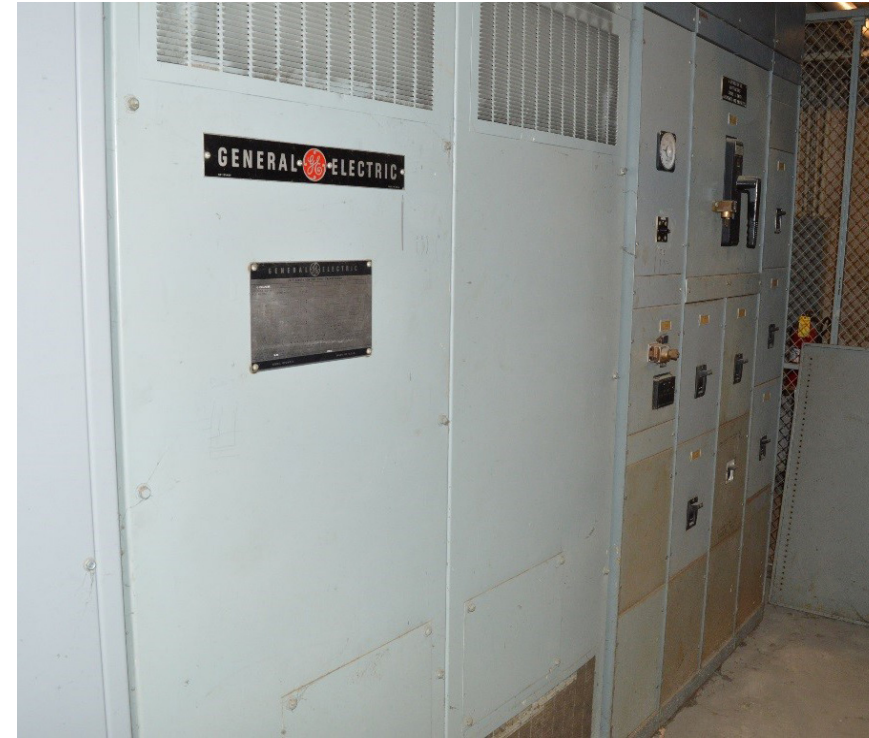
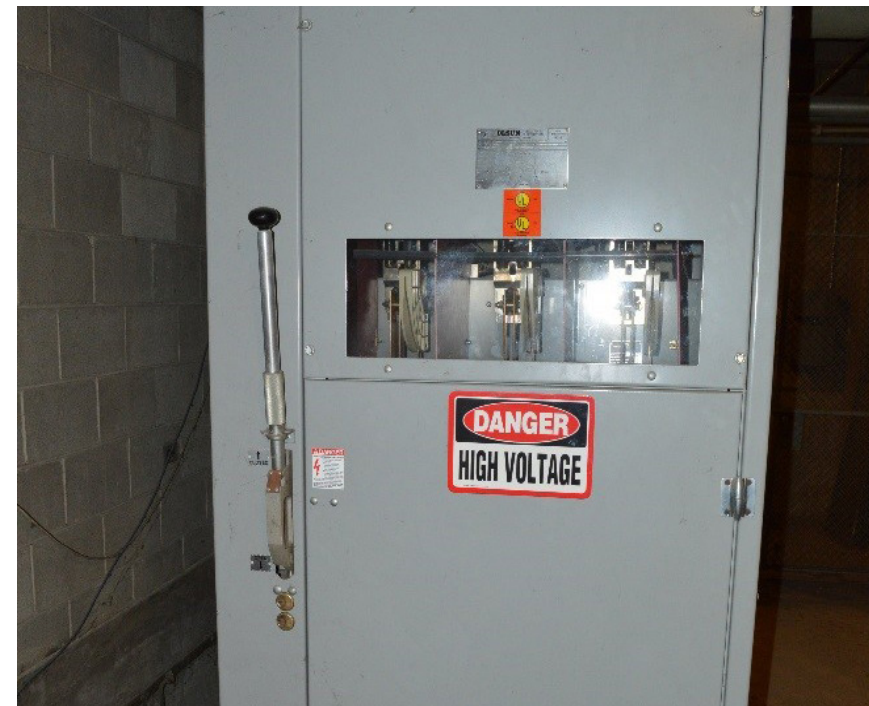
The first section of the B-Wing substation consists of a 4160V load break switch manufactured by Olsun Electric, the second section contains a 500 KVA transformer to step the voltage down to 120/208V. The third section has a 1600A circuit main secondary breaker, a 70A circuit breaker for an emergency panelboard, (7) circuit breakers for normal power, and a local ammeter. The substation was manufactured by General Electric, aside from the load break switch. The substation is original to the building, and the equipment is past its expected lifespan. Some older feeders in the substation are cloth-insulated.

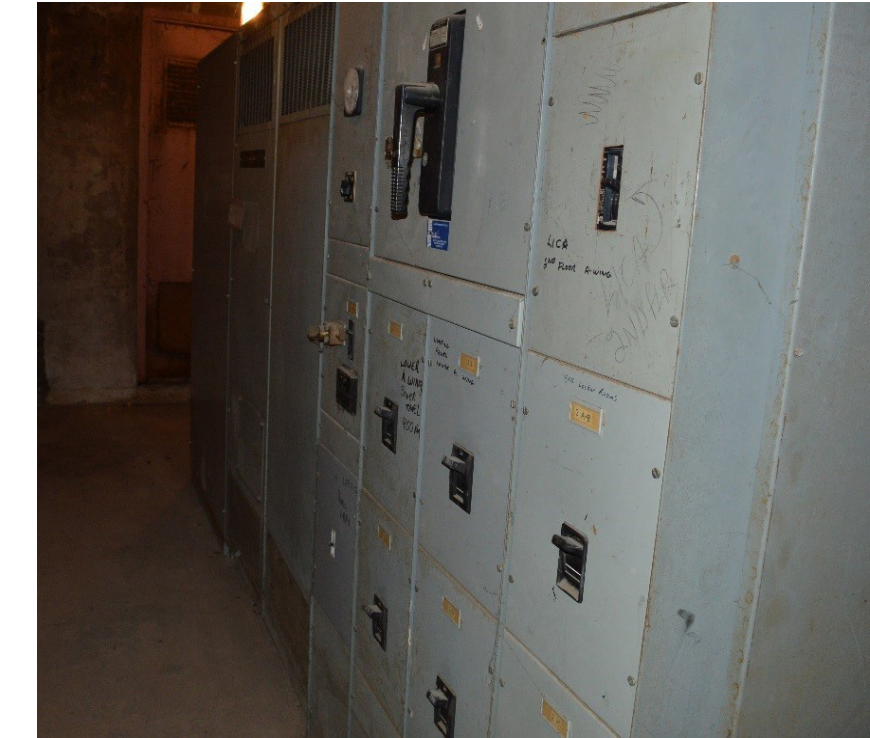
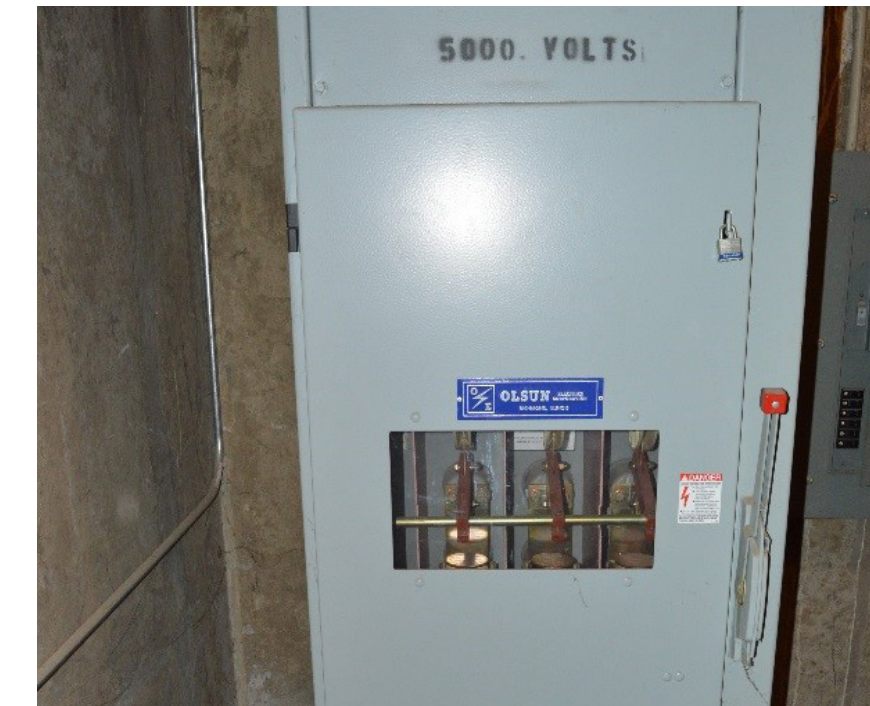
The first section of the A-Wing substation consists of a 4160V load break switch manufactured by Olsun Electric, the second section contains a 300 KVA transformer to step the voltage down to 120/208V. The third section has a 1600A circuit breaker for the building's distribution load, a 50A circuit breaker for an emergency panelboard, (9) circuit breakers for normal power, and a local ammeter. The substation was manufactured by General Electric, with the exception of the load break switch. The substation is original to the building, and the equipment is past its expected lifespan. Some older feeders in the substation are cloth-insulated.

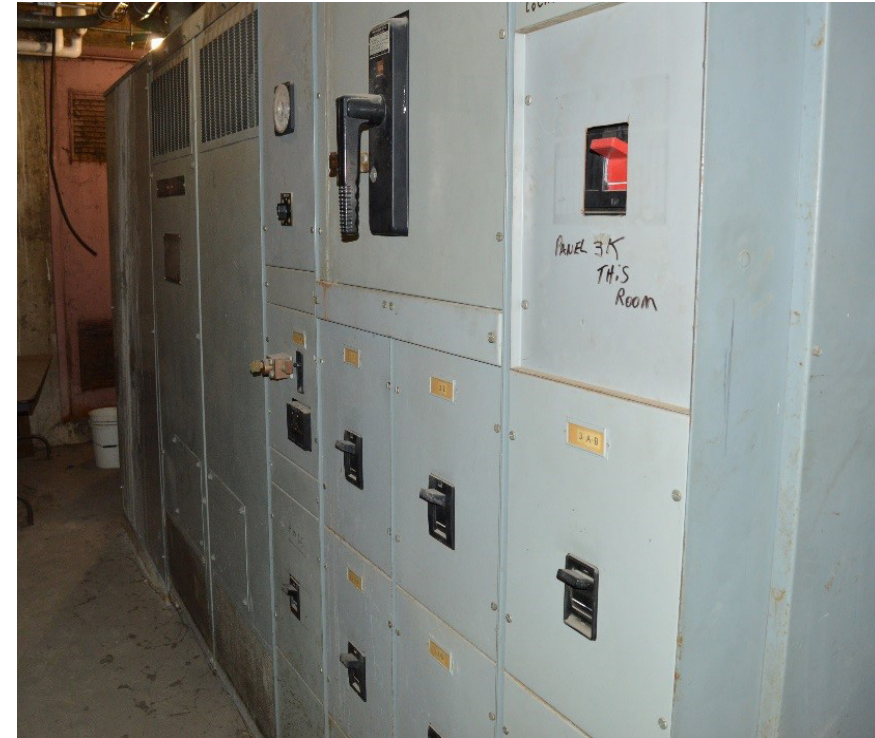
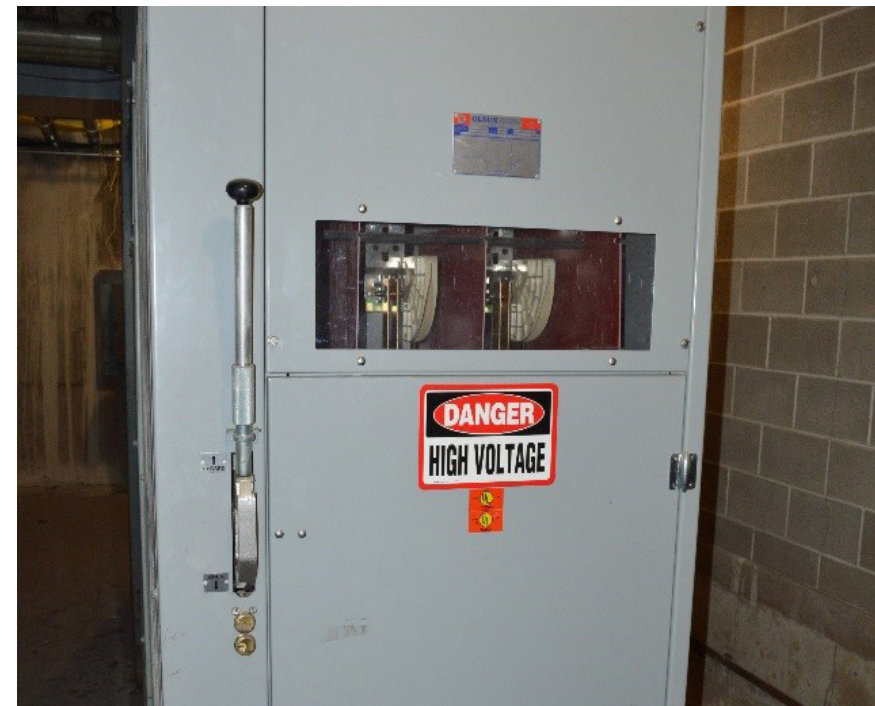
The first section of the A-Wing substation consists of a 4160V load break switch manufactured by Olsun Electric, the second section contains a 300 KVA transformer to step the voltage down to 120/208V. The third section has a 1600A circuit breaker for the building's distribution load, a 50A circuit breaker for an emergency panelboard, (9) circuit breakers for normal power, and a local ammeter. The substation is made up of parts from a number of different manufacturers. The substation is original to the building, and the equipment is past its expected lifespan. Some older feeders in the substation are cloth-insulated.

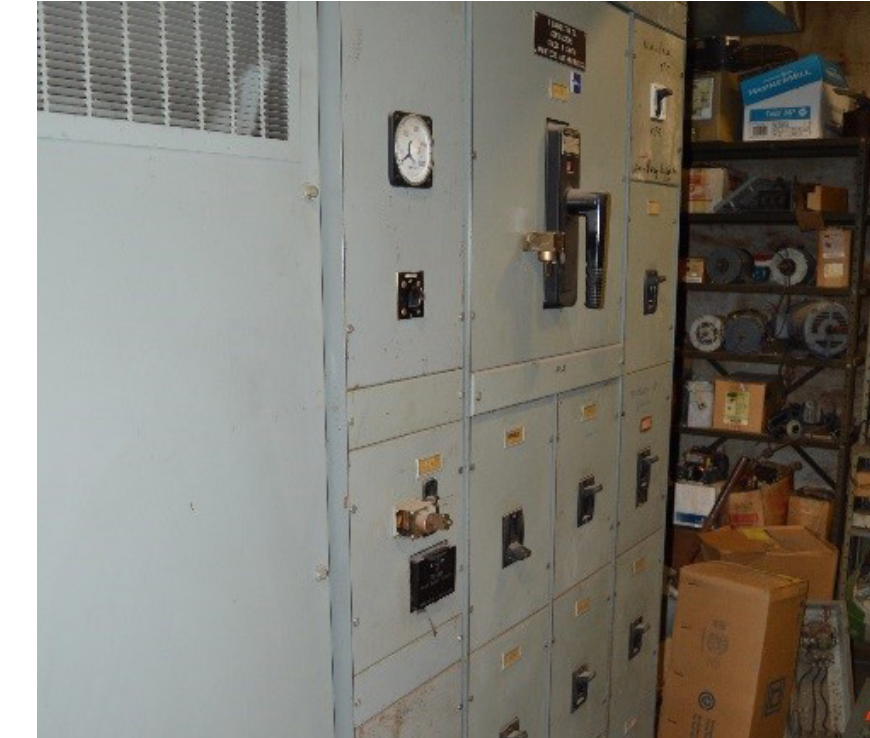
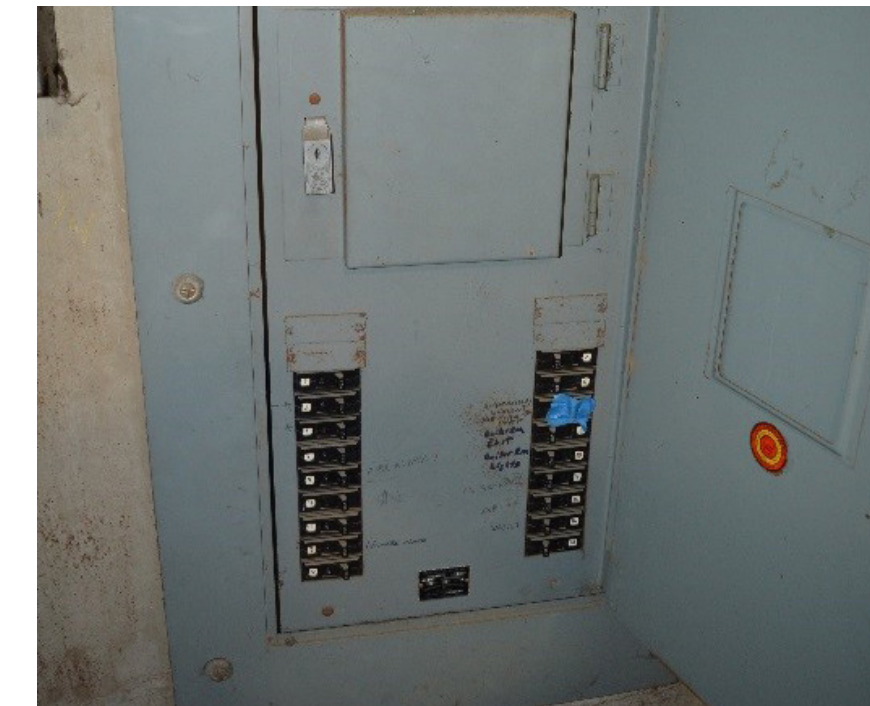
The first section of the D-Wing substation consists of a 4160V load break switch manufactured by Olsun Electric, the second section contains a 500 KVA transformer to step the voltage down to 120/208V. The third section has a 1600A circuit breaker for the building's distribution load, a 50A circuit breaker for an emergency panelboard, (13) circuit breakers for normal power, and a local ammeter. The substation was manufactured by General Electric aside from the load break switch. The substation is original to the building, and the equipment is past its expected lifespan. Some of the substation's older feeder wires are cloth-insulated.

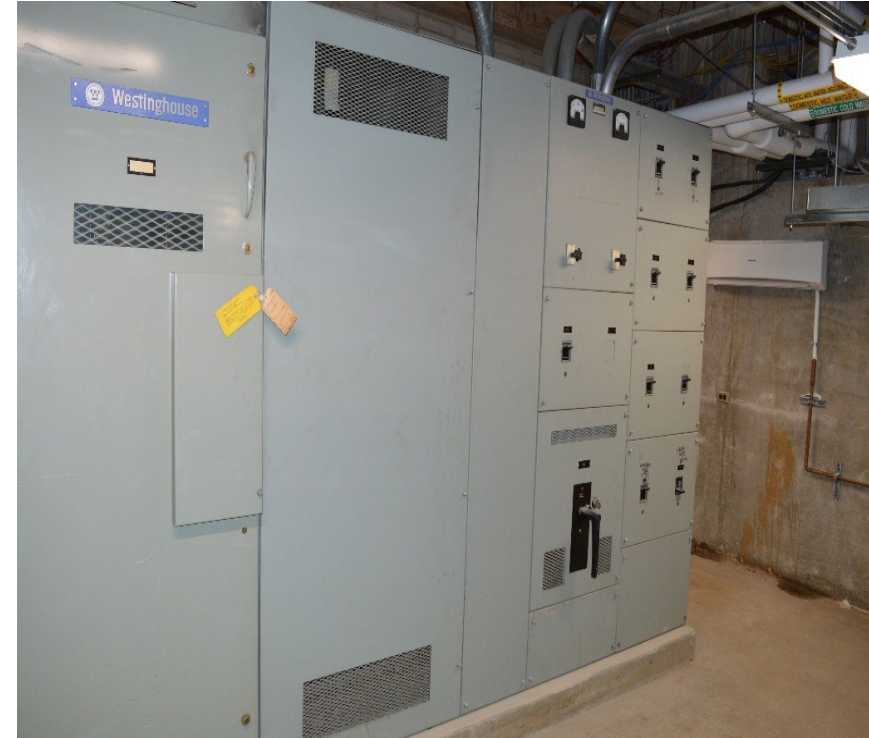
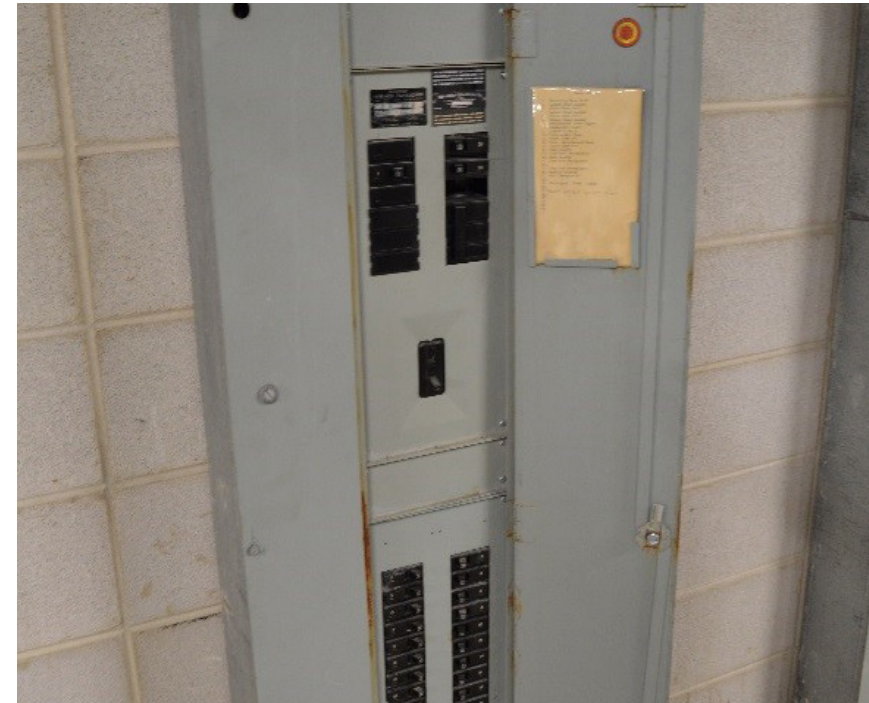
The first section of the E-Wing substation #1 consists of a 4160V load break switch manufactured by Westinghouse Electric, the second section contains a 500 KVA transformer to step the voltage down to 120/208V. The third section has a 1600A circuit breaker for the building's distribution load, a 125A circuit breaker for an emergency panelboard, (12) circuit breakers for normal power, and a local ammeter. The substation was manufactured by Westinghouse Electric. The substation is original to the building's E-Wing expansion, and the equipment is approximately at the end of its expected lifespan.

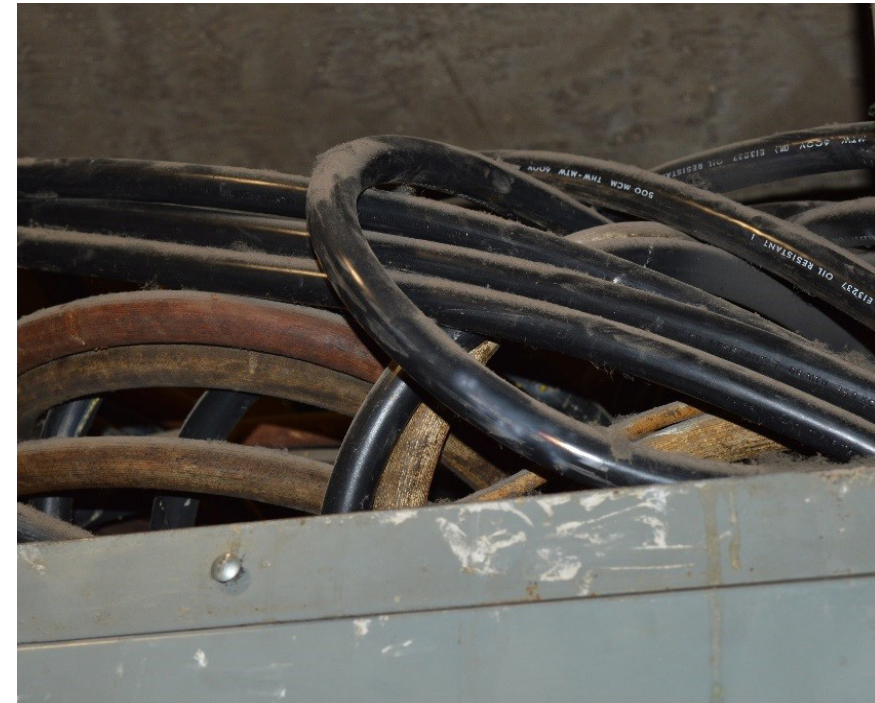
Center Core Substation – Wiring in Rear

The first section of the Center Core substation consists of a 4160V load break switch manufactured by Olsun Electric, the second section contains a 1000 KVA transformer to step the voltage down to 120/208V. The third section has a 1600A circuit breaker for the building's distribution load, a 150A circuit breaker for an emergency panelboard, (18) circuit breakers for normal power, and a local ammeter. The substation was manufactured by General Electric aside from the load break switch. The substation is original to the building, and the equipment is past its expected lifespan. Some of the substation's older feeder wires are cloth-insulated (pictured to the right).

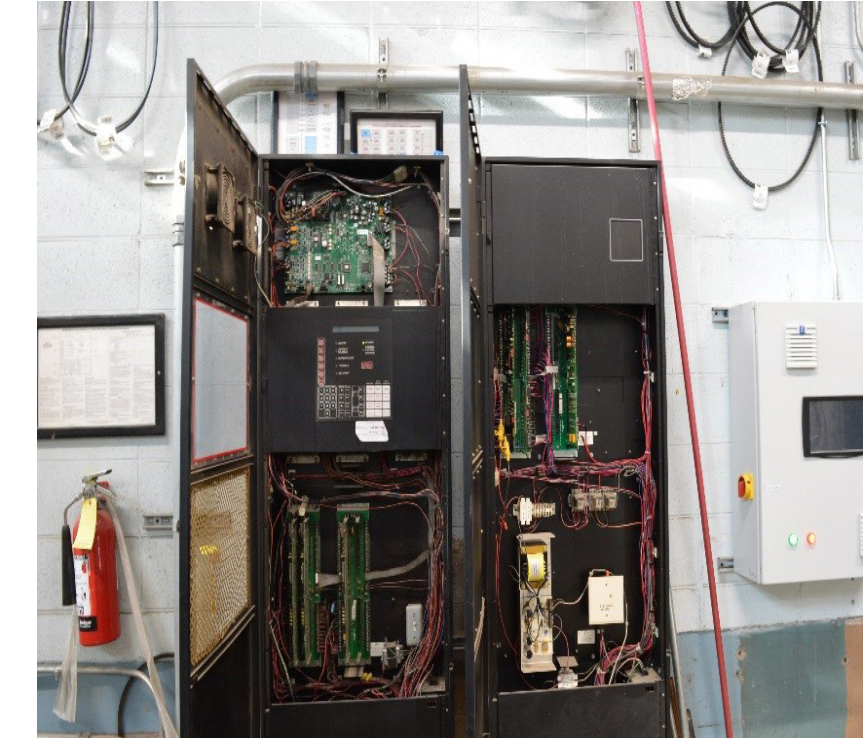
Fire Alarm Panel

The building contains a Simplex fire alarm system with a Cerberus Pyrotronics main fire alarm control panel, consisting of audio, visual, heat detector, smoke detector, and pull station devices. The system is outdated and does not meet present code in certain areas.
