MAINE WEST MEP CONDITION ASSESSMENT

MAINE WEST HIGH SCHOOL

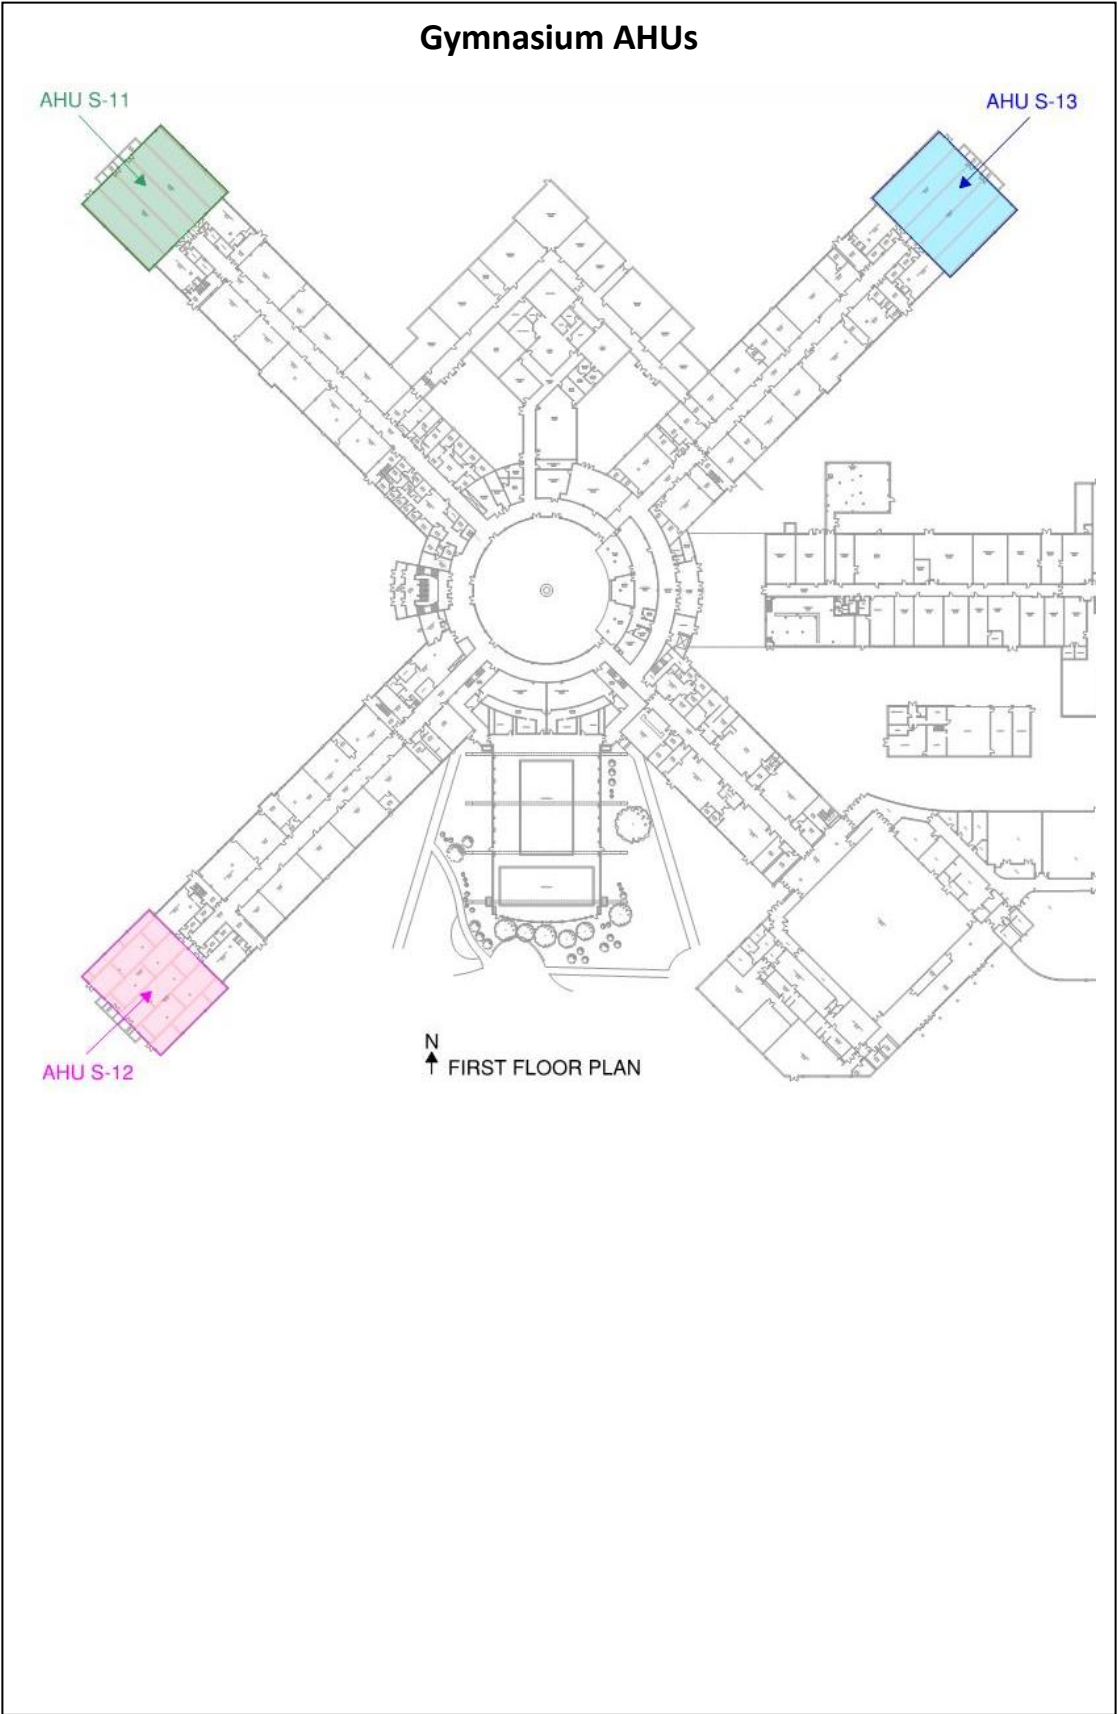
The gymnasium units are original to the building from 1958. According to ASHRAE, the median service life for these air handling units, such as those referenced above, is thirty (30) years. These units have exceeded their ASHRAE defined median equipment service life average; however, their reliability decreases with age.

Due to the limited mechanical space, it is recommended to update these units with, variable air volume packaged roof top units equipped with gas heating and DX cooling capabilities. With the transition to variable supply and cooling capabilities, considerable savings and comfort improvements would be achieved. Additionally, with the installation of a variable frequency drive (VFD) the fan motor life would be extended. The VFD allows the fan motor to “soft-start” meaning it allows the motor to slowly ramp up which reduces initial start-up shock when compared to a traditional motor start. Refer to the RTU Cost Estimates section for pricing details.

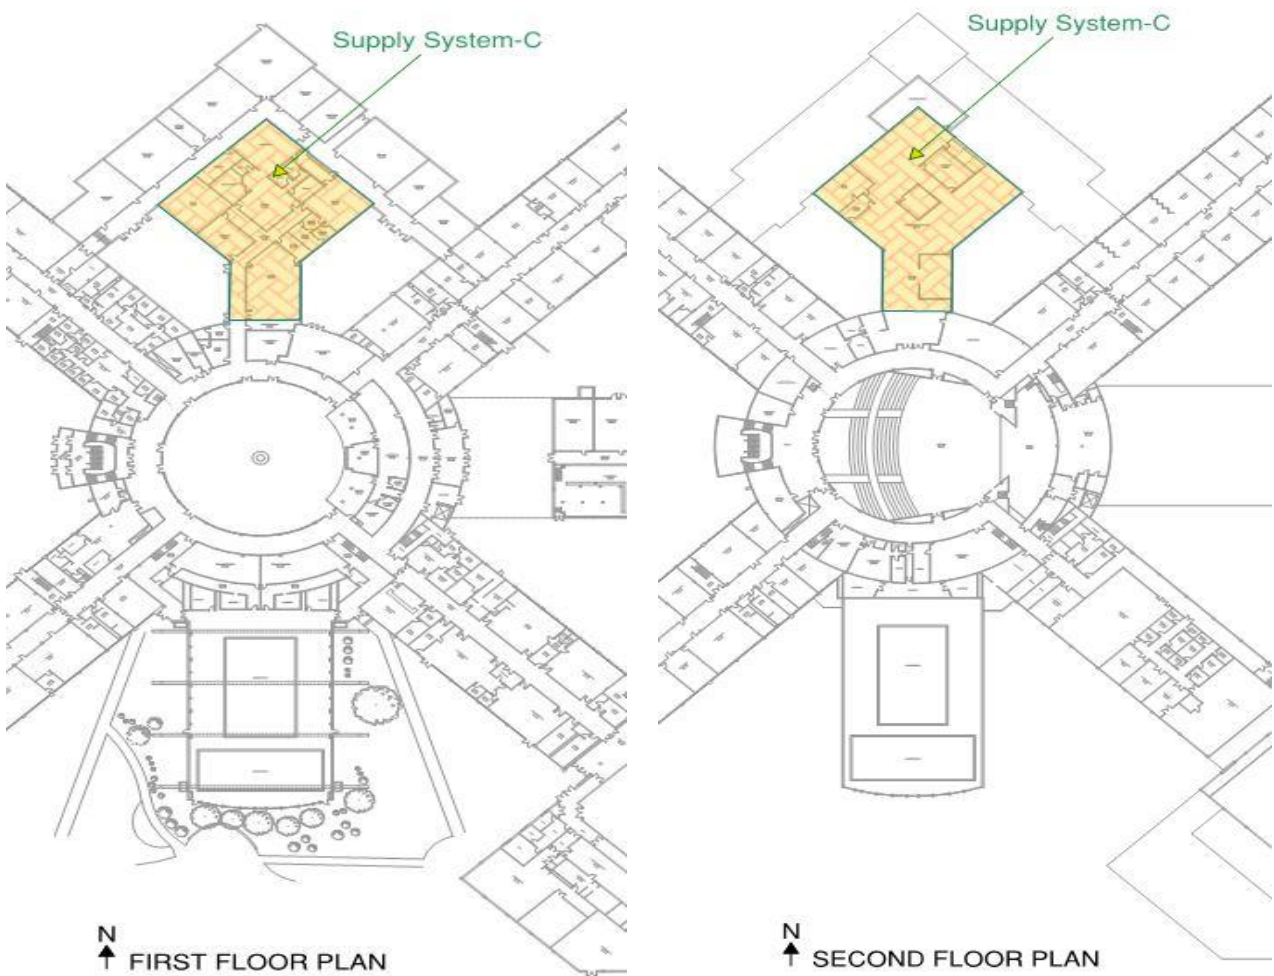
L-Wing AHU: Supply System-C

As mentioned previously, with a multi-zone system air passes through a “hot deck” and “cold deck” and then mixes to an appropriate discharge air temperature at the AHU before being delivered to a zone. Multi-zone systems are inefficient because *simultaneous* heating and cooling occurs at each air handler to serve the “hot deck” and “cold deck.” Additionally, constant volume systems are always running at full speed, even when the demand is low. Due to the units age there is a greater possibility of unit failure. There are two options for replacement:

OPTION 1 - Demolish the existing penthouse structure and to replace it with a variable volume RTU furnished with DX cooling, and gas heating.

OPTION 2 - Rebuild the penthouse and replace with a variable air volume AHU equipped with a chilled water coil and install terminal VAV boxes equipped with hot water reheat coils within the spaces. With both options, energy would be saved due to variable volume operation and the ability to provide heating or cooling based on space demands. Examine the AHU and RTU Cost Estimates section for further details regarding these recommended replacement options.

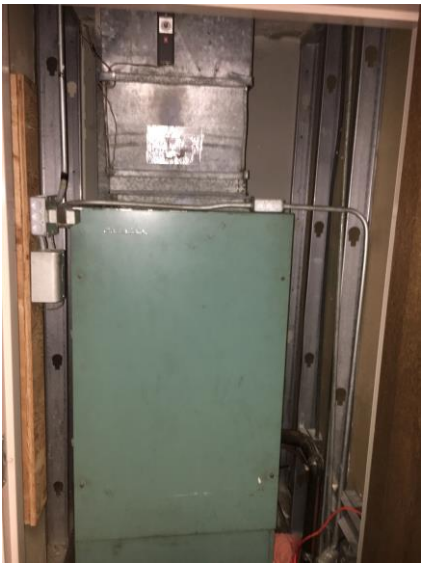
Counseling Offices Upper AHU

According to conversations with building maintenance staff, the Upper and Middle AHUs are reportedly difficult to control, cause some areas to overheat/overcool, and do not supply an adequate amount of ventilation air. The unequal temperature distribution is partly due to the single zone perimeter finned tubed radiators that provide additional heat for spaces near windows. Furthermore, the ASHRAE median service life for a packaged medium-duty air handling unit is 25 years.

It is recommended to replace the aged Upper and Middle units with variable volume supply AHUs and DDC capabilities. Benefits from this upgrade include: increased comfort control, reliability improvements, and reduced operating costs. Please reference the AHU Cost Estimates section for pricing details.

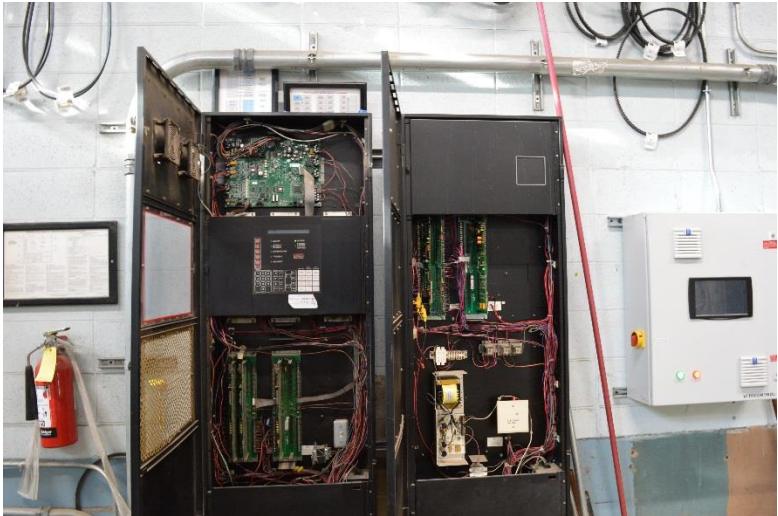
Fire Alarm Panel

The requirement of addressable devices requires the installation of new expansion cards in the existing fire alarm panel. There is not enough space in the existing fire alarm panel to install new cards, and due to the magnitude of new code requirements, it is recommended to install a completely new system that meets all requirements.
