MAINE SOUTH  
**MEP CONDITION ASSESSMENT**

## MAINE SOUTH HIGH SCHOOL

## Mechanical Assessment

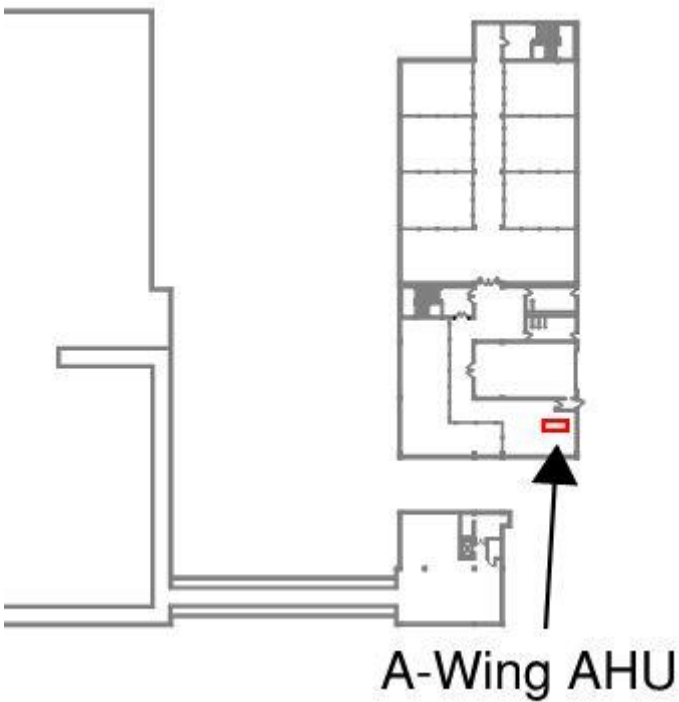
A-Wing Basement Location

The A-Wing basement AHU was installed in 1968 and is in poor condition due to its age. It is recommended to replace this AHU with a like for like replacement. Please reference the AHU Cost Estimates for pricing information.

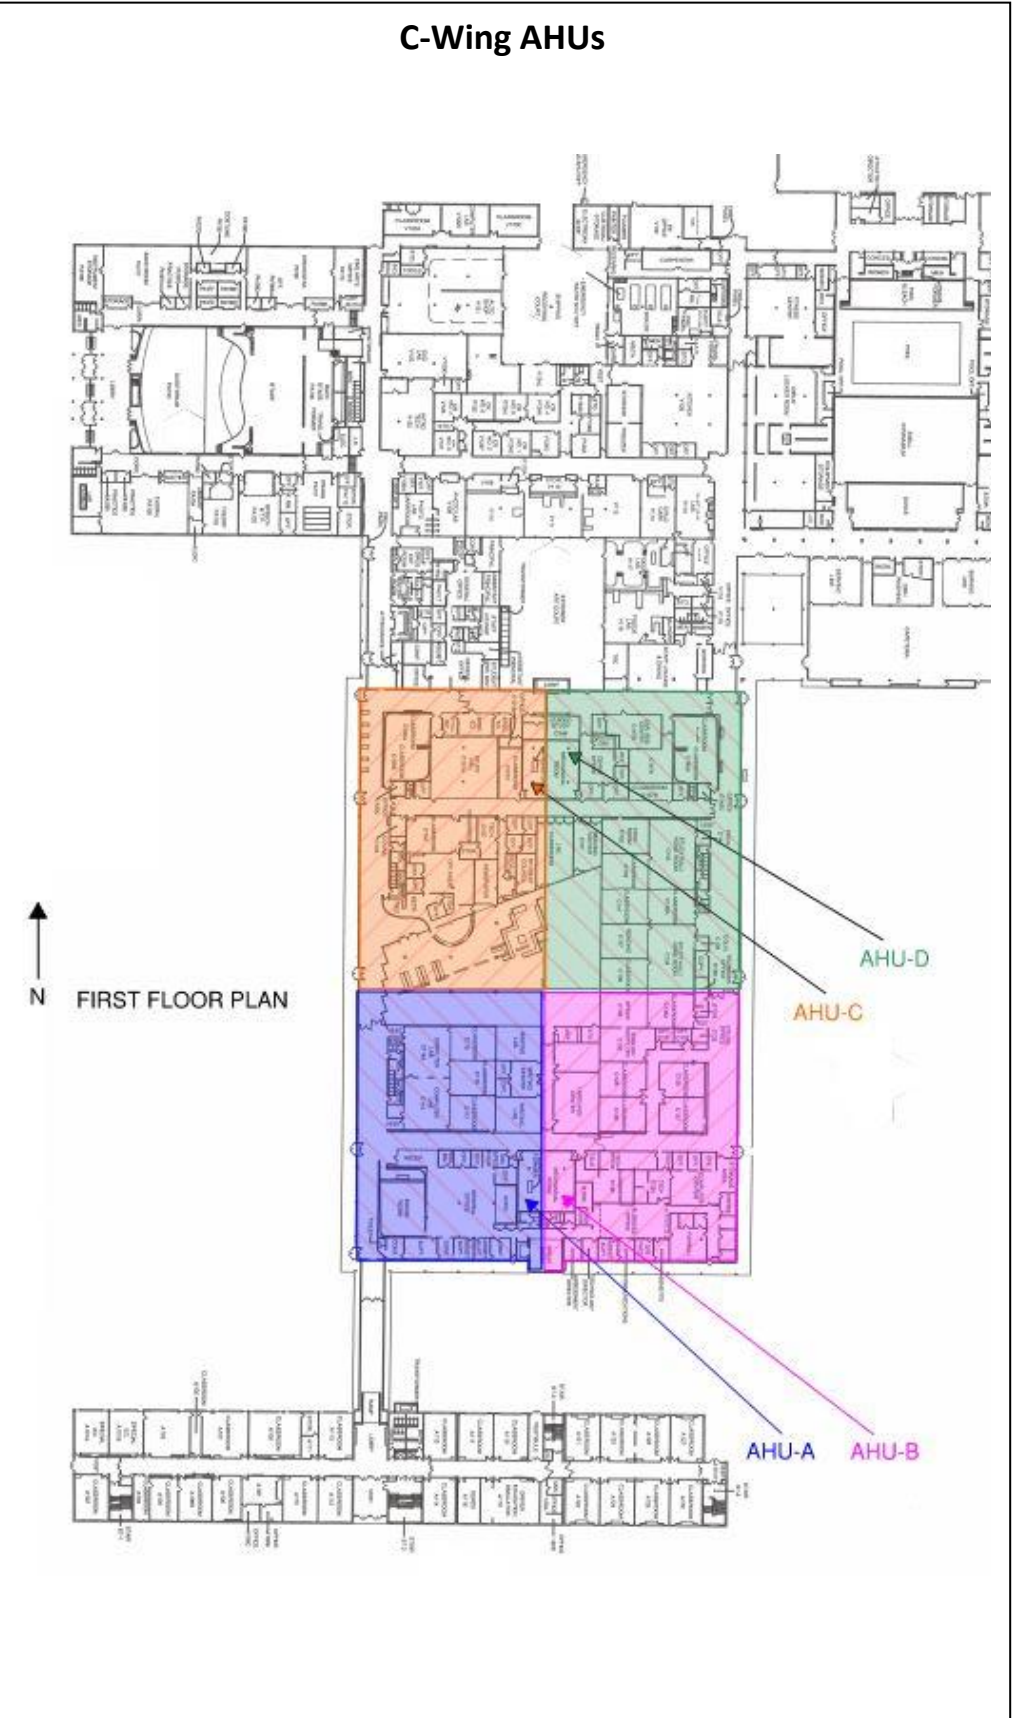
Dual-duct systems are energy intensive because *simultaneous* heating and cooling occurs at each air handler to serve “hot deck” and “cold deck” ducts, which mix to space appropriate temperatures at local mixing boxes. This type of operation is less efficient than *only* heating or *only* cooling a space. Additionally, the ASHRAE median equipment service life for built-up heavy-duty air handling units, such as those found within C-Wing, is thirty (30) years. In this case, these units have doubled the ASHRAE median service life.

Because of the age and inefficiency of the dual-duct systems present in C-Wing, it is recommended to replace the existing air handlers with variable flow AHUs that support either fan powered box terminal units or VAV box terminal units, each with hot water reheat coils. Both fan powered box and VAV systems would provide significant energy savings in comparison to the existing systems because they both provide variable fan speeds and heating or cooling to spaces *only* when necessary. Additionally, fan motor life is extended because a fan motor with a variable volume VFD can “soft-start.” A “soft-start” increases motor life because it allows the motor to slowly ramp up which reduces initial start-up shock when compared to a traditional motor start. Please reference the AHU Cost Estimates for pricing details.

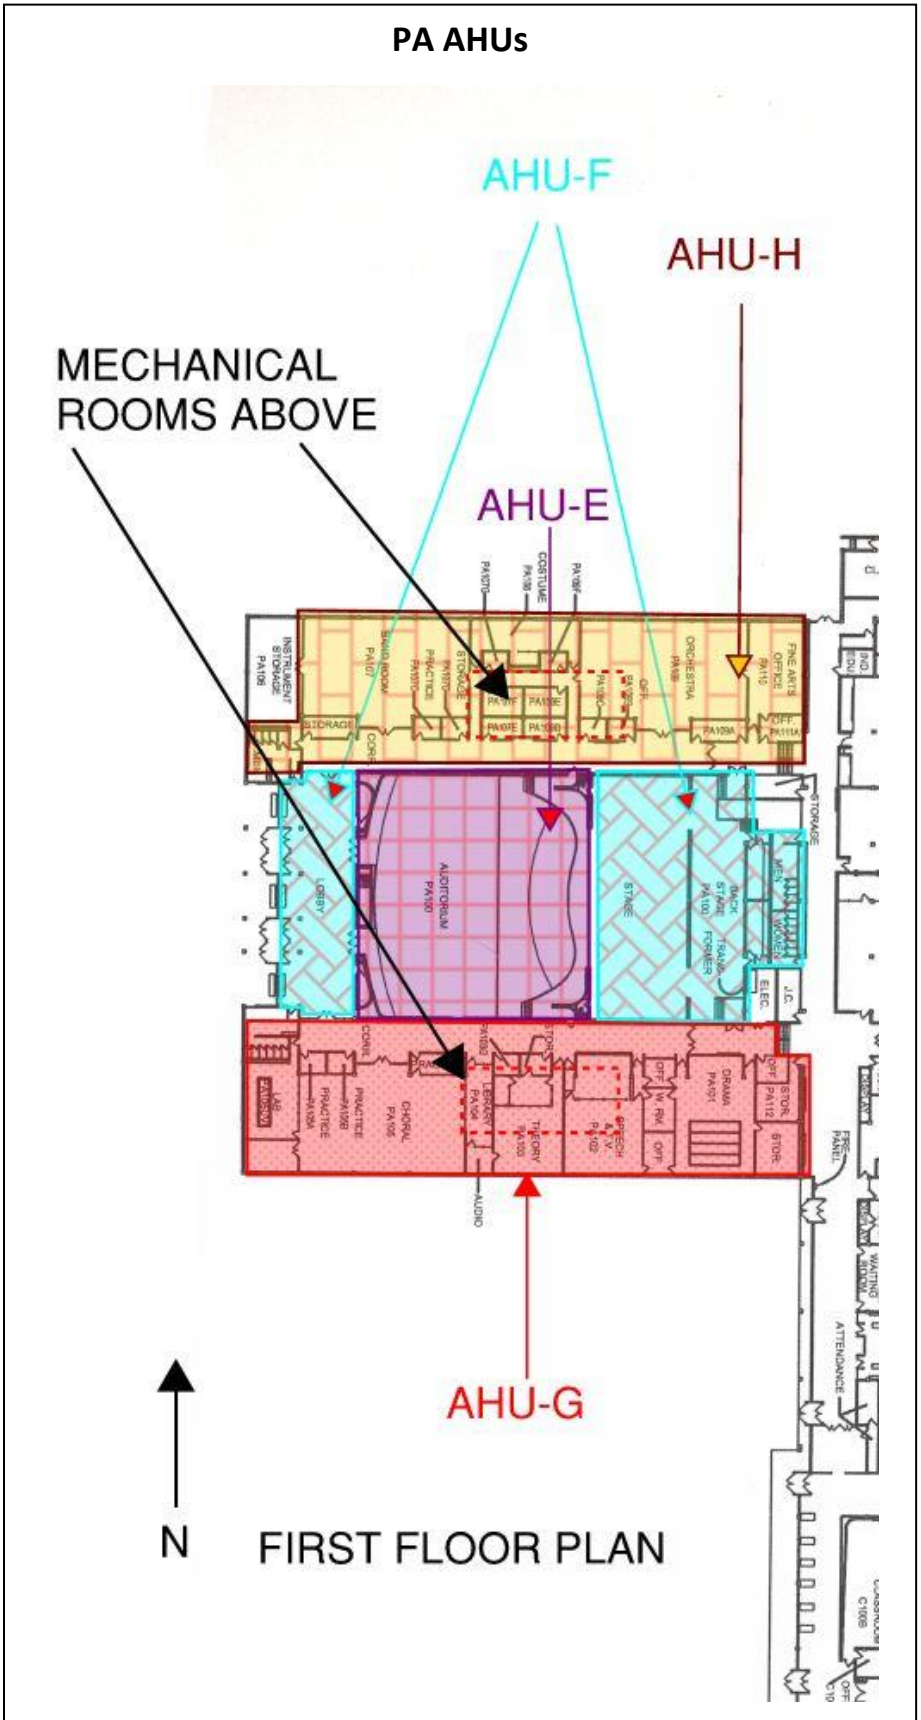
Auditorium AHUs E and F are original to the building from 1964. Each unit delivers constant volume supply air and utilizes chilled water and hot water coils to condition their space. These AHUs are substantially aged, and have surpassed their ASHRAE median equipment service life of thirty (30) years. Moreover, constant volume systems are considerably less energy efficient than today’s technology.

It is recommended to upgrade the AHUs referenced above with new AHUs that distribute variable volume supply directly to the zones of service. In these instances, the air handler itself acts as a VAV box providing variable supply to only one or two spaces. With a variable volume system upgrade, fan supply air is dependent on the space requirements; when demand is low, the fan reduces its speed, which results in significant energy savings both from the perspective of fan energy as well as heating and cooling energy. Please reference the AHU Cost Estimates for pricing information.

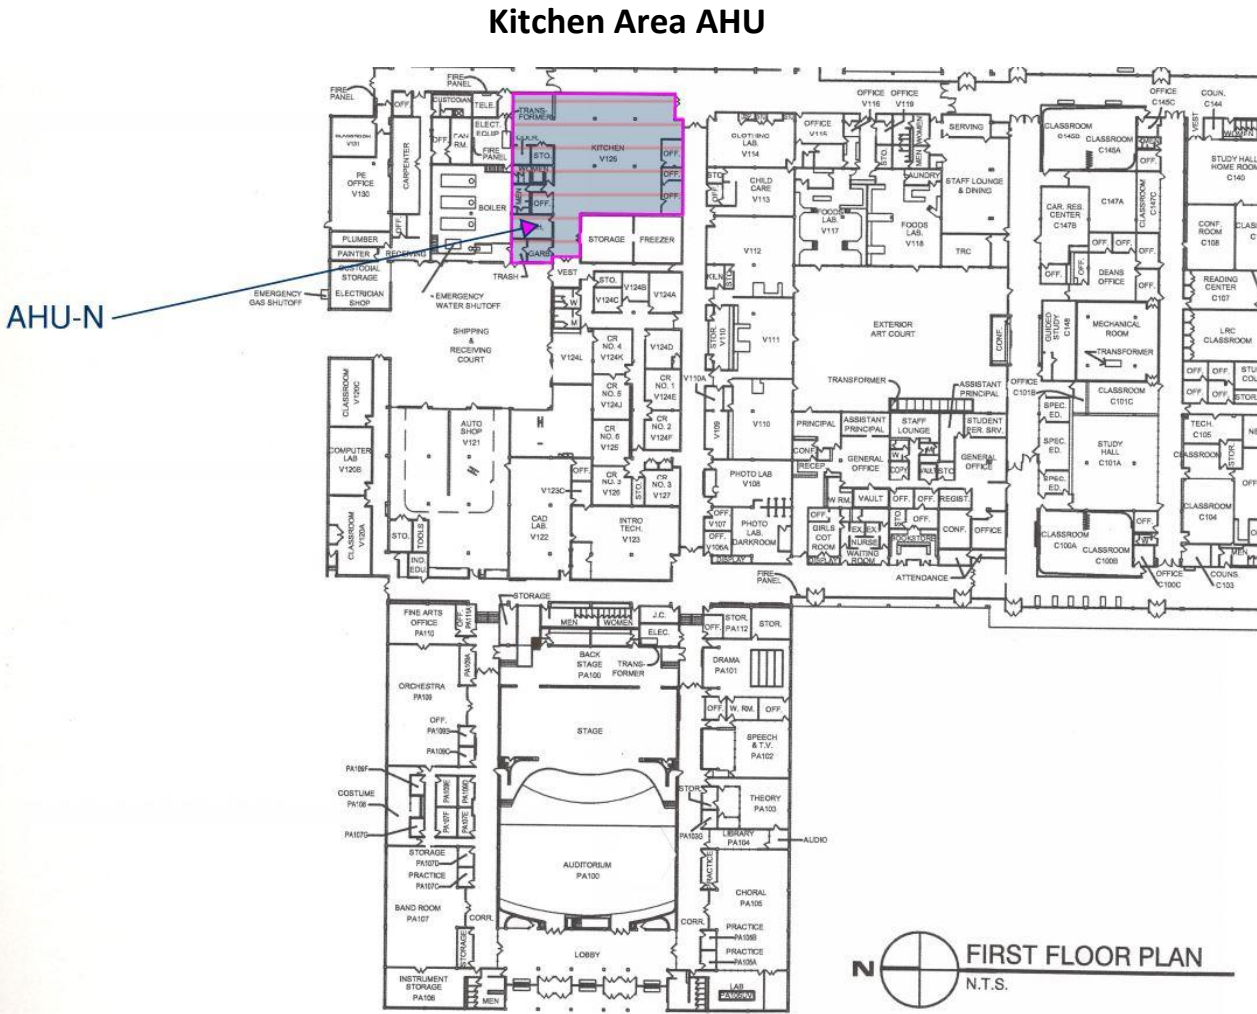
Kitchen AHU-N is original to the building from 1964. This unit delivers constant volume supply air and utilizes chilled water and hot water coils to condition the kitchen. AHU-N has surpassed its ASHRAE median equipment service life of thirty (30) years and is substantially aged. Additionally, constant volume systems are considerably less energy efficient than today’s technology.

It is recommended to upgrade the AHU-N with a new AHU that distributes variable volume supply directly to the zones of service. In this case, the air handler itself acts as a VAV box providing variable supply to only one or two spaces. With a variable volume system upgrade, fan supply air is dependent on the space requirements; when demand is low, the fan reduces its speed, which results in significant energy savings both from the perspective of fan energy as well as heating and cooling energy. Please reference the AHU Cost Estimates for pricing information.

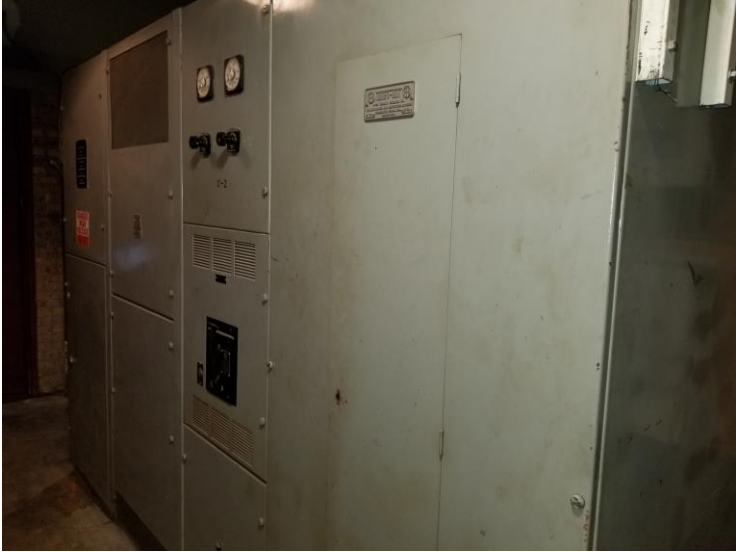
Substation C-2

The first section of the C-2 substation consists of a 4160V load break switch manufactured by I-T-E circuit breaker company, the second section contains a 500 KVA transformer to step the voltage down to 120/208V. The third section has a 1600A circuit breaker for the building's distribution load, as well as a 100A circuit breaker emergency panelboard. The fourth section has a board containing normal power distribution circuit breakers. The entire board is manufactured by I-T-E circuit breaker company. The substation is original to the building, and the equipment is past its expected lifespan.

Any panelboards fed via cloth-insulated wiring should be re-fed with equivalent thermoplastic-insulated wire as replacements occur.

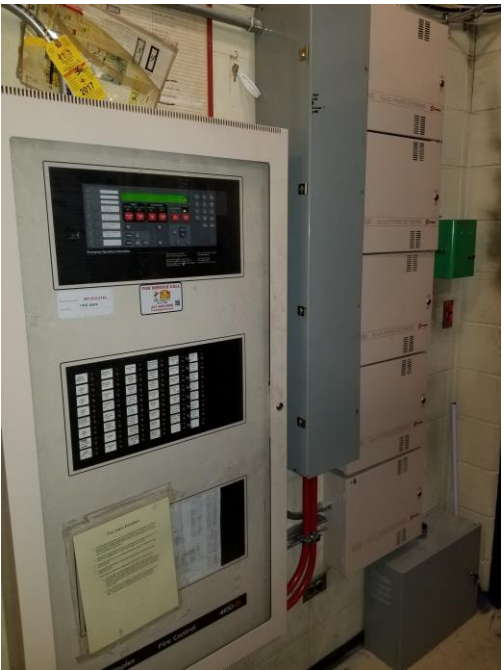
**Fire Alarm Panel**

The design process is underway for a complete replacement of the existing fire alarm system, to be implemented in 2018. This replacement serves as a modernization project, as the existing fire alarm control panel is outdated and incompatible with certain newer fire alarm technologies that are beneficial in a school setting such as voice communication.

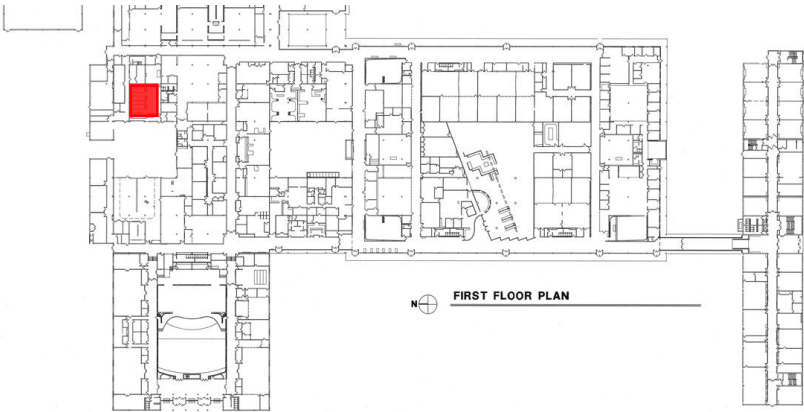
Domestic Hot Water Plant Location

Domestic hot water for Maine South is provided by one (1) domestic hot water plant. The plant is located in the main building mechanical boiler room (replaced in 2017).

The domestic hot water plant in the main building mechanical boiler room is comprised of three (3) 800-MBH high-efficiency gas-fired domestic water heaters and two (2) 500-gallon hot water storage tank. The water heaters and storage tank and localized piping were replaced in 2017. This plant serves entire building’s domestic hot water load, including the cafeteria conveyor dishwasher. The pictures on the right show the equipment and location of the domestic hot water plant.

No alterations are recommended for this equipment within the scope of this report.
