MECHANICAL, ELECTRICAL, PLUMBING, AND FIRE PROTECTION CONDITIONS

MAINE EAST HIGH SCHOOL

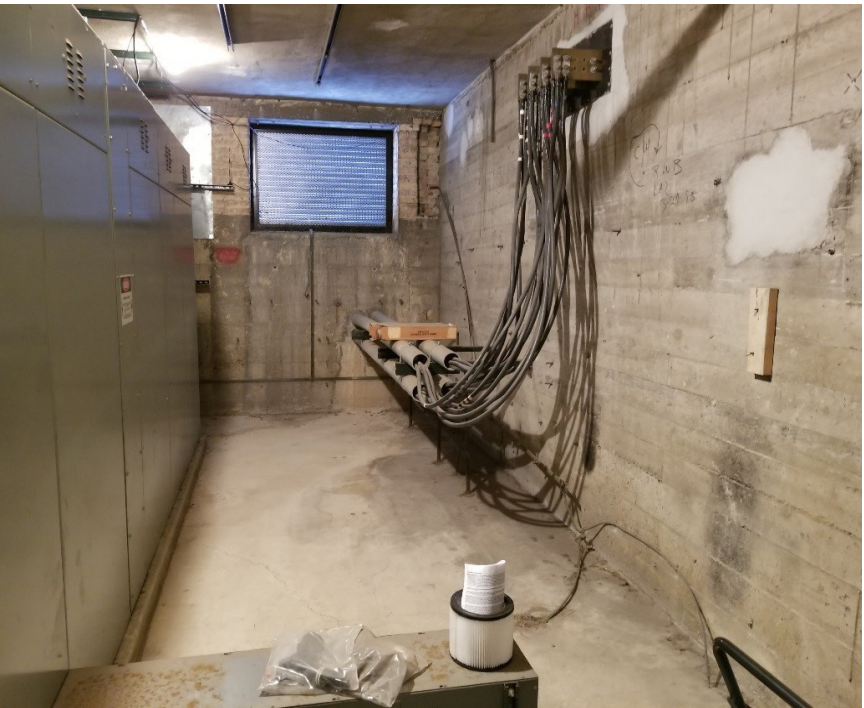
Secondary Cables to Basement Electrical Room

Some distribution equipment can be found in this room outside of the switchboard, mounted along the walls. While some of the oldest pieces of equipment are no longer functional, there are a few live-front enclosures that still see active use, such as fuse panels for lighting.

We strongly recommend the replacement of all existing live-front equipment as soon as possible. Virtually all such equipment can be replaced by a dead-front equivalent, providing much greater safety to maintenance personnel and anyone else who may need to access the equipment.

We recommend to exercise the existing switchboard breakers to verify proper operation and reduce risk of becoming stuck in a certain position at an inopportune time. Additionally, we recommend annual thermal inspections of the switchboard, distribution panels, and other equipment in order to more easily identify problematic areas of unwanted heat buildup in the system.

The switchboard room currently has several items scattered about the floor, obstructing access to most of the room's electrical equipment. It is recommended to find suitable storage for these items and maintain a minimum 36 inch front clearance for all electrical equipment.

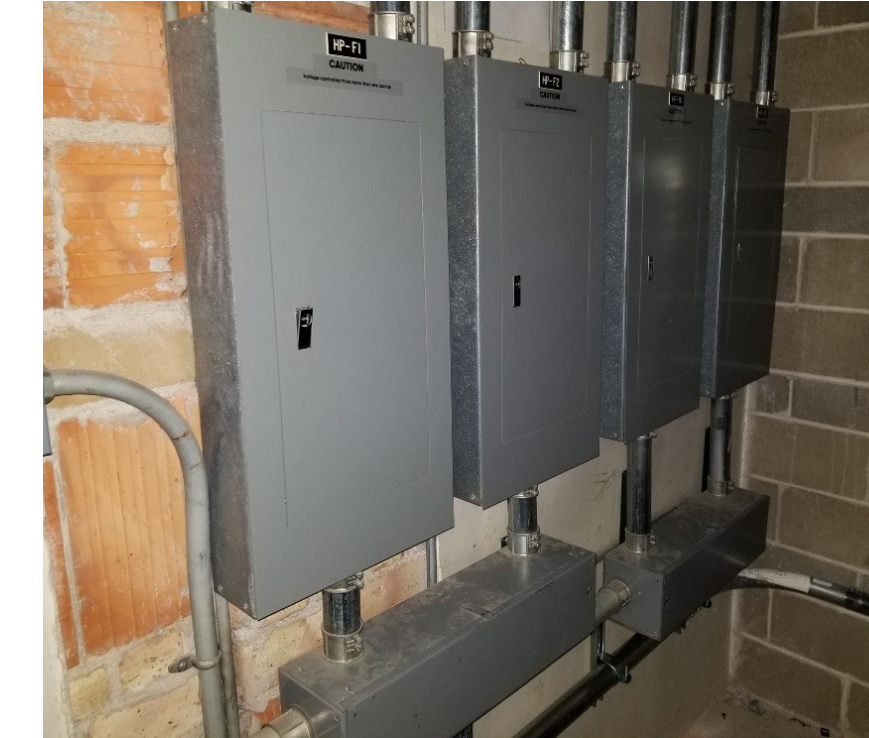
Lighting Panelboards - Auditorium

The school's load centers are distributed throughout the school, only a few are located in the switchboard rooms where the main power distribution resides. The condition of the panels are varied, many having been replaced over the course of the facility's history from live-front fuse panels to newer units from Square-D, I-T-E, and Erickson, though a few live-front units still remain. Almost all panelboards are three-phase units, with supply voltages that are either 120/208V or 277/480V throughout the school. Many panelboards are recessed-type, found in the facility corridors

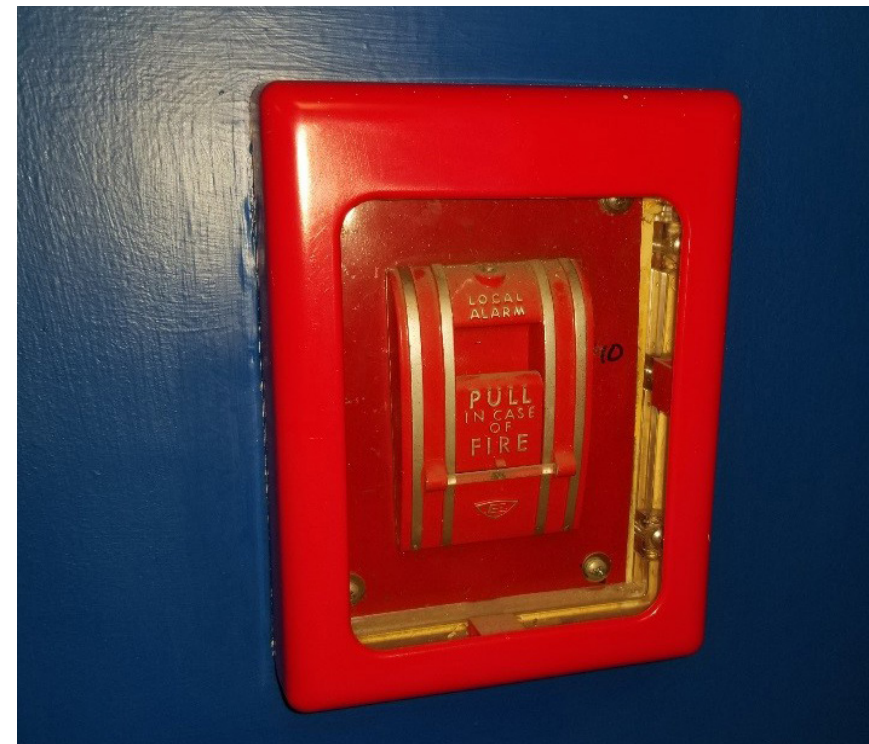
Fire Alarm Pull StationElectrical Room

The requirement of addressable devices requires the installation of new expansion cards in the existing fire alarm panel. There is not enough space in the existing fire alarm panel to install new cards, and due to the magnitude of new code requirements, it is recommended to install a completely new system that meets all requirements.

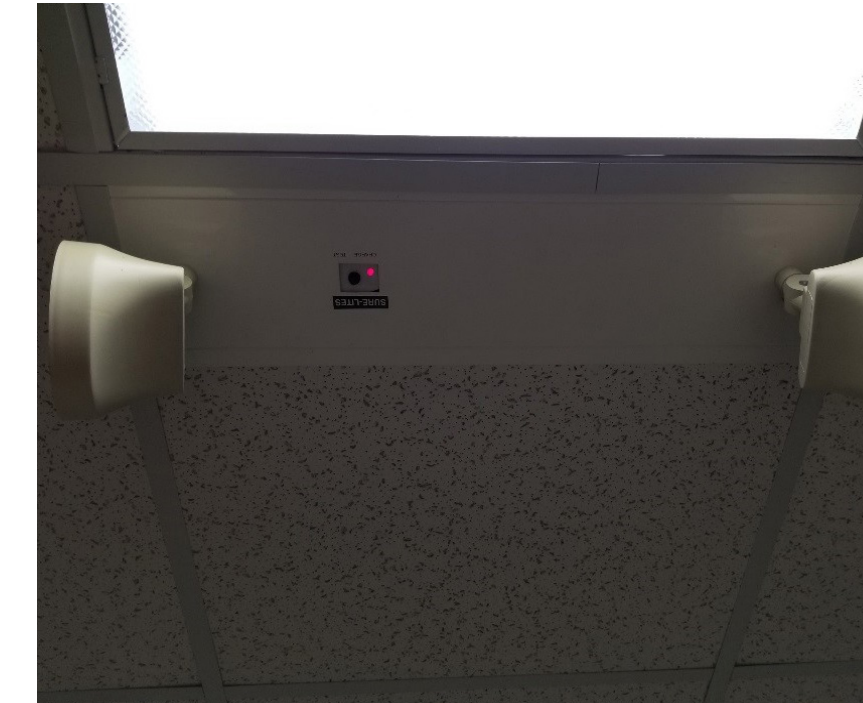
Emergency Lighting – Ceiling Mounted

The lighting system within the building consists primarily of T8 and T12 fluorescent fixtures within the corridors, classrooms, common spaces, and offices, using troffer, surface-mount, and pendant fixtures. Some corridors in the basement have retrofitted LED lamps in the T8 sockets. Control is performed mostly through toggle switches and contactors, with a dimming system used in the auditorium area. Lighting throughout most of the facility is 277V, with the exception of the center core area and emergency lighting, which uses 120V.

Another lighting recommendation is to expand the capabilities of the lighting control system to implement more modern technologies such as daylight harvesting in corridors and exterior areas, occupancy sensing in offices and other interior rooms, and more precise zoned controls. The new controls will offer additional energy savings for the school, and provide an extra level of precision for staff to customize the light output for the facility.
