MECHANICAL, ELECTRICAL, PLUMBING, AND FIRE PROTECTION CONDITIONS

MAINE SOUTH HIGH SCHOOL

This report section will overview the existing cooling and heating systems at Maine West High School. The sections will include: building cooling plant, building heating plant, mechanical ventilation systems, unit ventilators, roof top units and recommendations.

This report section will review the existing electrical systems at Maine West High School.

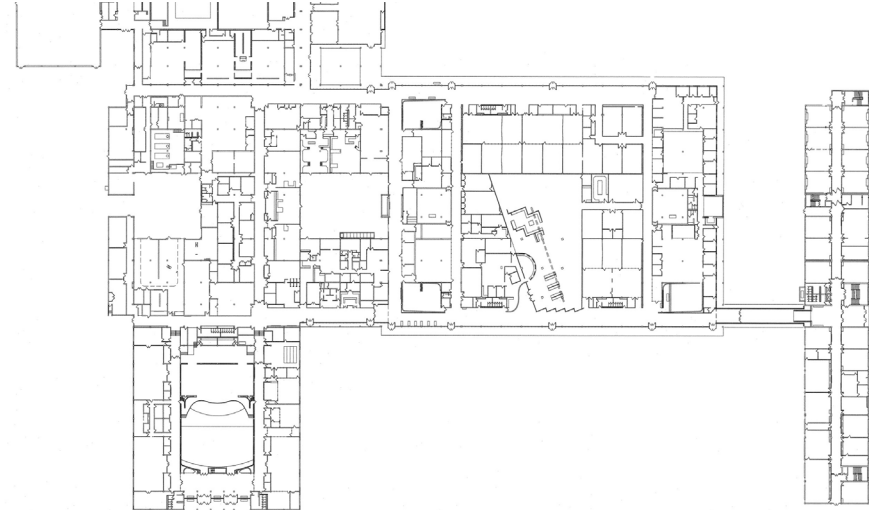
Domestic Hot Water Plant Location

Domestic hot water for Maine South is provided by one (1) domestic hot water plant. The plant is located in the main building mechanical boiler room (replaced in 2017).

The domestic hot water plant in the main building mechanical boiler room is comprised of three (3) 800-MBH high-efficiency gas-fired domestic water heaters and two (2) 500-gallon hot water storage tank. The water heaters and storage tank and localized piping were replaced in 2017. This plant serves entire building's domestic hot water load, including the cafeteria conveyor dishwasher. The pictures on the right show the equip ment and location of the domestic hot water plant.

No alterations are recommended for this equipment within the scope of this report.

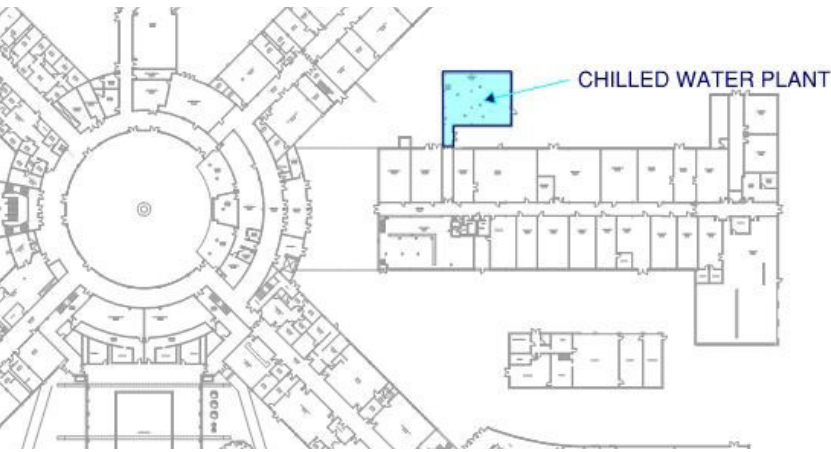
Chilled Water Plant

The chillers are 2017 “Carrier” electric, variable speed, water-cooled, centrifugal chillers rated for 400 nominal tons each. Chilled water system operates utilizing a primary loop and secondary loop. The primary loop supplies constant volume to the chillers via three (3) constant speed “Bell & Gossett” chilled water pumps (CHWP-1,2, and 3). The primary pumps are each rated for 20 HP, 36 ft. of head, and 1025 GPM. Chilled water is distributed throughout the secondary loop via two (2) variable speed “Bell & Gossett” pumps (CHWP-4 and CHWP-5) rated for 40 HP, 90 ft. of head, and 1050 GPM. These five (5) pumps were installed in 1997.

The ASHRAE median service life for base mounted pumps such as those described above is 25 years. Chilled water pumps tagged CHWP-1 to 5, and condenser water pumps tagged CWP-1 and CWP-3 have been in operation since approximately 1997, therefore, they are 20 years old. Given the age of the pumps, it is recommended to replace them within the 6 to 10-year timeframe. Please reference the Pump Cost Estimates Section for pricing details.

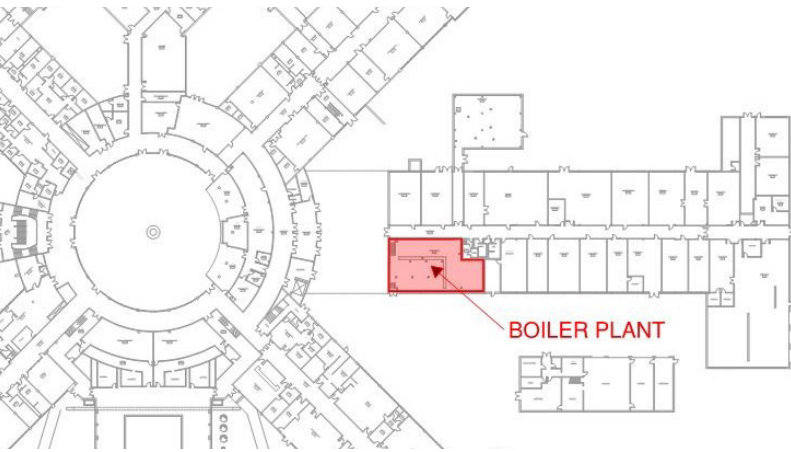
Boiler Plant

Space heating is provided by five (5) high efficiency hot water condensing boilers that were installed during the 2017 Steam to Hot Water Boiler Conversion Project. The hot water boilers serve perimeter finned tube radiators, AHUs, four-pipe UVs, fan coil units (FCUs), and unit heaters (UHs). Hot water is distributed to this equipment from the one (1) boiler plant; its location is highlighted to the right. The boilers and associated pumps are controlled by the “Siemens” building automation system. New and existing equipment located in the boiler room includes:

The ASHRAE median service life for base-mounted pumps is 25 years. It Is recommended to replace the two (2) hot water pumps installed in 1997 with a like for like replacement within this timeframe. Please reference the Pump Cost Estimates section for additional details.

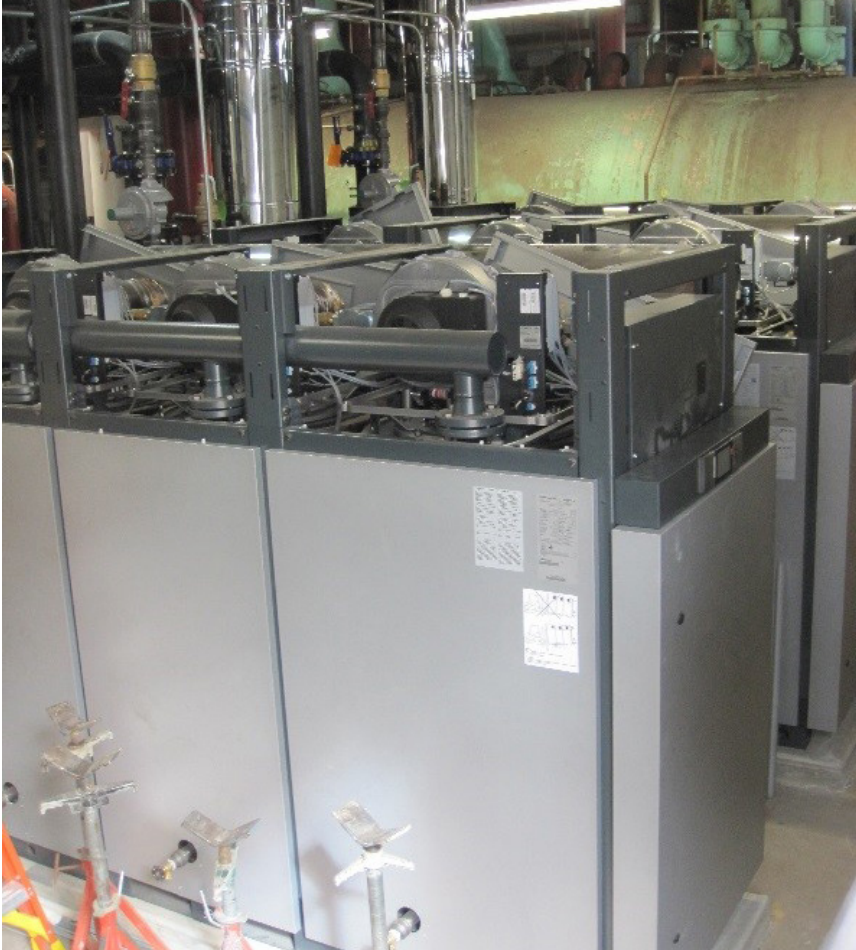
2017 Condensing Hot Water Boilers

- Five (5) 2017 “Viessmann” condensing hot water boilers with 6,000 MBH input and combustion efficiencies capable of exceeding 94%
- Three (3) 2017 “Armstrong” primary loop hot water boiler pumps each with 25 HP, 87 ft. of head, 840 GPM and variable frequency drives (VFDs) – tagged P-W1.1, 1.2, 1.3
- Two (2) 1997 “Bell & Gossett” constant flow hot water pumps rated for 20 HP, 100 ft. of head, and 460 GPM serving D-Wing hot water heating equipment – tagged HWP-7, 8
- One (1) 2017 “Armstrong” air and dirt separator
- Two (2) 2017 hot water suspended unit heaters
- One (1) new “Armstrong” expansion tank

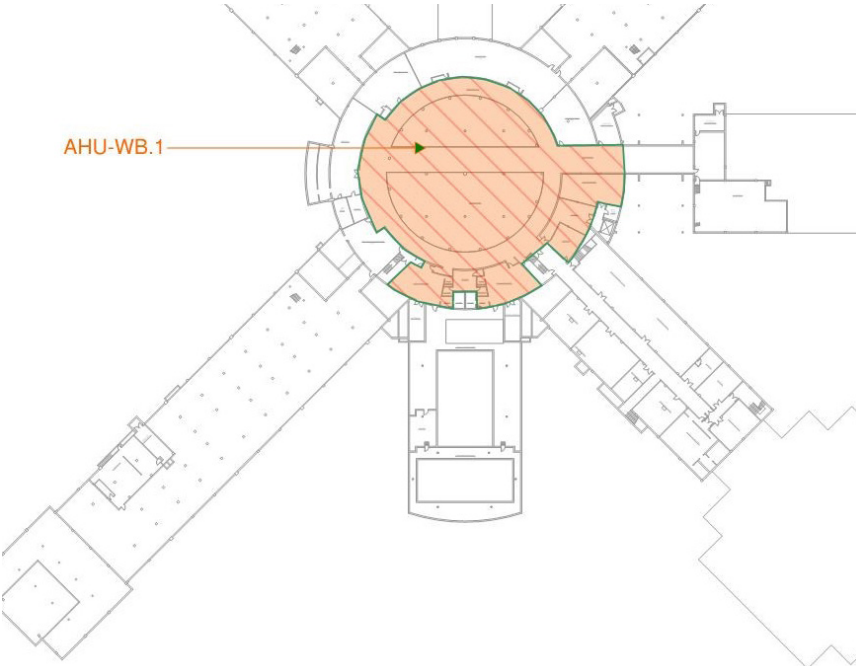
Basement Track AHU

AHU-WB.1 was installed in 2017. This constant volume makeup air unit supplies the basement fitness center with conditioned air and is located in the C-Wing basement mechanical room. AHU-WB.1 is equipped with a chilled water coil, hot water coil, exhaust fan and an energy recovery coil. The energy recovery coil absorbs heat leaving the building from the exhaust air airstream via an energy recovery coil located in the exhaust airstream. The heated water is then pumped to the energy recovery coil located inside the air handling units outdoor airstream where the heat extracted from the exhaust is utilized to precondition the incoming outside air to the unit. This unit is controlled by the “Siemens” building automation system.

No alterations are recommended for this equipment within the scope of this report.

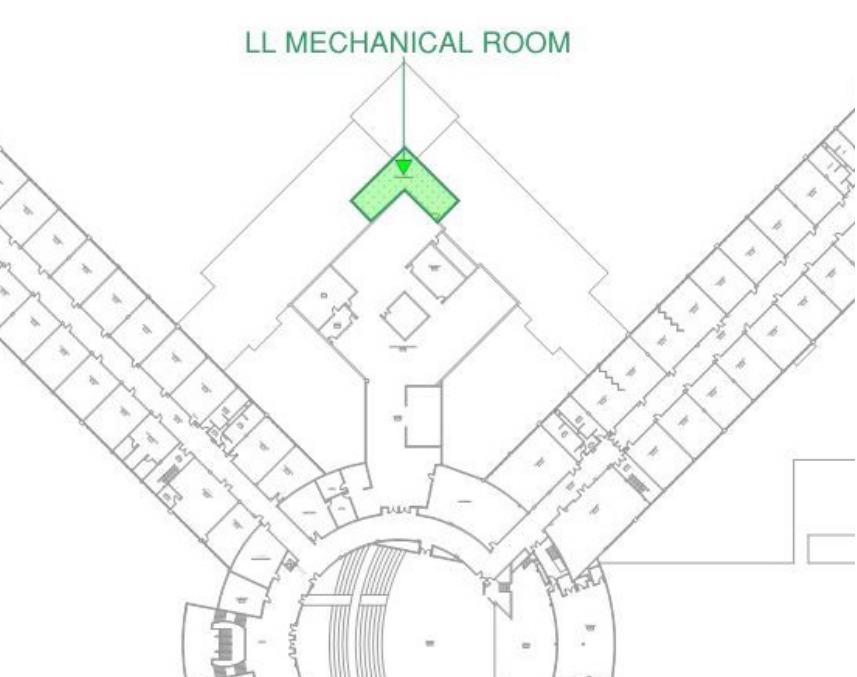
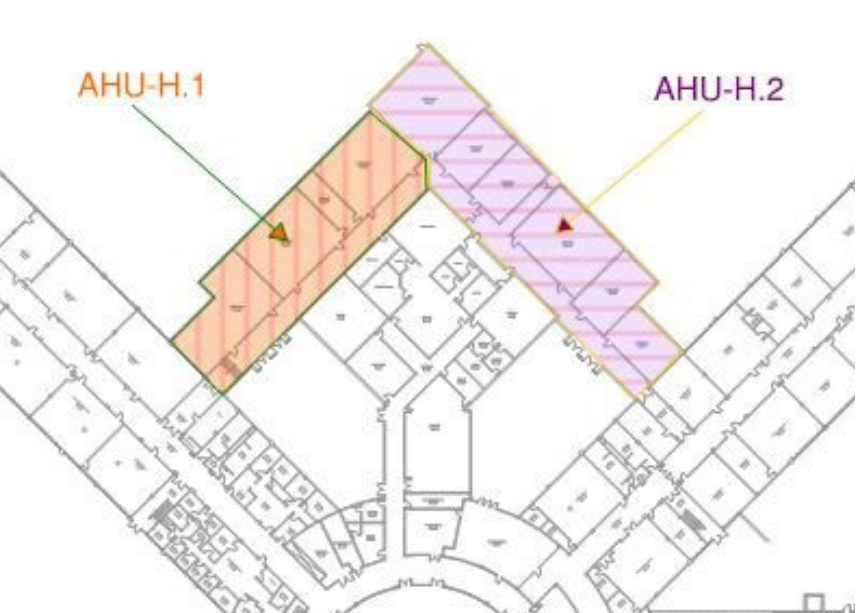
H-Wing AHUs Location

No alterations are recommended for this equipment within the scope of this report.

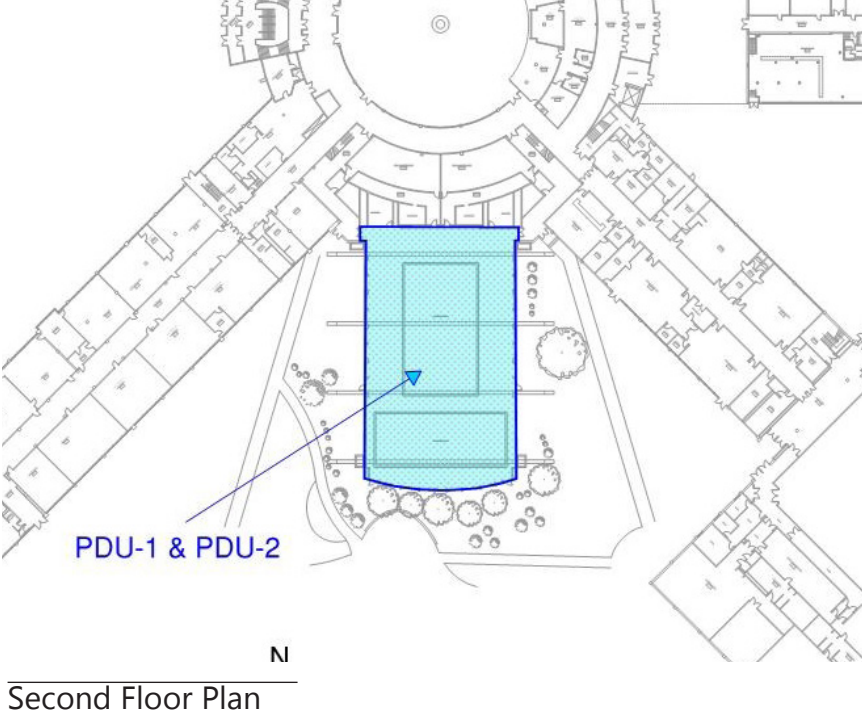
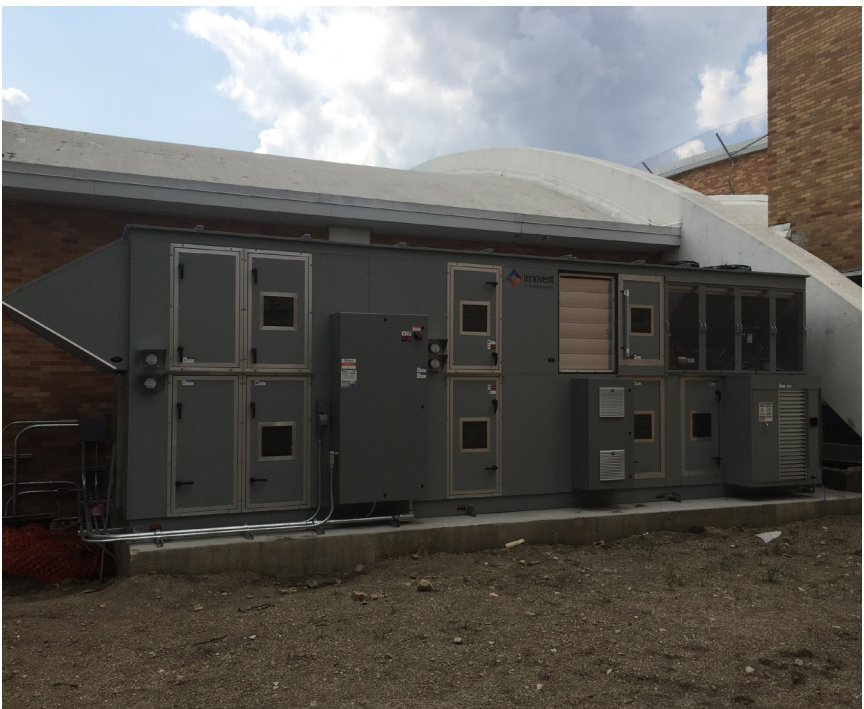
P-Wing Pool Dehumidification AHUs

The pool was upgraded with two (2) new pool dehumidification air handling units in 2017. The “Innovent” AHUs are located outside on the West and East side of the pool and utilize a DX cooling coil, and gas furnace to condition and dehumidify the pool space. There are two (2) supply fans and two (2) return fans per unit and each set of fans is equipped with a VFD. Air enters the units from a combination of outside air and return air ducts.

No alterations are recommended for this equipment within the scope of this report.

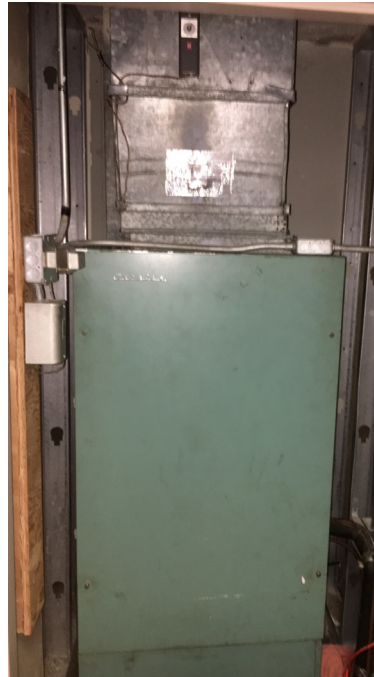
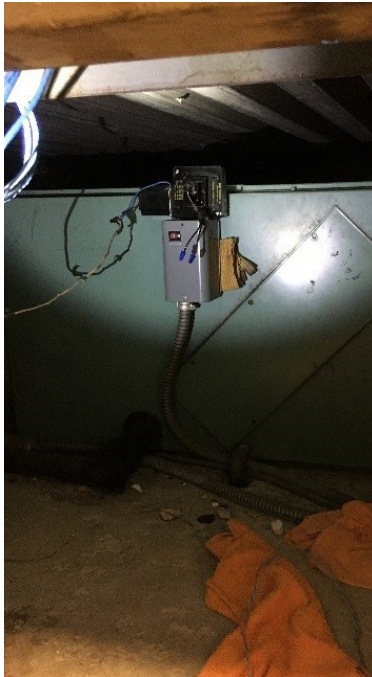
Counseling Offices
Upper AHU

Counseling Offices
Middle AHU

According to conversations with building maintenance staff, the Upper and Middle AHUs are reportedly difficult to control, cause some areas to overheat/overcool, and do not supply an adequate amount of ventilation air. The unequal temperature distribution is partly due to the single zone perimeter finned tubed radiators that provide additional heat for spaces near windows. Furthermore, the ASHRAE median service life for a packaged medium-duty air handling unit is 25 years.

It is recommended to replace the aged Upper and Middle units with variable volume supply AHUs and DDC capabilities. Benefits from this upgrade include: increased comfort control, reliability improvements, and reduced operating costs. Please reference the AHU Cost Estimates section for pricing details.

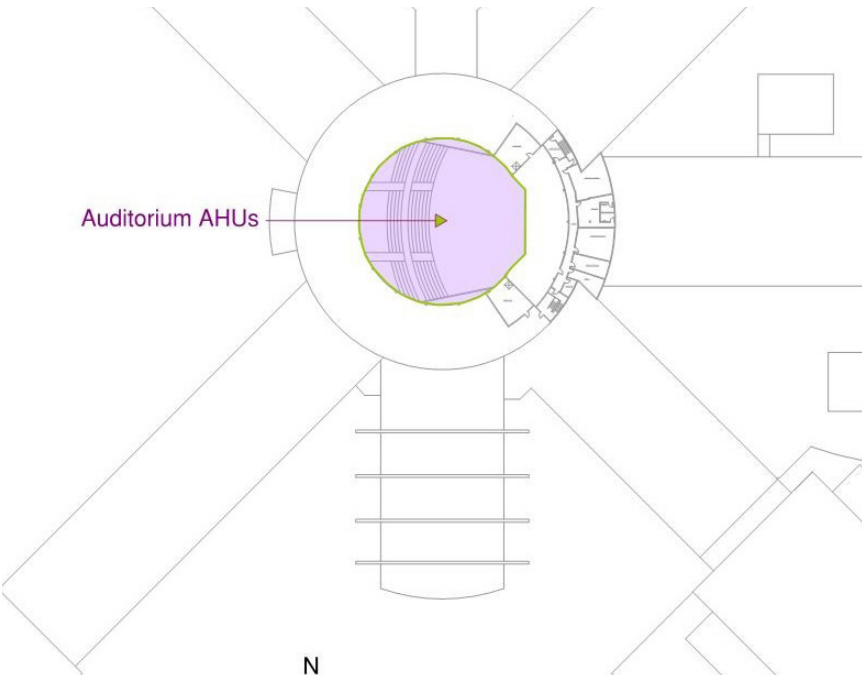
Auditorium AHUs

No alterations are recommended for this equipment within the scope of this report.

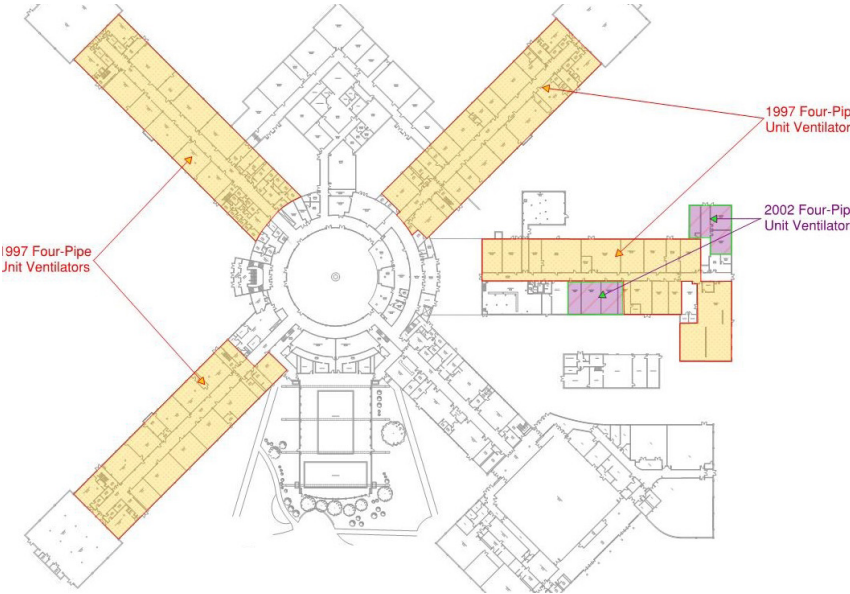
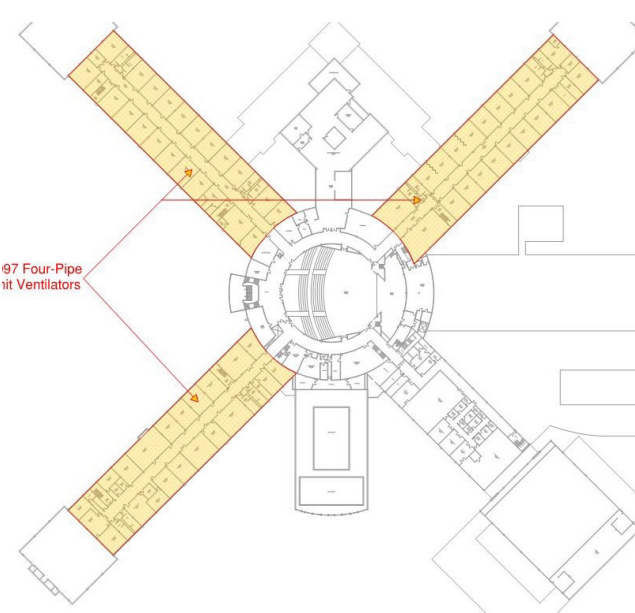
Four-pipe unit ventilators serve the classrooms in the A, B, C, and D wing classrooms on the first floor and the A, B, and C-Wing classrooms on the 2nd floor. During a 1997 noise abatement project conducted by the Federal Aviation Administration (FAA), most classroom UVs located in the wings were replaced; It is our understanding that Maine West did not have much or any input regarding the specs of these UVs. In 2002 there were a few additional classroom UV upgrades. Refer to the graphic to the right for an overview on UV zones.

Temperature control and noise can be an issue, and part replacements are often costly. Additionally, these UVs are not equipped with face and bypass dampers and, as a result, during below-freezing temperatures, cooling coils commonly “pop” due to the temperature differences causing the fluid to expand and burst the coil.

First Floor UVs

2nd Floor UVs

There are two options for UV replacement: Option 1 is to replace with vertical change air UVs. This would provide increased comfort control and reliability, as well as the option of installing UVs with face and bypass dampers to eliminate coil “pops.” Option 2 is to install a variable flow, dedicated outdoor air supply unit (DOAS) on the roof that serves local fan coil units with hot water heating and chilled water cooling coils. This system provides optimum temperature control and would yield long-term energy savings due to its variable volume supply. Please reference the UV Cost Estimates section for pricing details.

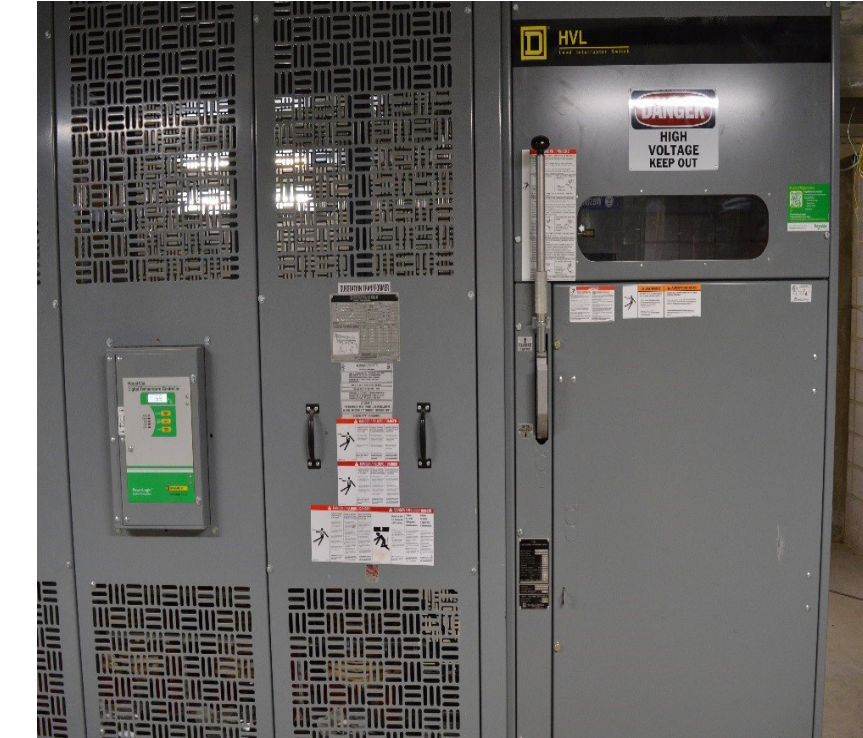
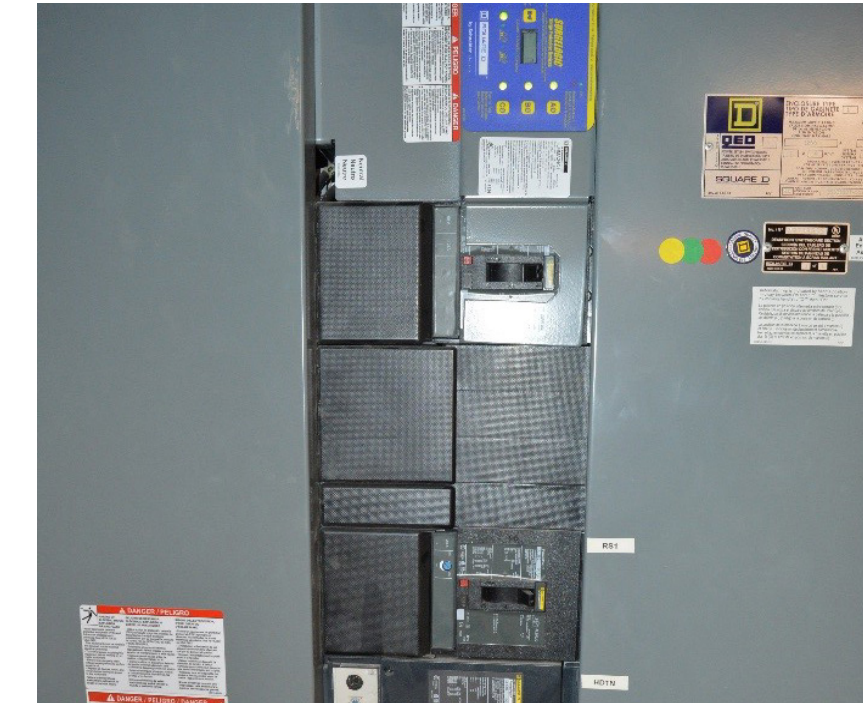
E-Wing Substation #2 – Load Break Switch and Transformer

The first section of the E-Wing substation #2 consists of a 4160V load break switch manufactured by Square-D, the second section contains a 750/1000 KVA transformer to step the voltage down to 277/480V. The third section has a main 1200A circuit breaker for the building's distribution load and a local meter, and the fourth section contains (4) branch breakers with (2) active currently, some spaces for additional circuit breakers, and a surge protection module. The substation is manufactured entirely by Square-D. The substation was installed concurrent with the upgrades to the Spectator Gymnasium, performed within the last ten years. The substation is in good condition overall.

We recommend to continue exercising the existing 4160V switches every two years to verify proper operation and reduce risk of becoming stuck in a certain position at an inopportune time. Additionally, we recommend annual thermal inspections of the substation, switches, distribution panels, and other equipment in order to more easily identify problematic areas of unwanted heat buildup in the system.

OSHA 2015 regulations require the application of an arc flash label that provides information on arc flash protection boundary, incident energy, working distance, PPE class, and available short circuit information. It is recommended to perform an arc flash study and apply the labels in a timely manner to comply.

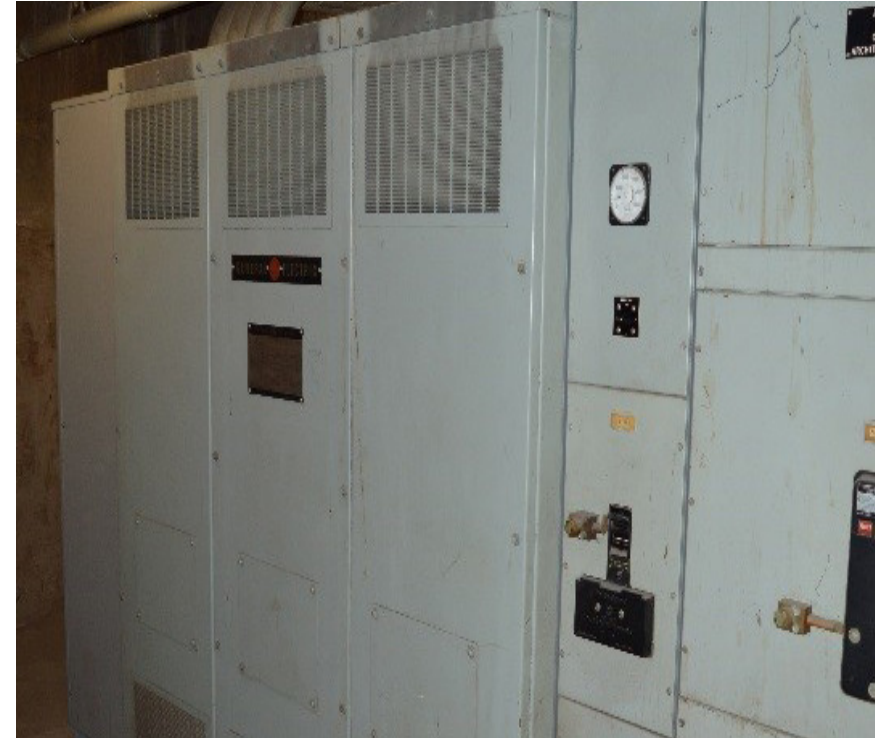
Center Core Substation – Transformer and EM Breaker

The Center Core substation is original to the building from 1964. The unit is aged beyond its expected lifespan, and the various sections of the board contain parts that are outdated and difficult to obtain for replacement purposes. Due to the inherent reliability issues of the unit, it is recommended to replace this substation in the coming years.

We recommend to continue exercising the existing 4160V switches every two years to verify proper operation and reduce risk of becoming stuck in a certain position at an inopportune time. Additionally, we recommend annual thermal inspections of the substation, switches, distribution panels, and other equipment in order to more easily identify problematic areas of unwanted heat buildup in the system.

A like-for-like replacement can be implemented by custom switchboard manufacturers, replacing the primary switch, transformer, and main and distribution breakers in a package of the same size as the existing. We recommend the replacement of all cloth-insulated cables with copper thermoplastic-insulated wire. Any cables that are not cloth-insulated may remain.

OSHA 2015 regulations require the application of an arc flash label that provides information on arc flash protection boundary, incident energy, working distance, PPE class, and available short circuit information. It is recommended to perform an arc flash and coordination study at the same time the switchboards are replaced.

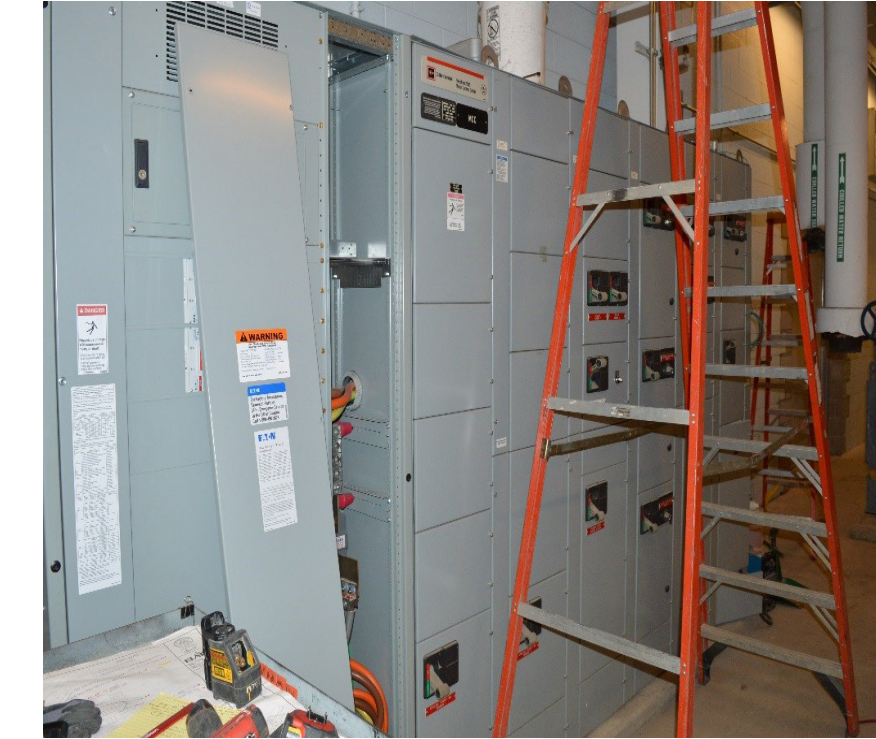
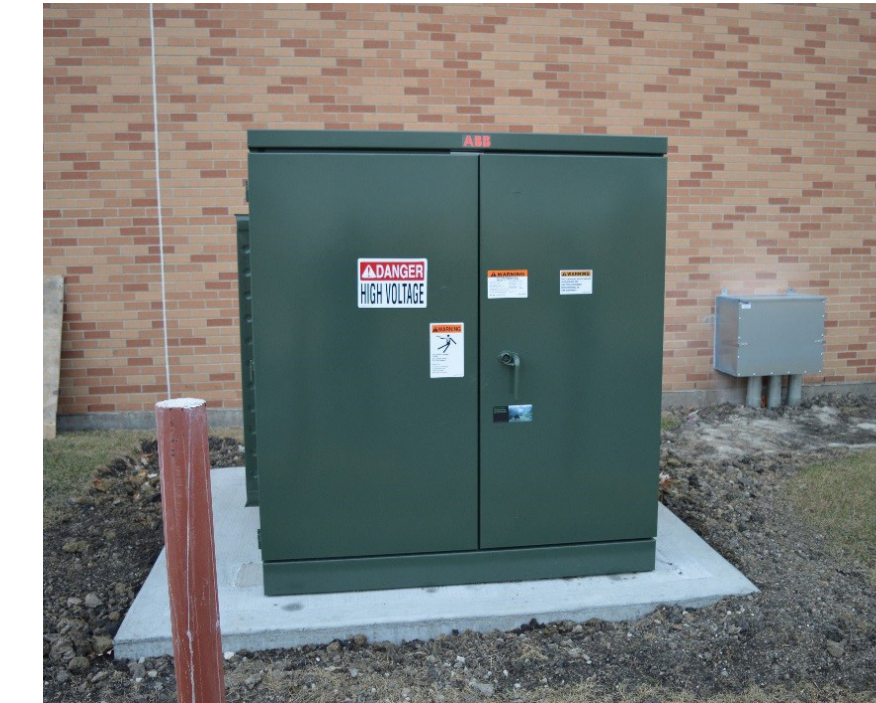
Chiller Room – MDP and MCC

The chiller room electrical distribution is currently undergoing an upgrade as part of a chiller replacement project. The room is fed via a 4160V service from the B-Wing substation that travels through a load break switch in the corner (manufactured by Cutler-Hammer), then heads outside underground to a new 1000KVA, 4160-480V transformer. The feeder then re-enters the room and connects to a 1200A distribution panelboard which feeds the two new chillers and the existing 6-section motor control center located in the room. All indoor distribution equipment were manufactured by Cutler-Hammer/Eaton, and the outdoor transformer was manufactured by ABB. The existing equipment appeared to be in good condition from a visual inspection.

We recommend to continue exercising the existing 4160V switches every two years to verify proper operation and reduce risk of becoming stuck in a certain position at an inopportune time. Additionally, we recommend annual thermal inspections of the substation, switches, distribution panels, and other equipment in order to more easily identify problematic areas of unwanted heat buildup in the system.

OSHA 2015 regulations require the application of an arc flash label that provides information on arc flash protection boundary, incident energy, working distance, PPE class, and available short circuit information on all distribution equipment. It is recommended to perform an arc flash and coordination study for the motor control center and primary distribution switch.

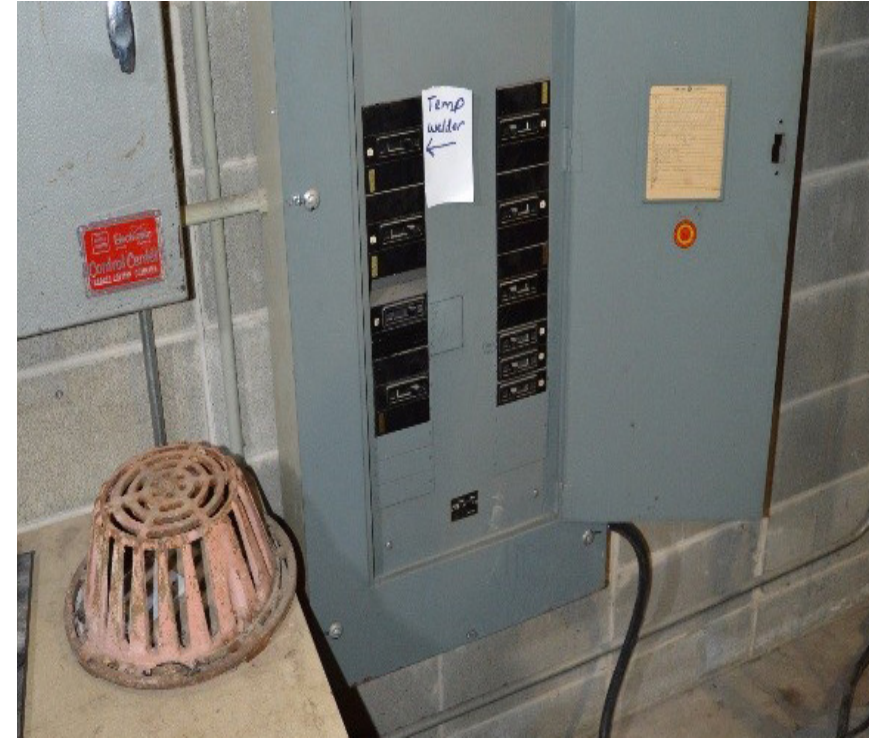
GE “Original” Panel – Located in Track Area

The school's lighting and power panelboards are distributed throughout the school, only a few are located in the substation rooms where the main power distribution resides. The condition of the panels are varied, many having been replaced over the course of the facility's history from GE original panels to newer units from Challenger, GE, Square-D, and Cutler-Hammer. Almost all panelboards are three-phase units, with supply voltages that are either 120/208V or 277/480V throughout the school.

Certain panelboards found in the school are original to the building, manufactured by GE. These panels are beyond their expected lifespan, and it is recommended to replace them in the near future with a new unit. We recommend the new panels to contain additional spare circuits inside them to help anticipate future electrical needs.

OSHA 2015 regulations require the application of an arc flash label that provides information on arc flash protection boundary, incident energy, working distance, PPE class, and available short circuit information. It is recommended to perform an arc flash study and apply the labels as soon as possible to comply.

Additionally, we recommend annual thermal inspections of the substation, switches, distribution panels, and other equipment in order to more easily identify problematic areas of unwanted heat buildup in the system.

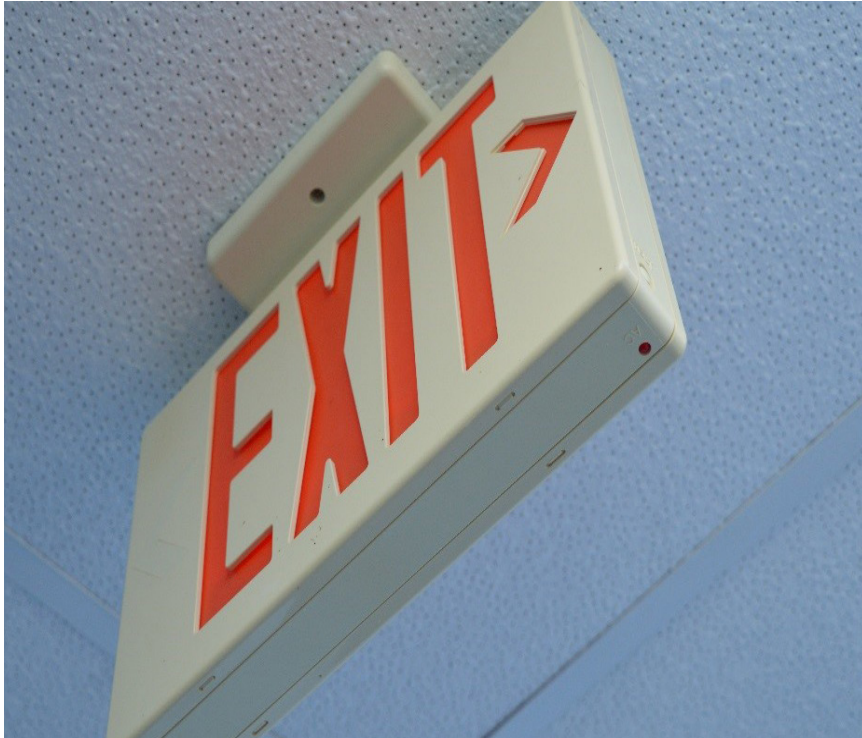
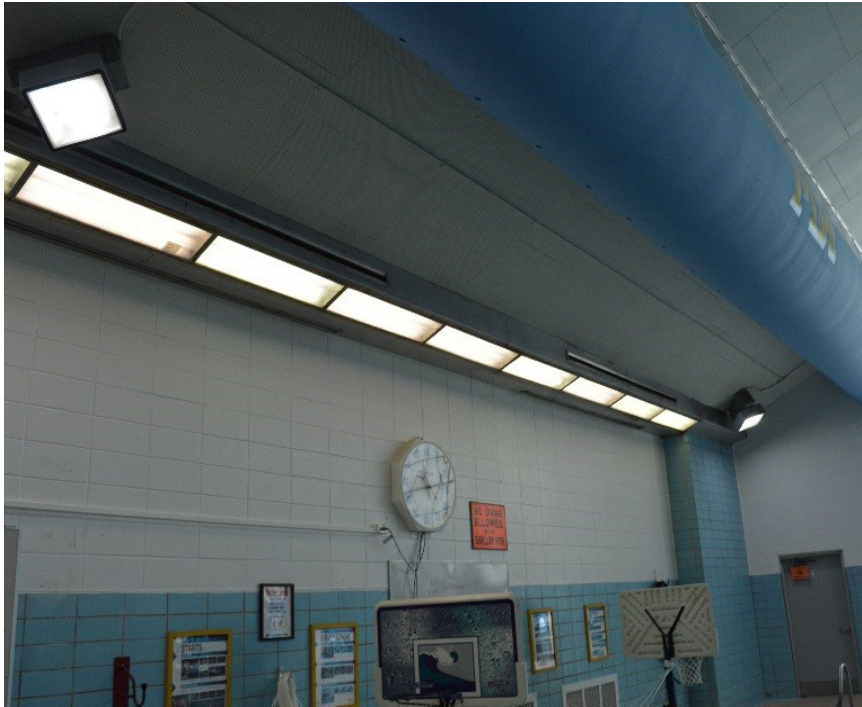
Exit Sign

The lighting system within the building contains several types of fixtures. The primary lighting method is T8 lamps, but several corridors and some classrooms have been retrofitted with direct-wire LED T8 retrofit lamps by the building electrician. The entrance to the auditorium uses can-style LED downlights. Some T12 fixtures are still encountered at points in the school, with the understanding that they are retrofitted to T8 style when the lamps burn out. The Spectator Gym area consists of new LED troffers and T5HO high-bay fixtures. The swimming pool contains LED pendant high-bay fixtures, LED floodlights retrofitted inside a metal-halide fixture, and several fluorescent fixtures along the side of the room. The auditorium/theater contains several bi-pin compact fluorescent lamps as a retrofit for incandescent lights. Canopy lights outdoors are large compact fluorescent lamps retrofitted from metal halide.

The primary recommendation for the lighting system is the conversion of all fixtures, including emergency and exit lighting, to LED. LED technology carries significant benefits and cost-savings in energy usage and maintenance that in many cases will turn into a payback to the facility over time. Fixtures that have been retrofitted with LED T8 tube replacements should eventually be removed and replaced with fixtures that contain integrated LEDs and drivers, due to the higher quality and longer life of a dedicated fixture.
