MAINE WEST MEP CONDITION ASSESSMENT

MAINE WEST HIGH SCHOOL

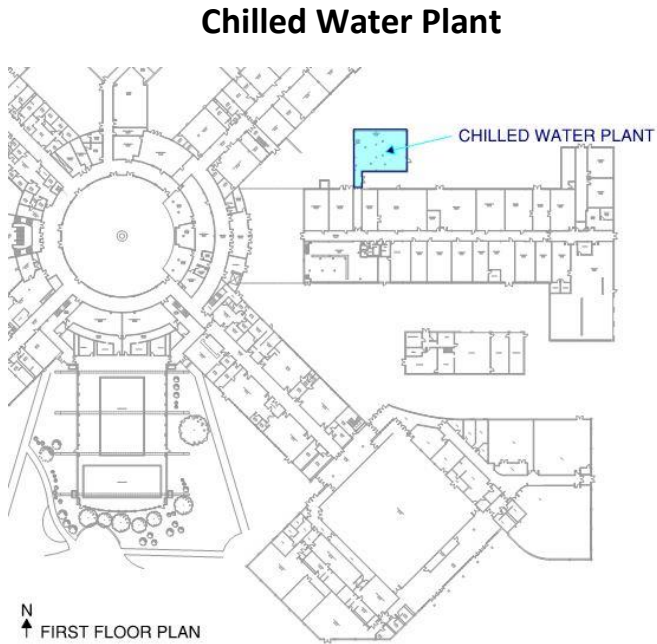
Table 1: Chilled Water Plant Pumps

The chillers are 2017 “Carrier” electric, variable speed, water-cooled, centrifugal chillers rated for 400 nominal tons each. Chilled water system operates utilizing a primary loop and secondary loop. The primary loop supplies constant volume to the chillers via three (3) constant speed “Bell & Gossett” chilled water pumps (CHWP-1,2, and 3). The primary pumps are each rated for 20 HP, 36 ft. of head, and 1025 GPM. Chilled water is distributed throughout the secondary loop via two (2) variable speed “Bell & Gossett” pumps (CHWP-4 and CHWP-5) rated for 40 HP, 90 ft. of head, and 1050 GPM. These five (5) pumps were installed in 1997.

The ASHRAE median service life for base mounted pumps such as those described above is 25 years. Chilled water pumps tagged CHWP-1 to 5, and condenser water pumps tagged CWP-1 and CWP-3 have been in operation since approximately 1997, therefore, they are 20 years old. Given the age of the pumps, it is recommended to replace them within the 6 to 10-year timeframe. Please reference the Pump Cost Estimates Section for pricing details.

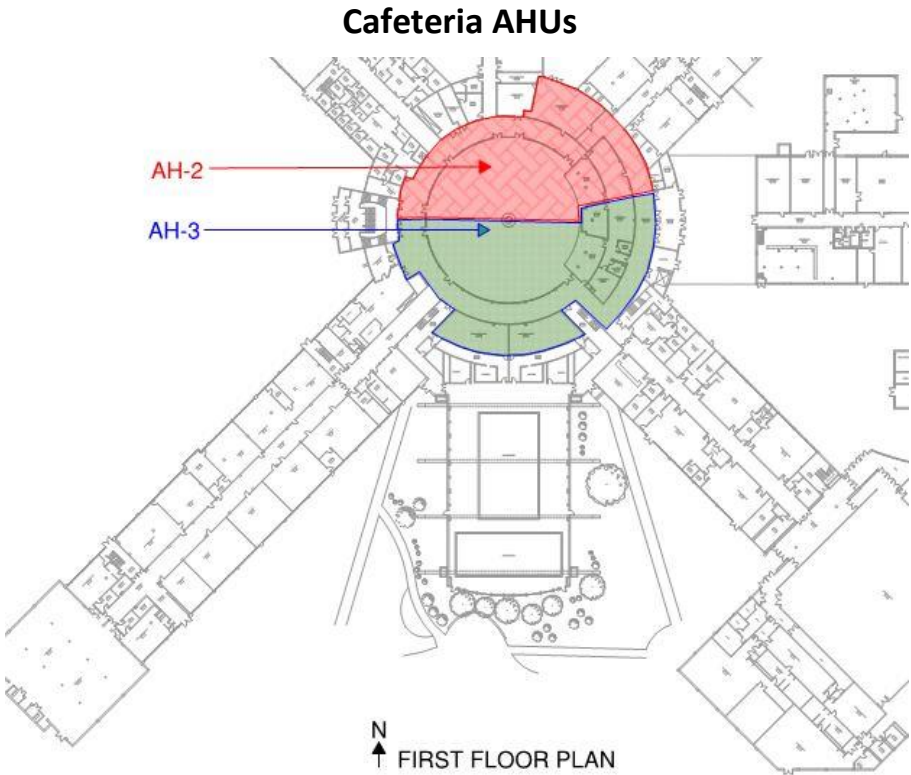
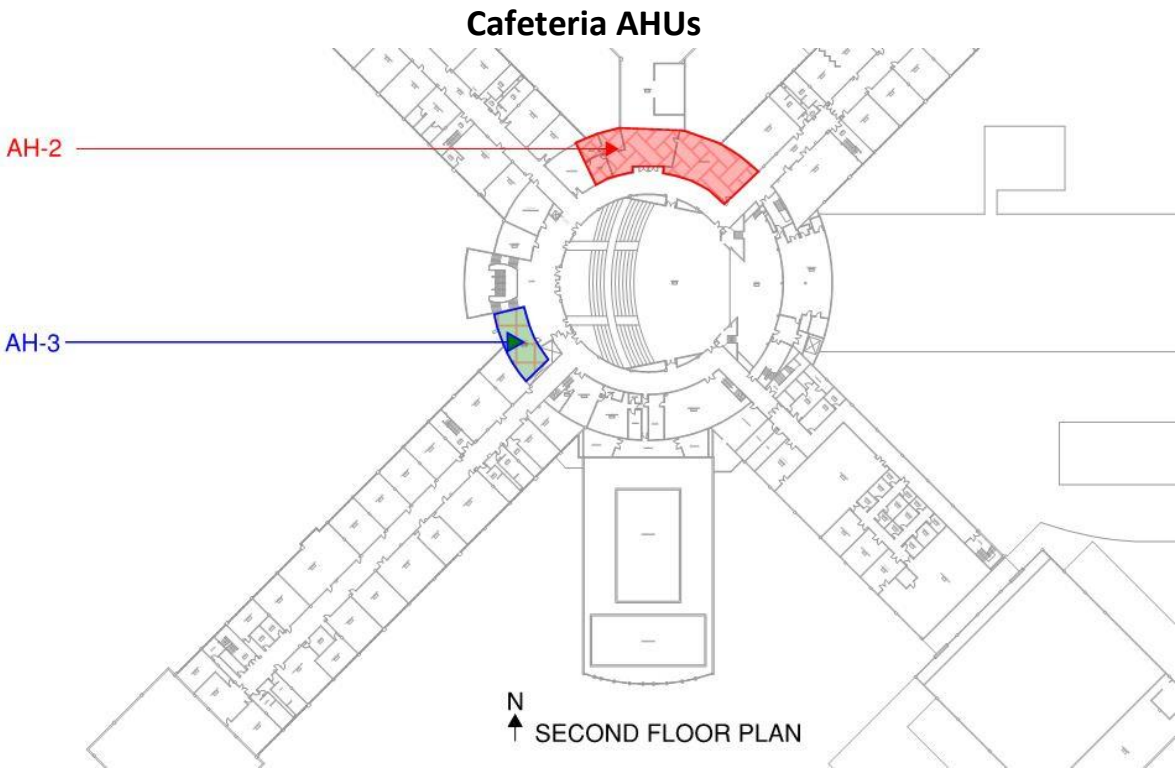
Both cafeteria units have associated return fans that are original to the building and in poor condition. Due to their age, replacement parts can be costly and challenging to find.

It is recommended to replace the exhaust/return fans with a “like for like” replacement. This upgrade would provide increased reliability and efficiency due to new motor technologies. For additional details, please reference the Exhaust/Return Fan Cost Estimates section.

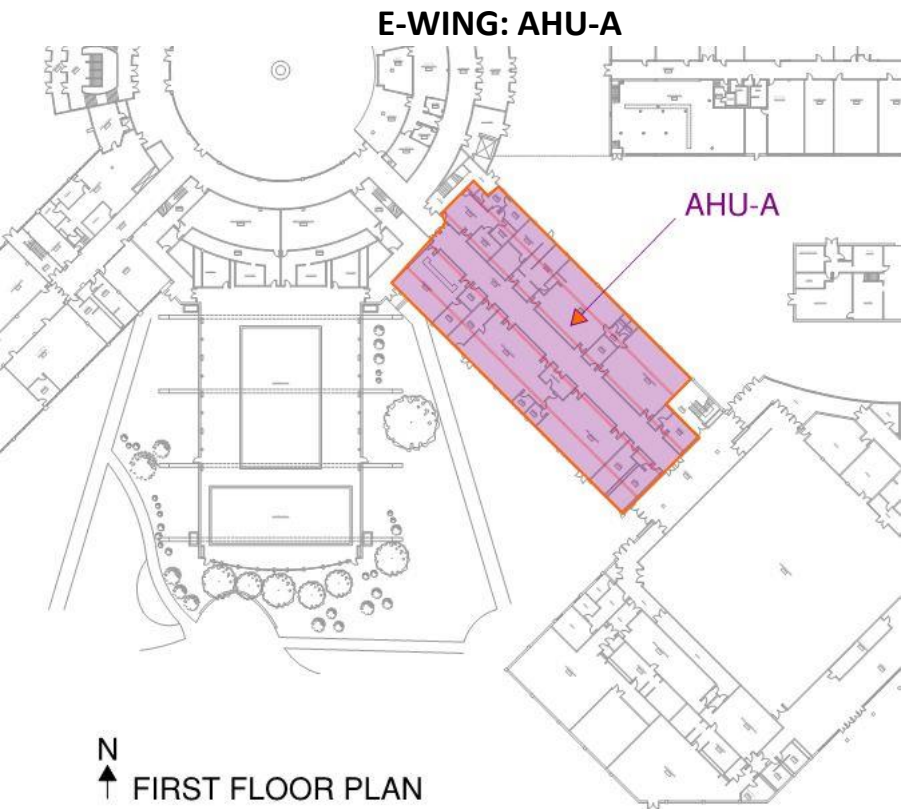
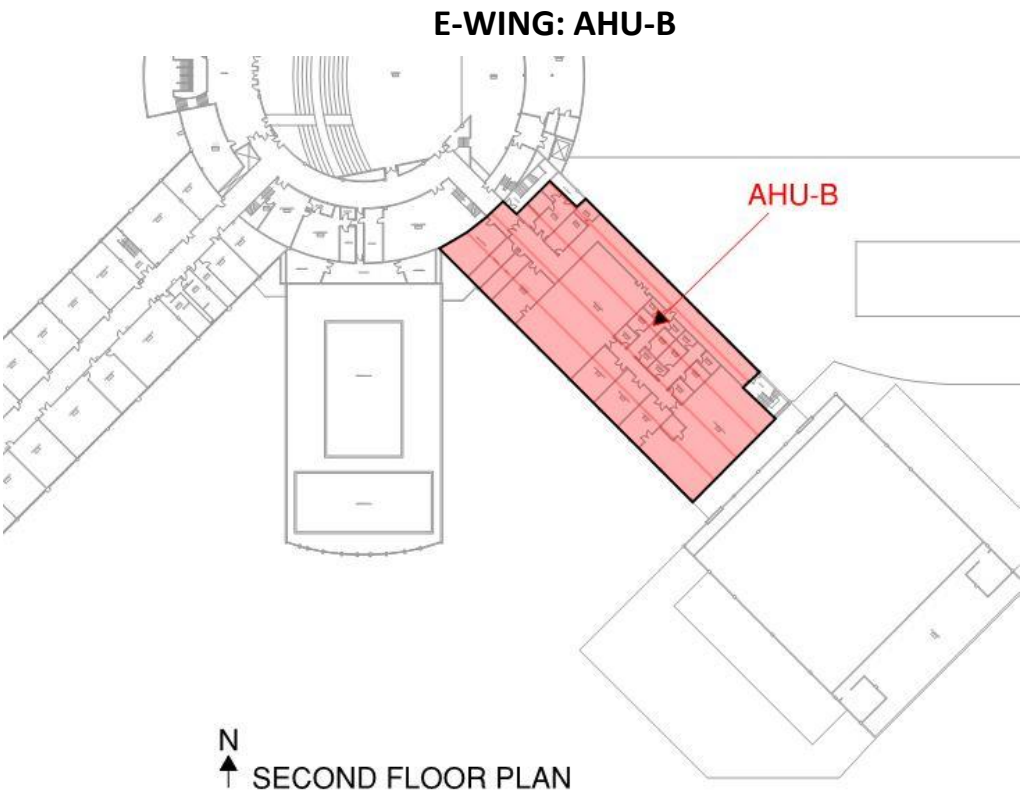
Multi-zone systems like the E-Wing AHUs, operate using a “hot deck” and “cold deck.” Air passes through both a “hot deck” and “cold deck” and then mixes to an appropriate discharge air temperature at the AHU before being delivered to a zone. This type of system is inefficient because *simultaneous* heating and cooling occurs at each air handler to serve the “hot deck” and “cold deck”. Additionally, the opportunity exists to convert the units from constant volume to variable volume. Variable volume systems operate based on space demands and, therefore are more energy efficient. Furthermore, each of these AHUs is aged beyond their ASHRAE median equipment service life of 30 years, therefore, the reliability of these units continues to decrease with age.

Because of the age and inefficiency of the E-Wing AHUs, it is recommended to replace the existing air handlers with variable flow AHUs that support either fan powered box (FPB) terminal units or variable air volume (VAV) box terminal units equipped with hot water reheat coils. Both FPB and VAV systems would provide significant energy savings due to their variable operation and ability to provide heating or cooling based on the needs of the space at any given time. Reference the AHU Cost Estimates section for further information.

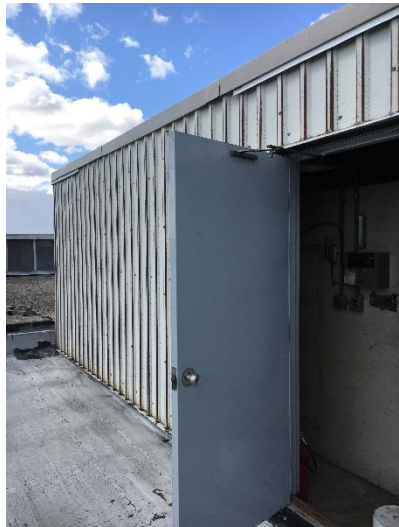
L-Wing AHU Roof Location

As mentioned previously, with a multi-zone system air passes through a “hot deck” and “cold deck” and then mixes to an appropriate discharge air temperature at the AHU before being delivered to a zone. Multi-zone systems are inefficient because *simultaneous* heating and cooling occurs at each air handler to serve the “hot deck” and “cold deck.” Additionally, constant volume systems are always running at full speed, even when the demand is low. Due to the units age there is a greater possibility of unit failure. There are two options for replacement:

OPTION 1 - Demolish the existing penthouse structure and to replace it with a variable volume RTU furnished with DX cooling, and gas heating.

OPTION 2 - Rebuild the penthouse and replace with a variable air volume AHU equipped with a chilled water coil and install terminal VAV boxes equipped with hot water reheat coils within the spaces. With both options, energy would be saved due to variable volume operation and the ability to provide heating or cooling based on space demands. Examine the AHU and RTU Cost Estimates section for further details regarding these recommended replacement options.

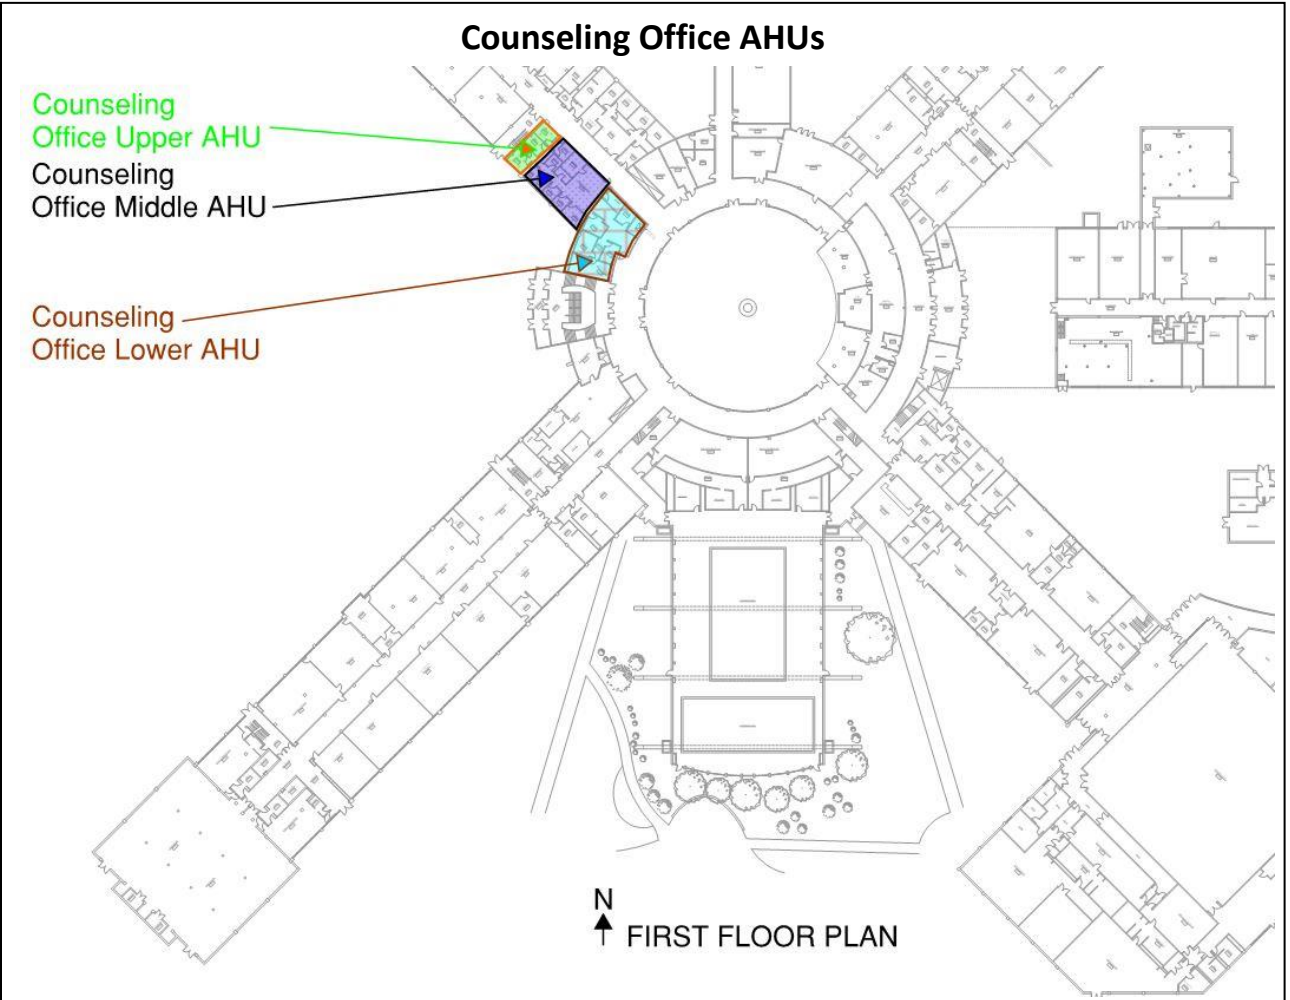
Counseling Offices Upper AHU

According to conversations with building maintenance staff, the Upper and Middle AHUs are reportedly difficult to control, cause some areas to overheat/overcool, and do not supply an adequate amount of ventilation air. The unequal temperature distribution is partly due to the single zone perimeter finned tubed radiators that provide additional heat for spaces near windows. Furthermore, the ASHRAE median service life for a packaged medium-duty air handling unit is 25 years.

It is recommended to replace the aged Upper and Middle units with variable volume supply AHUs and DDC capabilities. Benefits from this upgrade include: increased comfort control, reliability improvements, and reduced operating costs. Please reference the AHU Cost Estimates section for pricing details.

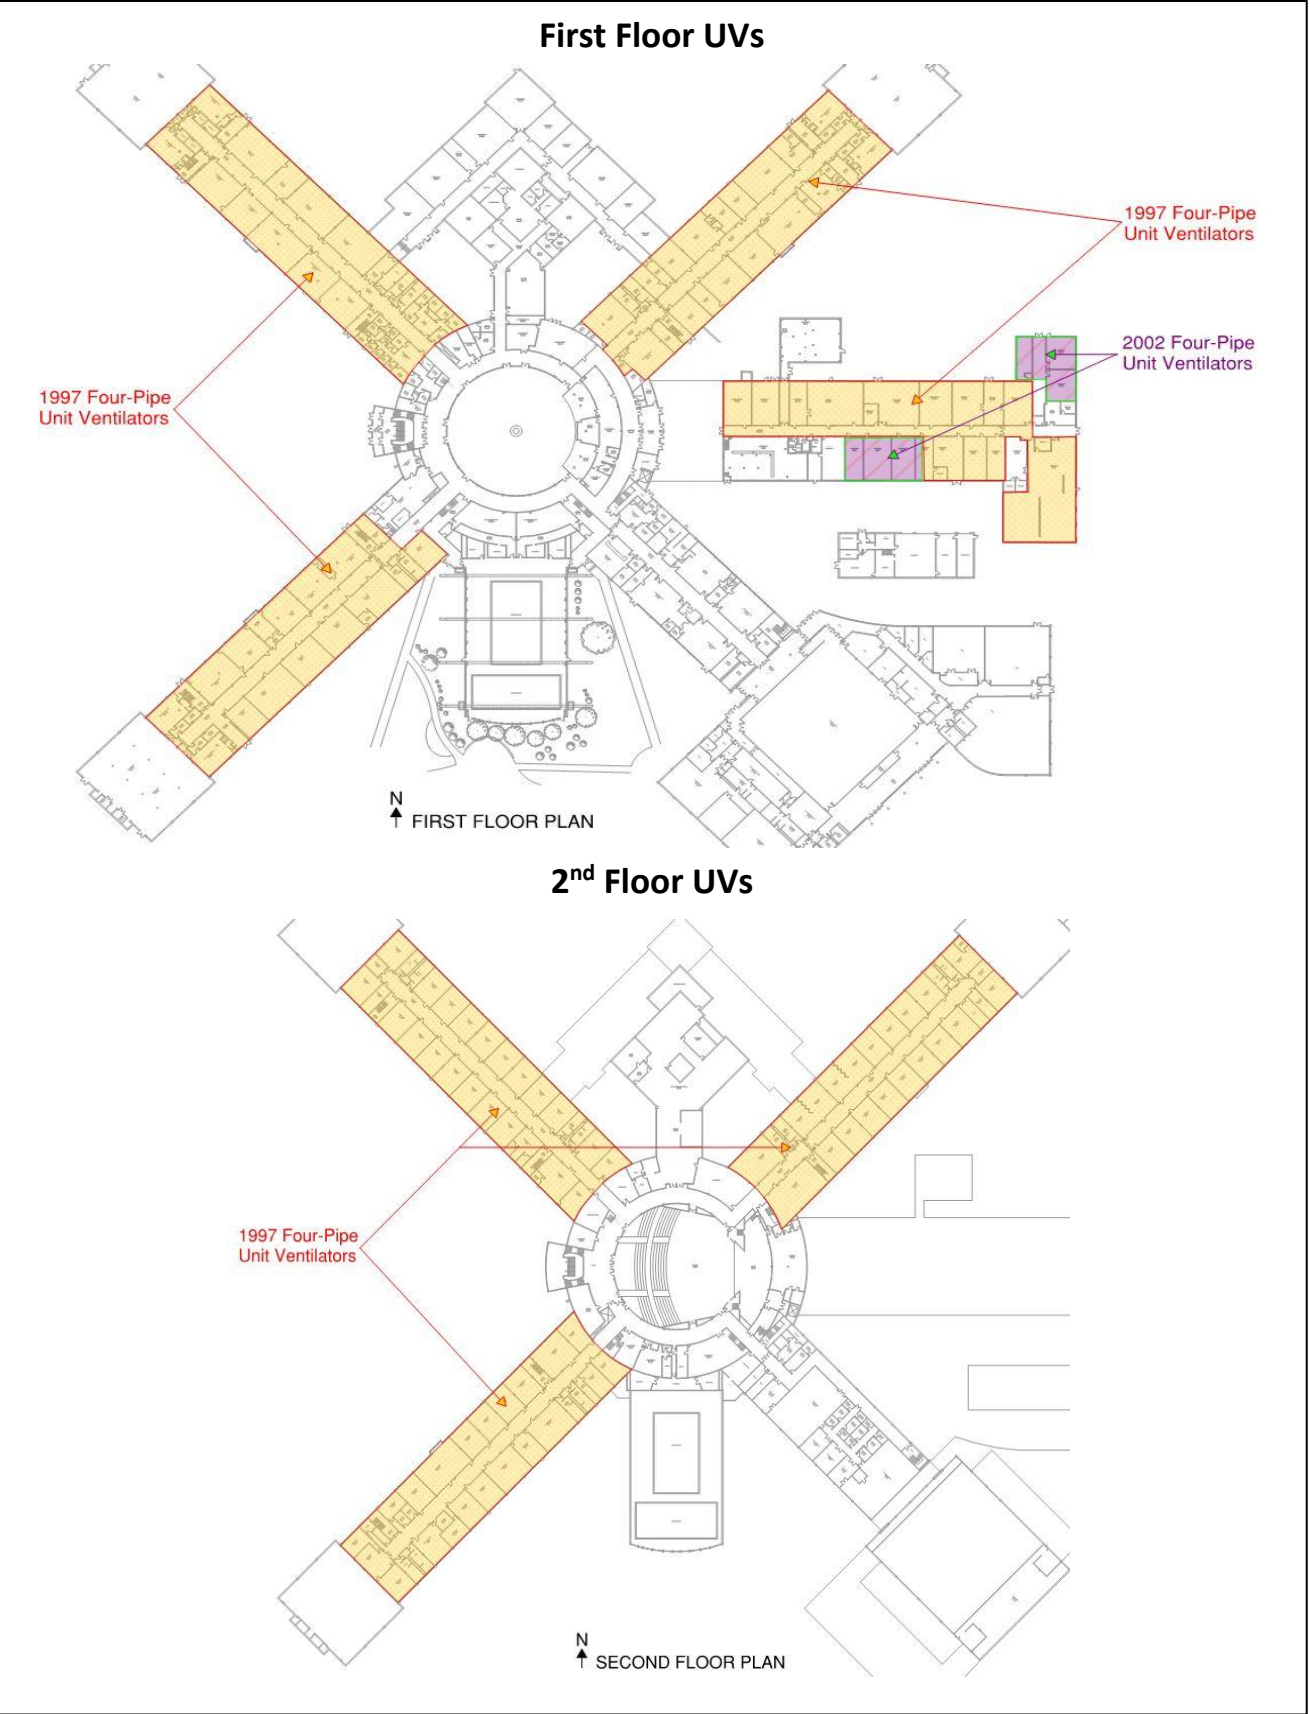
Temperature control and noise can be an issue, and part replacements are often costly. Additionally, these UVs are not equipped with face and bypass dampers and, as a result, during below-freezing temperatures, cooling coils commonly “pop” due to the temperature differences causing the fluid to expand and burst the coil.

There are two options for UV replacement: Option 1 is to replace with vertical change air UVs. This would provide increased comfort control and reliability, as well as the option of installing UVs with face and bypass dampers to eliminate coil “pops.” Option 2 is to install a variable flow, dedicated outdoor air supply unit (DOAS) on the roof that serves local fan coil units with hot water heating and chilled water cooling coils. This system provides optimum temperature control and would yield long-term energy savings due to its variable volume supply. Please reference the UV Cost Estimates section for pricing details.

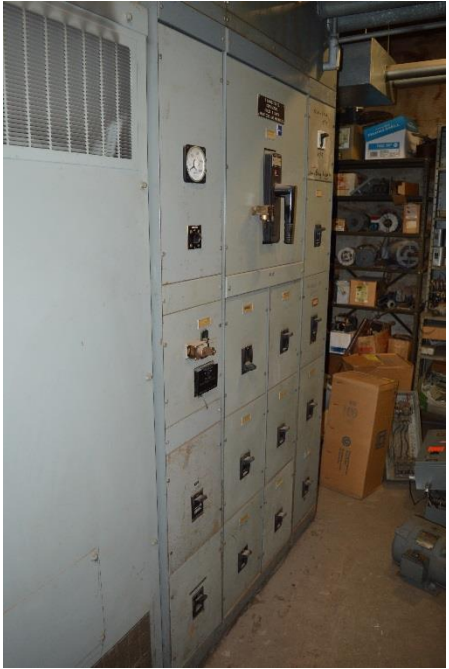
D-Wing Substation Transformer and Circuit Breakers

The D-Wing substation is original to the building from 1959. The unit is aged beyond its expected lifespan, and the various sections of the board contain parts that are outdated and difficult to obtain for replacement purposes. Due to the inherent reliability issues of the unit, it is recommended to replace this substation in the coming years.

We recommend to continue exercising the existing 4160V switches every two years to verify proper operation and reduce risk of becoming stuck in a certain position at an inopportune time. Additionally, we recommend annual thermal inspections of the substation, switches, distribution panels, and other equipment in order to more easily identify problematic areas of unwanted heat buildup in the system.

A like-for-like replacement can be implemented by custom switchboard manufacturers, replacing the primary switch, transformer, and main and distribution breakers in a package of the same size as the existing. We recommend the replacement of all cloth-insulated cables with copper thermoplastic-insulated wire. Any cables that are not cloth-insulated may remain.

OSHA 2015 regulations require the application of an arc flash label that provides information on arc flash protection boundary, incident energy, working distance, PPE class, and available short circuit information. It is recommended to perform an arc flash and coordination study at the same time the switchboards are replaced.

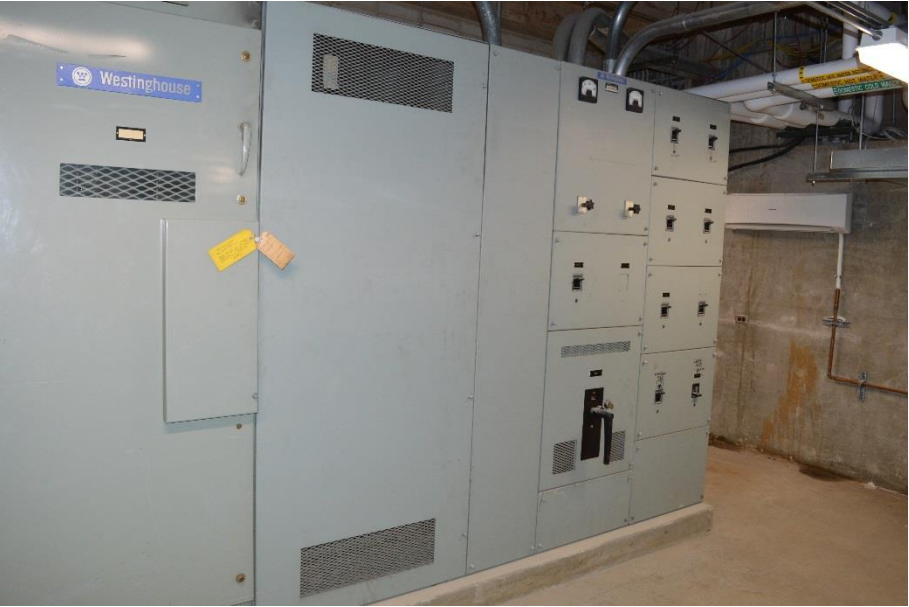
E-Wing Substation #1 - Front

This substation is original to the building's E-Wing expansion from 1967. The unit is aged beyond its expected lifespan, and the various sections of the board contain parts that are outdated and difficult to obtain for replacement purposes. Due to the inherent reliability issues of the unit, it is recommended to replace this substation in the coming years.

We recommend to continue exercising the existing 4160V switches every two years to verify proper operation and reduce risk of becoming stuck in a certain position at an inopportune time. Additionally, we recommend annual thermal inspections of the substation, switches, distribution panels, and other equipment in order to more easily identify problematic areas of unwanted heat buildup in the system.

A like-for-like replacement can be implemented by custom switchboard manufacturers, replacing the primary switch, transformer, and main and distribution breakers in a package of the same size as the existing. We recommend the replacement of any cloth-insulated cables with copper thermoplastic-insulated wire. Any cables that are not cloth-insulated may remain.

OSHA 2015 regulations require the application of an arc flash label that provides information on arc flash protection boundary, incident energy, working distance, PPE class, and available short circuit information. It is recommended to perform an arc flash and coordination study at the same time the switchboards are replaced.

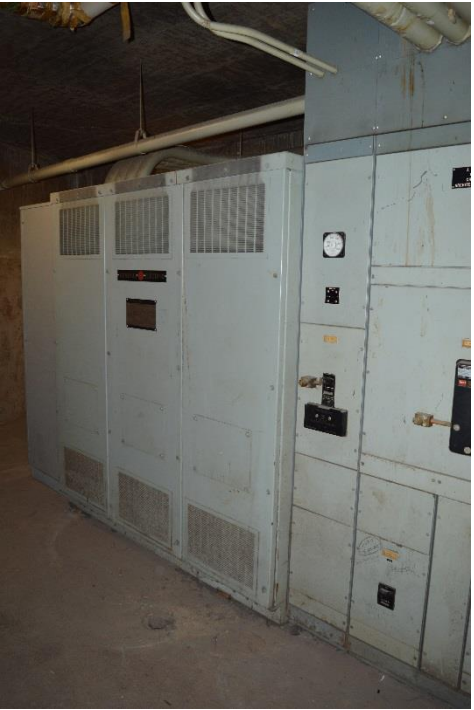
Center Core Substation – Transformer and EM Breaker

The Center Core substation is original to the building from 1964. The unit is aged beyond its expected lifespan, and the various sections of the board contain parts that are outdated and difficult to obtain for replacement purposes. Due to the inherent reliability issues of the unit, it is recommended to replace this substation in the coming years.

We recommend to continue exercising the existing 4160V switches every two years to verify proper operation and reduce risk of becoming stuck in a certain position at an inopportune time. Additionally, we recommend annual thermal inspections of the substation, switches, distribution panels, and other equipment in order to more easily identify problematic areas of unwanted heat buildup in the system.

A like-for-like replacement can be implemented by custom switchboard manufacturers, replacing the primary switch, transformer, and main and distribution breakers in a package of the same size as the existing. We recommend the replacement of all cloth-insulated cables with copper thermoplastic-insulated wire. Any cables that are not cloth-insulated may remain.

OSHA 2015 regulations require the application of an arc flash label that provides information on arc flash protection boundary, incident energy, working distance, PPE class, and available short circuit information. It is recommended to perform an arc flash and coordination study at the same time the switchboards are replaced.

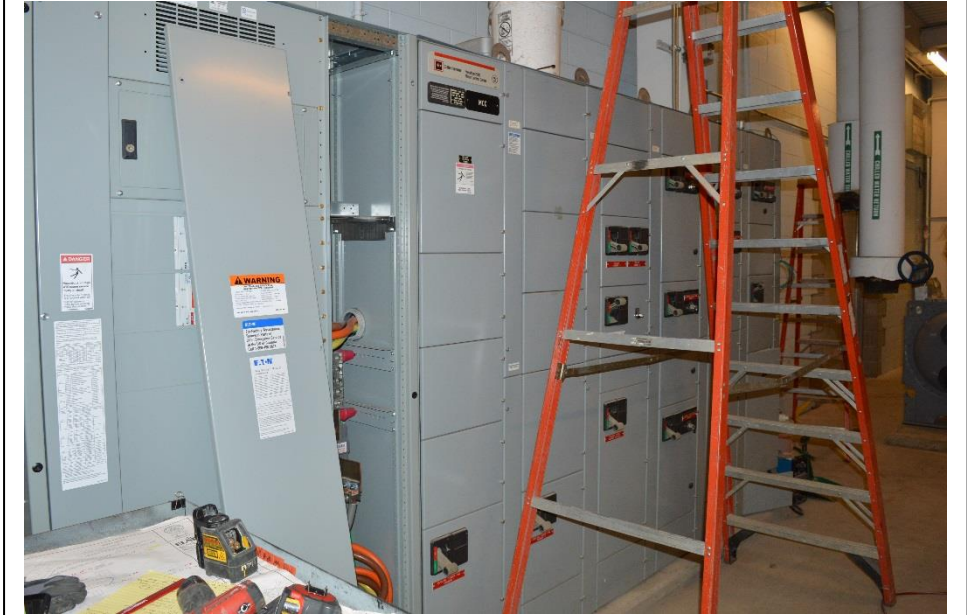
Chiller Room – MDP and MCC

The chiller room electrical distribution is currently undergoing an upgrade as part of a chiller replacement project. The room is fed via a 4160V service from the B-Wing substation that travels through a load break switch in the corner (manufactured by Cutler-Hammer), then heads outside underground to a new 1000KVA, 4160-480V transformer. The feeder then re-enters the room and connects to a 1200A distribution panelboard which feeds the two new chillers and the existing 6-section motor control center located in the room. All indoor distribution equipment were manufactured by Cutler-Hammer/Eaton, and the outdoor transformer was manufactured by ABB. The existing equipment appeared to be in good condition from a visual inspection.

We recommend to continue exercising the existing 4160V switches every two years to verify proper operation and reduce risk of becoming stuck in a certain position at an inopportune time. Additionally, we recommend annual thermal inspections of the substation, switches, distribution panels, and other equipment in order to more easily identify problematic areas of unwanted heat buildup in the system.

OSHA 2015 regulations require the application of an arc flash label that provides information on arc flash protection boundary, incident energy, working distance, PPE class, and available short circuit information on all distribution equipment. It is recommended to perform an arc flash and coordination study for the motor control center and primary distribution switch.

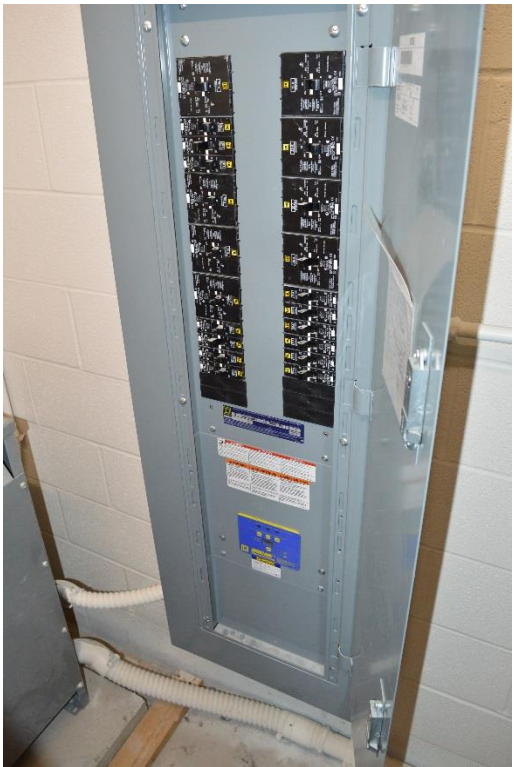
New 480V Panel – From E-Wing Substation #2 (Spectator Gym)

The school’s lighting and power panelboards are distributed throughout the school, only a few are located in the substation rooms where the main power distribution resides. The condition of the panels are varied, many having been replaced over the course of the facility’s history from GE original panels to newer units from Challenger, GE, Square-D, and Cutler-Hammer. Almost all panelboards are three-phase units, with supply voltages that are either 120/208V or 277/480V throughout the school.
