This report section will overview the existing cooling and heating systems at Maine South High School. The sections will include: building cooling plant, building heating plant, mechanical ventilation systems, unit ventilators, roof top units and recommendations.

MECHANICAL, ELECTRICAL, PLUMBING, AND FIRE PROTECTION CONDITIONS

MAINE SOUTH HIGH SCHOOL

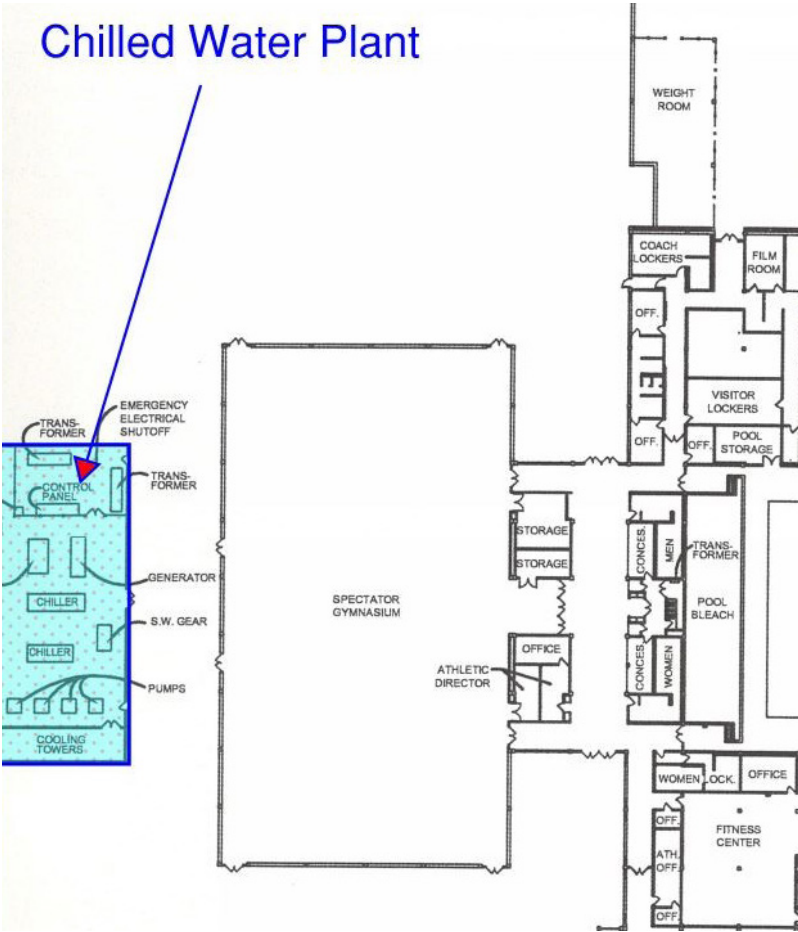
Building Chilled Water Plant Location

Space cooling for Maine South is provided by one (1) chilled water plant, located in a separate chiller building to the north of the spectator gymnasium as indicated in the picture to the right. The plant is made up of two (2) chillers which serve two-pipe unit ventilators (UVs) in the A-Wing as well as various air handling units (AHUs) throughout the building.

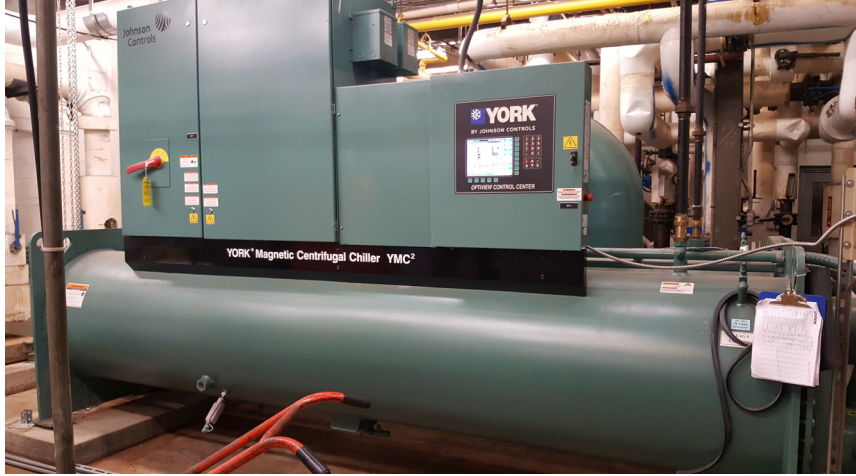
CH-1: YORK Magnetic Centrifugal Chiller

Chiller #1 is a “York” Magnetic Centrifugal Chiller installed in 2015 and rated for 550 nominal tons. This chiller is equipped with three (3) variable speed compressors. Chilled water is circulated through this chiller and out to the building by two (2) “Bell & Gossett” chilled water pumps, installed in 2015, and equipped with variable frequency drives (VFDs) to provide variable flow. The pumps are each rated for 60 HP, 150 ft. of head, and 950 GPM.

Heat rejection for Chiller #1 is provided by a dual-cell “Evapco” cooling tower located outside, adjacent to the chiller building. It is equipped with two (2) “Baldor” tower fans, each rated for 30 HP. The cooling tower and related components were recently refurbished or replaced in 2015. Condenser water for Chiller #1 is circulated by two (2) “Bell and Gossett” condenser water pumps, installed in 2015, and equipped with VFDs. Each condenser water pump is rated for 40 HP, 60 ft. of head, and 1650 GPM. Examine the table below and pictures on the right for additional details.

No alterations are recommended for this equipment within the scope of this report.

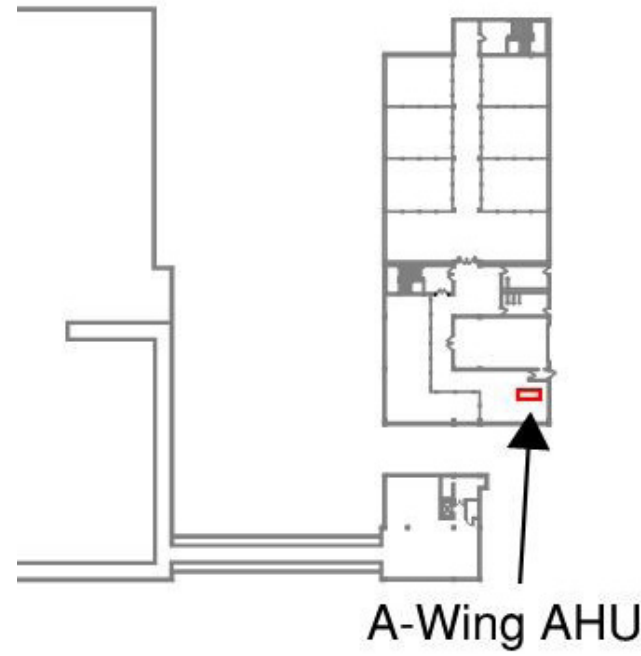
A-Wing Basement Location

A-Wing Basement AHU

The A-Wing basement AHU was installed in 1968 and is in poor condition due to its age.

It is recommended to replace this AHU with a like for like replacement. Please reference the AHU Cost Estimates for pricing information.

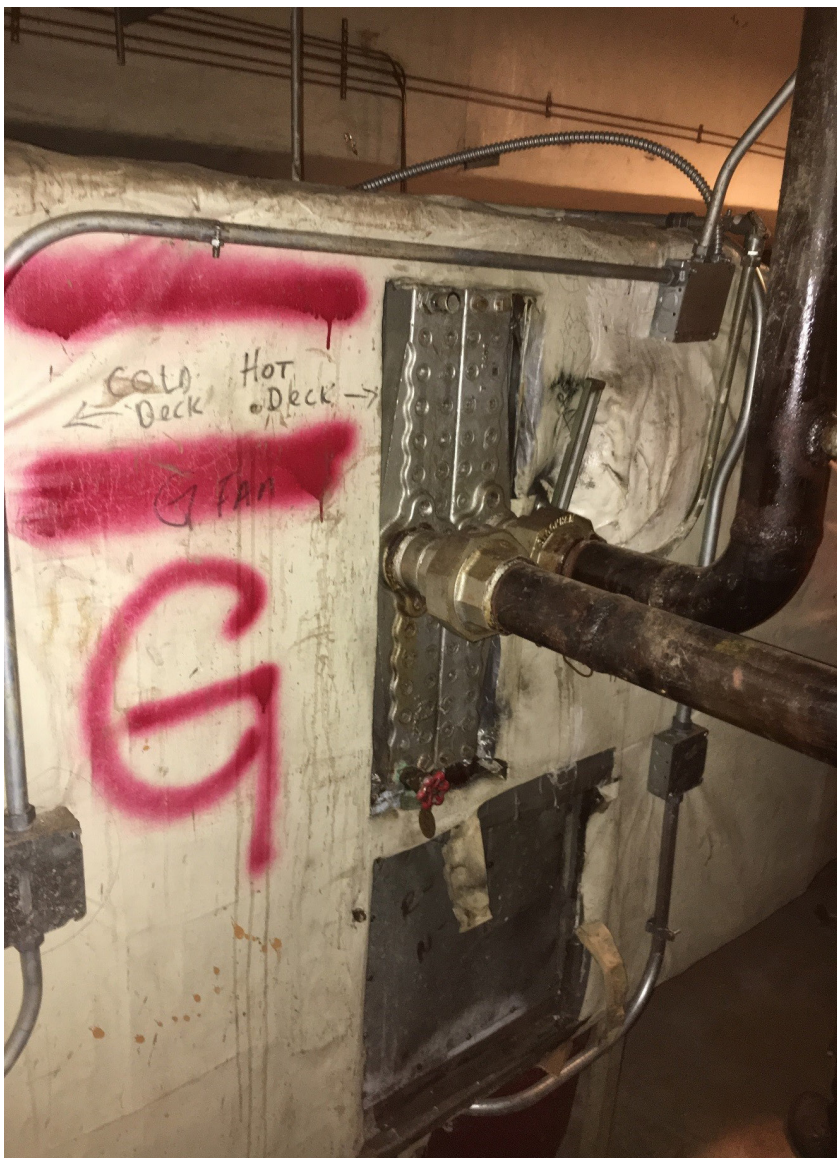
AHU-G

AHUs G, and H are constant flow multi-zone units that are original to the building. Like dual-duct systems, multi-zone systems are energy intensive because of constant flow fans and simultaneous heating and cooling. In a multi-zone system, air passes through a "hot deck" and "cold deck" and then mixes to an appropriate discharge air temperature at the AHU before being delivered to a zone. These types of systems are therefore energy inefficient. Furthermore, each of these AHUs is old and significantly beyond their ASHRAE median equipment service life of thirty (30) years.

It is recommended to replace the aforementioned multi-zone units with new AHUs serving VAV boxes with hot water reheat coils. Replacing constant volume systems would result in substantial energy savings due to variable flow supply, and the elimination of concurrent heating and cooling. Please reference the AHU Cost Estimates for pricing details.

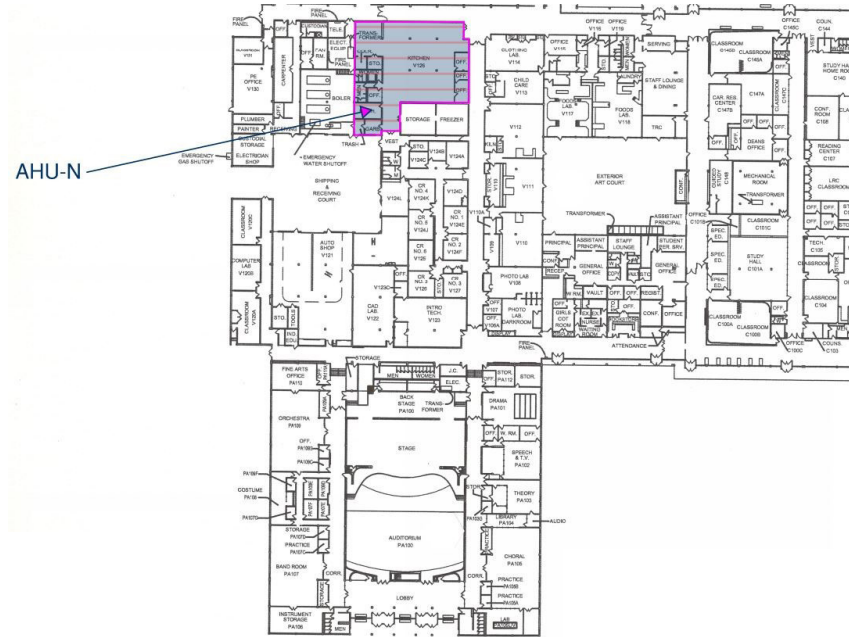
Kitchen Area AHU

Kitchen AHU-N is original to the building from 1964. This unit delivers constant volume supply air and utilizes chilled water and hot water coils to condition the kitchen. AHU-N has surpassed its ASHRAE median equipment service life of thirty (30) years and is substantially aged. Additionally, constant volume systems are considerably less energy efficient than today’s technology.

It is recommended to upgrade the AHU-N with a new AHU that distributes variable volume supply directly to the zones of service. In this case, the air handler itself acts as a VAV box providing variable supply to only one or two spaces. With a variable volume system upgrade, fan supply air is dependent on the space requirements; when demand is low, the fan reduces its speed, which results in significant energy savings both from the perspective of fan energy as well as heating and cooling energy. Please reference the AHU Cost Estimates for pricing information.

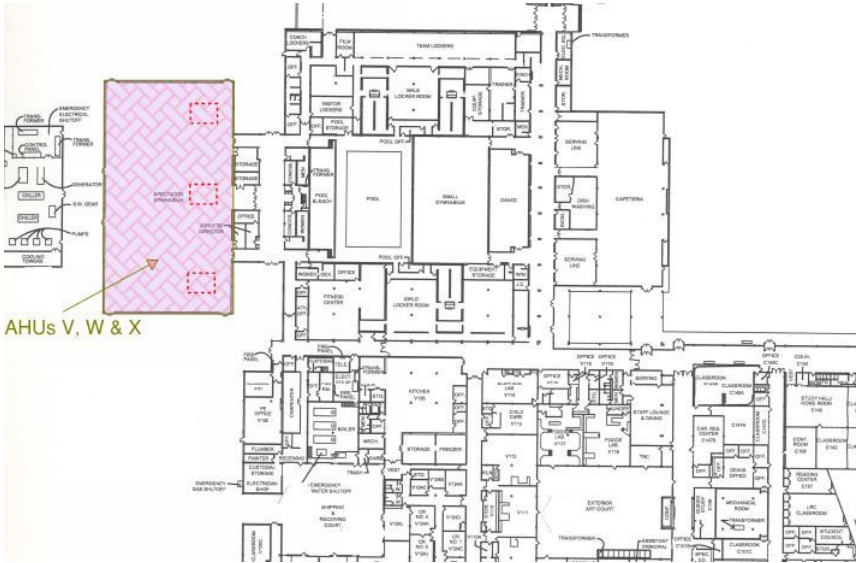
Spectator Gym AHUs

The spectator gym AHUs are original to the building from 1964 and provide constant volume air with heating only via hot water coils. Since these units are hung from the ceiling, they are difficult to service. According to ASHRAE, the median service life of a packaged medium-duty air handling unit is 25 years. Impressively, these units have doubled the ASHRAE median equipment service life average; however, they are in a poor condition.

It is recommended to update these units with more accessible, variable speed, packaged roof top units equipped with hot water heating and cooling capabilities. With the transition to variable flow, improved serviceability, and cooling capabilities, considerable savings and comfort improvements would be achieved. Please reference the AHU Cost Estimates for pricing information.

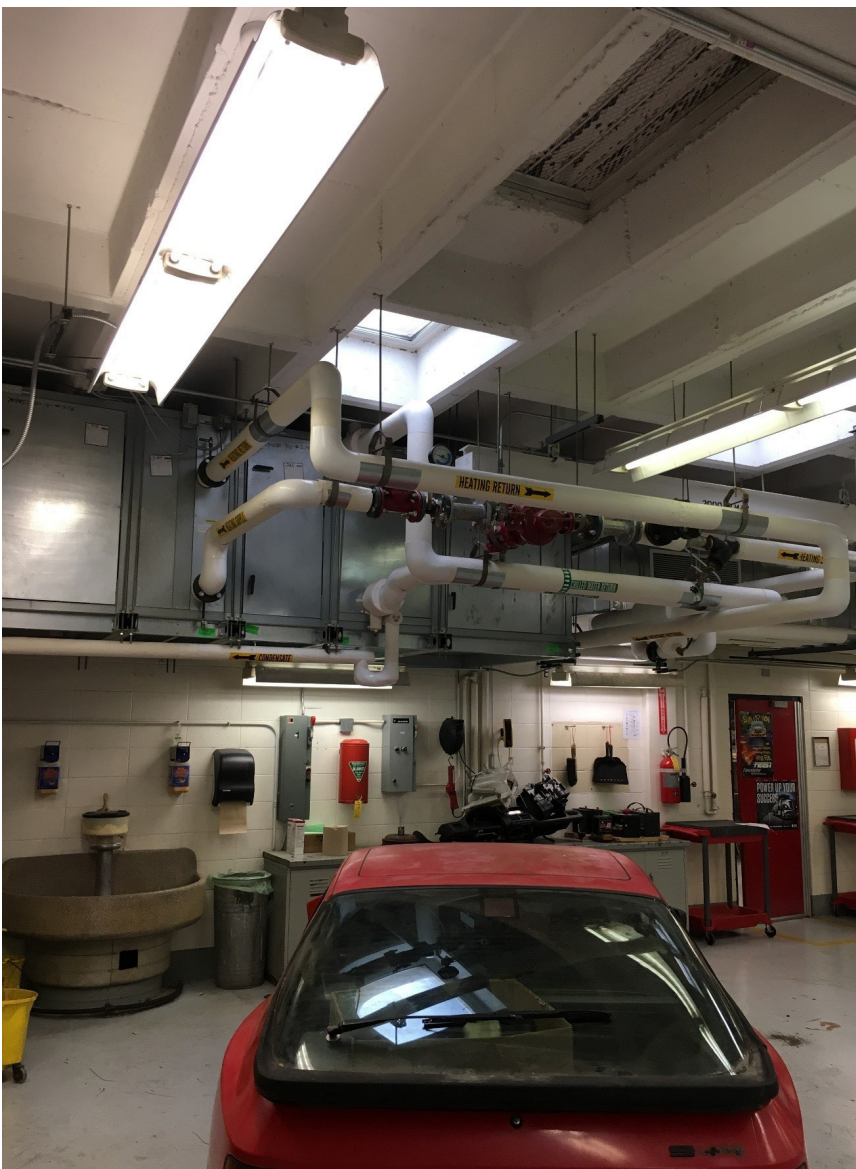
Auto Shop AHU

Two (2) AHUs equipped with chilled water and hot water coils deliver constant volume air to the auto shop area. These units were installed in 2002 and are outfitted with return air and outdoor air dampers. The picture on the right shows one (1) of the auto shop AHUs, and the picture below displays the zone both units serve.

No alterations are recommended for this equipment within the scope of this report.

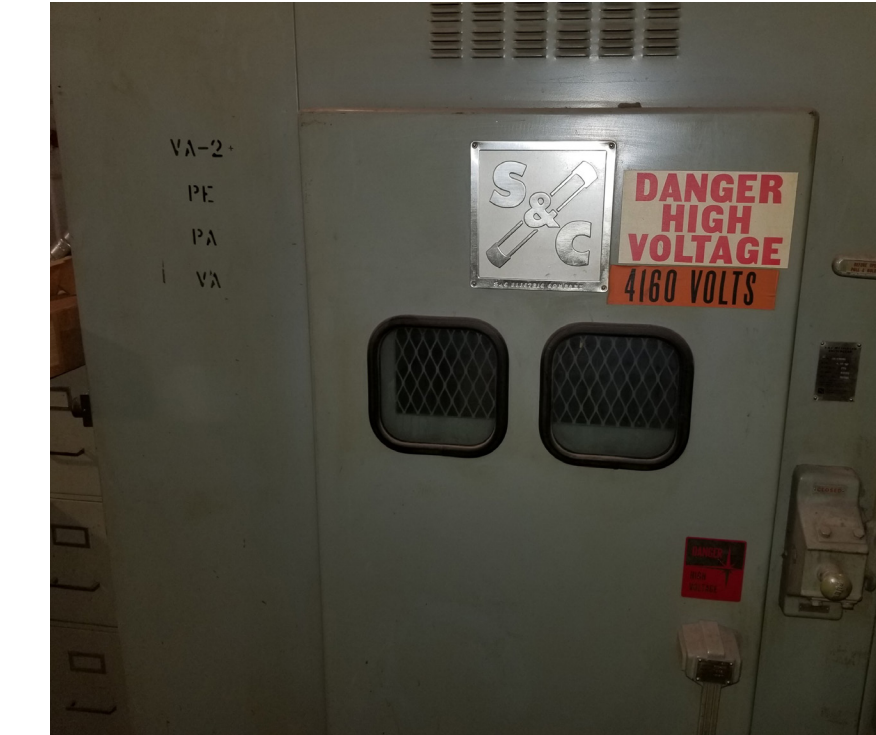
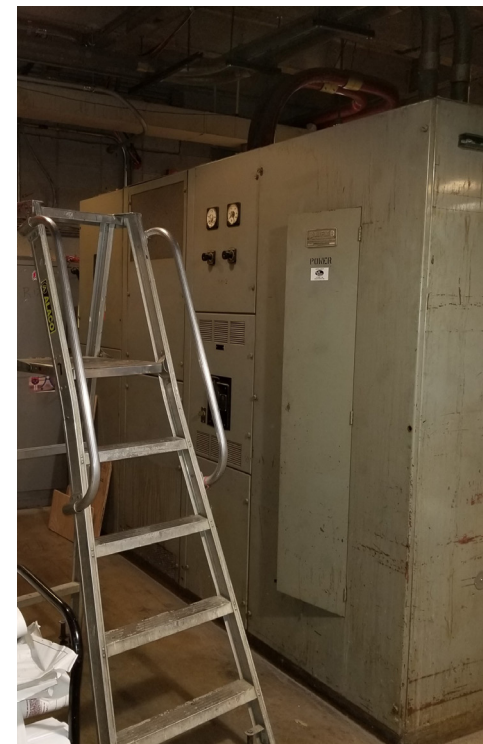
Substation VA-2 4160V Switch

The indoor switchgear adjacent to substation 'VA-2' consists of (2) load break, metal-clad 4160V switches manufactured by S&C which feed a total of (8) substations.

Substation VA-2 is original to the building from 1964. The unit is significantly aged and was manufactured by a company that no longer formally exists. Due to the inherent reliability issues of the unit being beyond its expected lifespan along with the difficulty of obtaining relevant parts, it is recommended to replace this substation in the coming years. If the substation is fed by cloth-insulated wiring, it should be replaced with an equivalent thermoplastic-insulated wire during the substation replacement.

We recommend to exercise the existing 4160V switches to verify proper operation and reduce risk of becoming stuck in a certain position at an inopportune time. Additionally, we recommend annual thermal inspections of the substation, switches, distribution panels, and other equipment in order to more easily identify problematic areas of unwanted heat buildup in the system.

A like-for-like replacement can be implemented by custom switchboard manufacturers, replacing the primary switch, 500 KVA transformer, circuit breakers, and distribution board in a package of the same size as the existing. The incoming and outgoing feeders may remain as they currently are.

OSHA 2015 regulations require the application of an arc flash label that provides information on arc flash protection boundary, incident energy, working distance, PPE class, and available short circuit information. It is recommended to perform an arc flash and coordination study at the same time the switchboards are replaced.

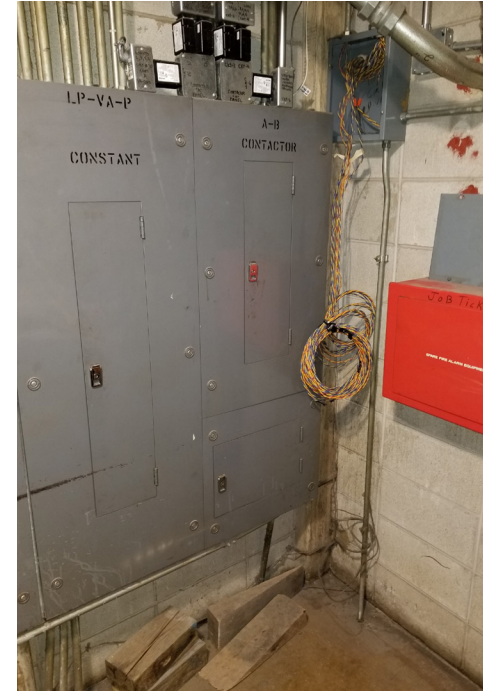
VA-2 Distribution Panels

The panelboards fed from substation VA-2 are also original to the building and are due for a replacement. The panels may be furnished by either a reputable manufacturer, or a custom switchboard manufacturer. The existing panel feeders and branch circuits may remain as existing.

Any panelboards fed via cloth-insulated wiring should be re-fed with equivalent thermoplastic-insulated wire as replacements occur.

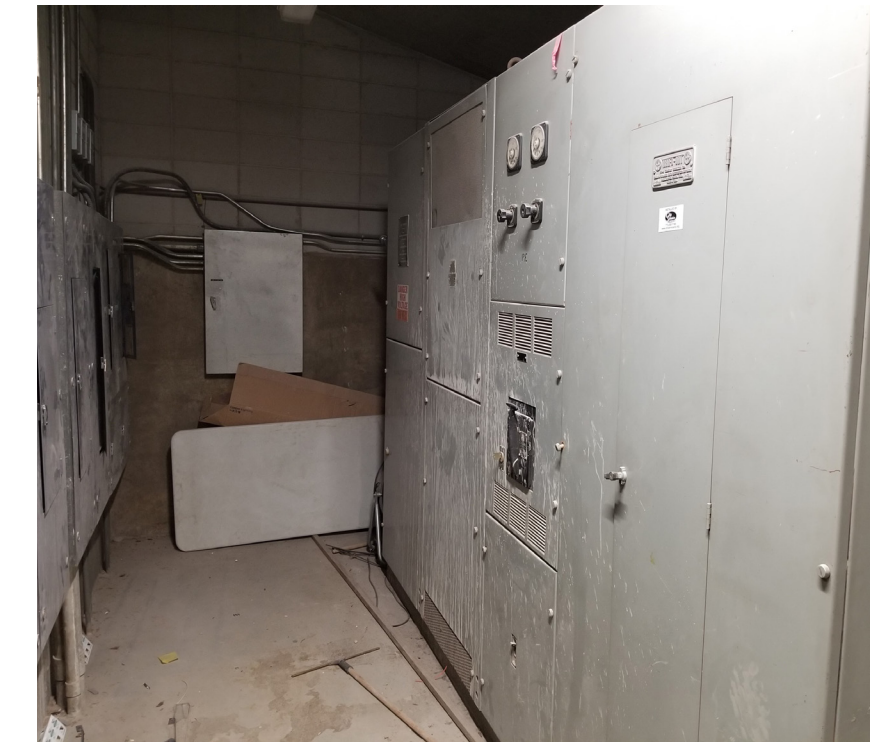
Substation PE and Distribution Panels

The first section of the PE substation consists of a 4160V load break switch manufactured by I-T-E circuit breaker company, the second section contains a 500 KVA transformer to step the voltage down to 120/208V. The third section has a 1600A circuit breaker for the building's distribution load, as well as a 100A circuit breaker emergency panelboard. The fourth section has a board containing normal power distribution circuit breakers. The entire board is manufactured by I-T-E circuit breaker company. The substation is original to the building, and the equipment is past its expected lifespan.

Any panelboards fed via cloth-insulated wiring should be re-fed with equivalent thermoplastic-insulated wire as replacements occur.

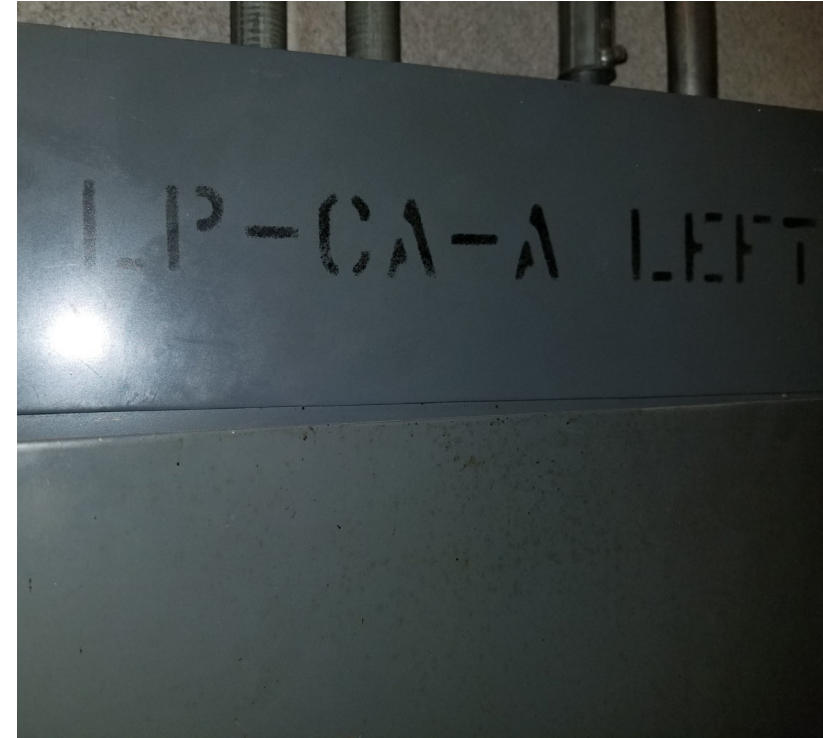
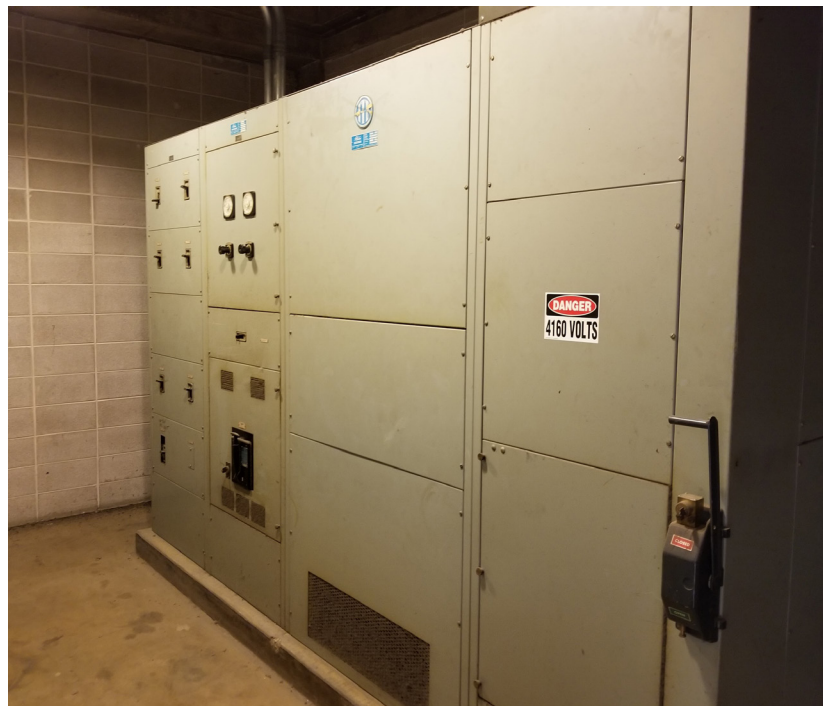
Substation CA

The first section of the CA substation consists of a 4160V load break switch manufactured by I-T-E circuit breaker company, the second section contains a 500 KVA transformer to step the voltage down to 120/208V. The third section has a 1600A circuit breaker for the building's distribution load, as well as a 100A circuit breaker emergency panelboard. The fourth section has a board containing normal power distribution circuit breakers. The entire board is manufactured by I-T-E circuit breaker company. The substation is original to the building, and the equipment is past its expected lifespan.

Any panelboards fed via cloth-insulated wiring should be re-fed with equivalent thermoplastic-insulated wire as replacements occur.

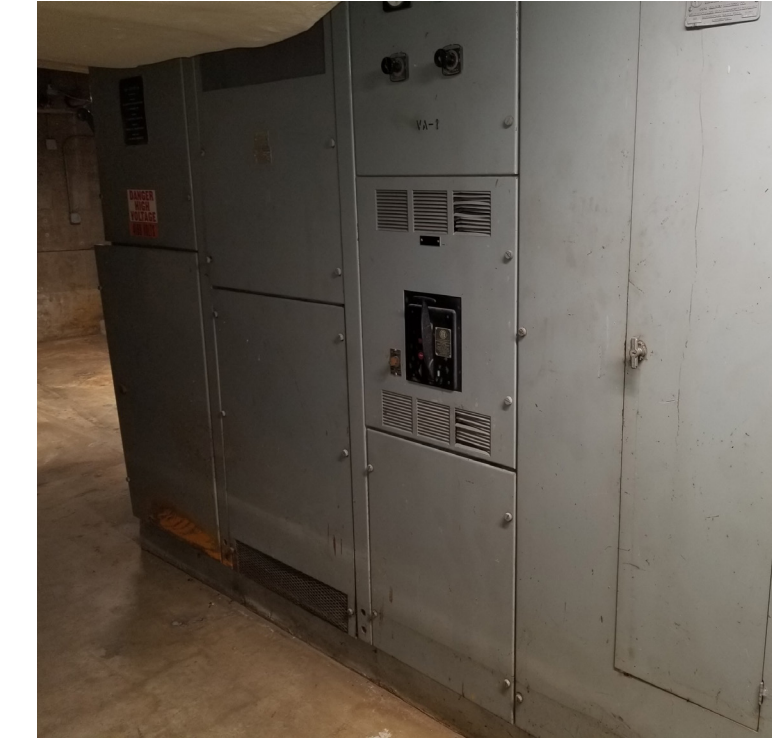
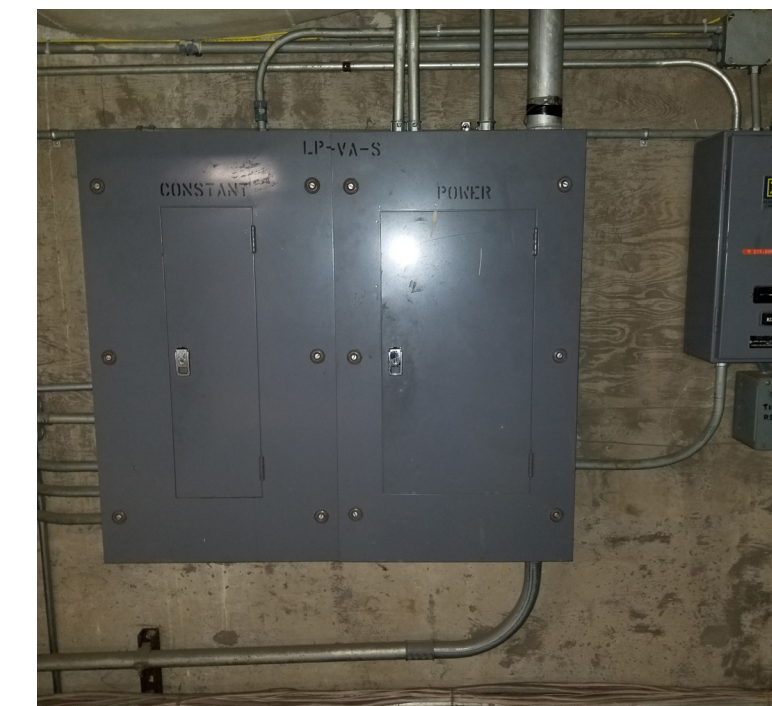
Substation VA-1

The first section of the VA-1 substation consists of a 4160V load break switch manufactured by I-T-E circuit breaker company, the second section contains a 500 KVA transformer to step the voltage down to 120/208V. The third section has a 1600A circuit breaker for the building's distribution load. The fourth section has a board containing normal power distribution circuit breakers. The entire board is manufactured by I-T-E circuit breaker company. The substation is original to the building, and the equipment is past its expected lifespan.

Any panelboards fed via cloth-insulated wiring should be re-fed with equivalent thermoplastic-insulated wire as replacements occur.

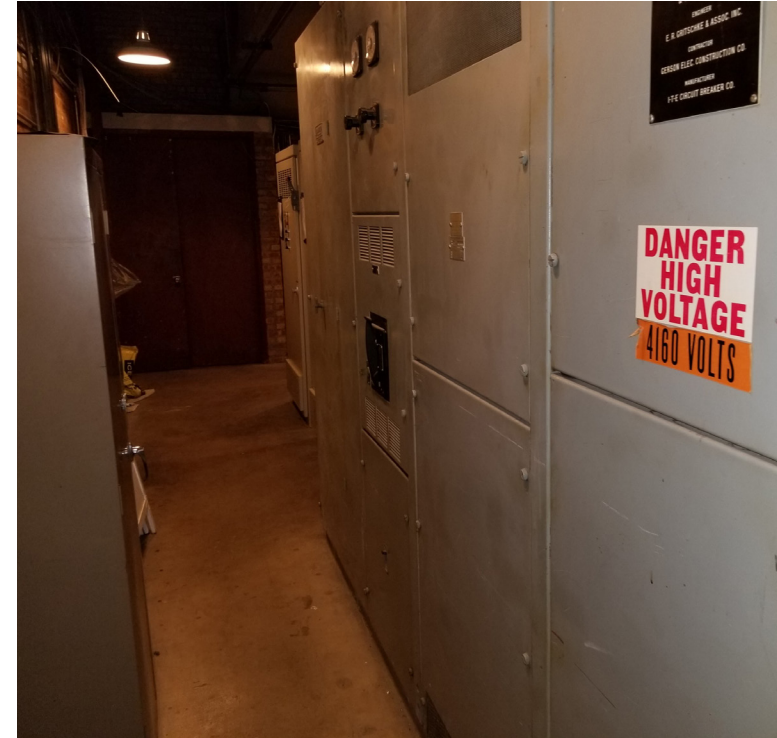
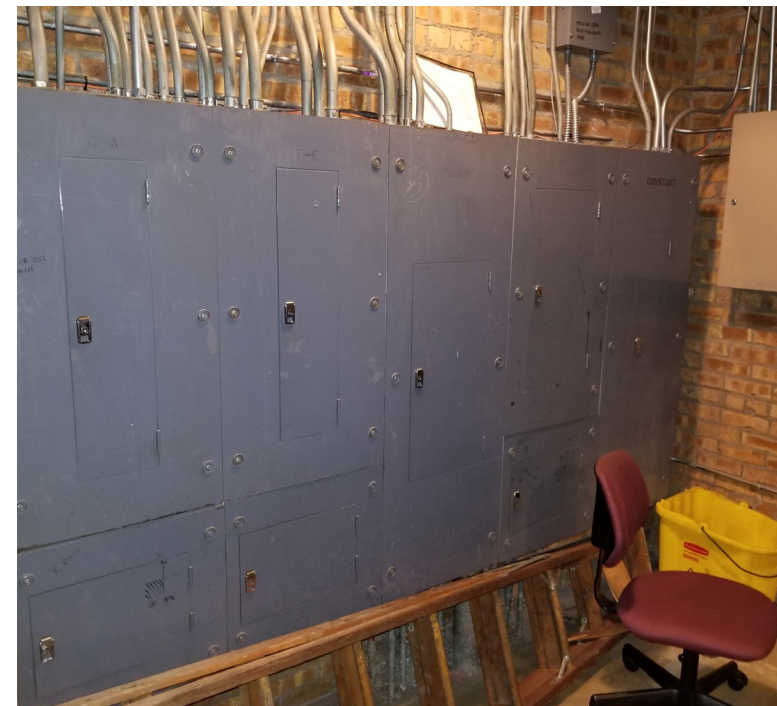
Substation C-1

The first section of the C-1 substation consists of a 4160V load break switch manufactured by I-T-E circuit breaker company, the second section contains a 500 KVA transformer to step the voltage down to 120/208V. The third section has a 1600A circuit breaker for the building's distribution load, as well as a 100A circuit breaker emergency panelboard. The fourth section has a board containing normal power distribution circuit breakers. The entire board is manufactured by I-T-E circuit breaker company. The substation is original to the building, and the equipment is past its expected lifespan.

Any panelboards fed via cloth-insulated wiring should be re-fed with equivalent thermoplastic-insulated wire as replacements occur.

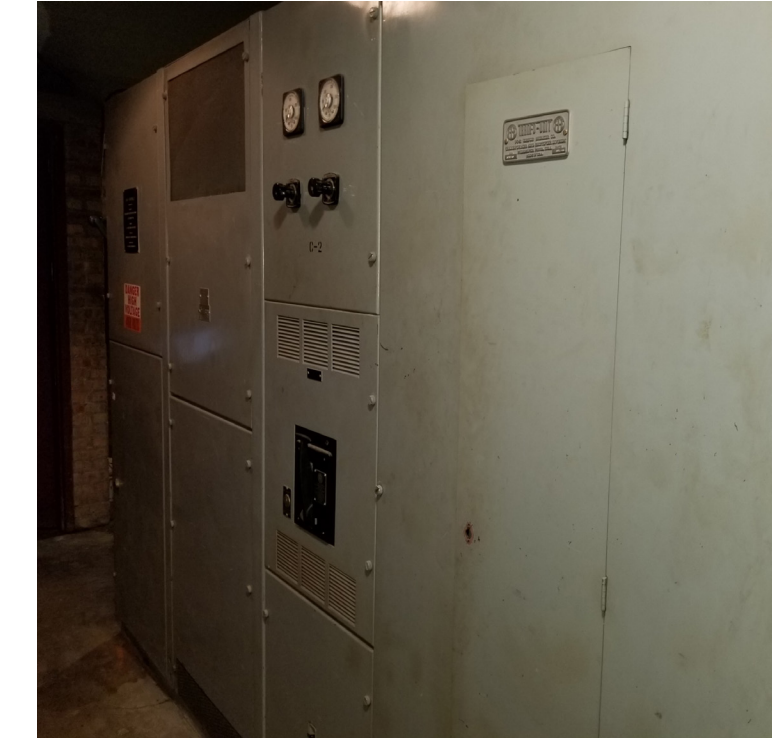
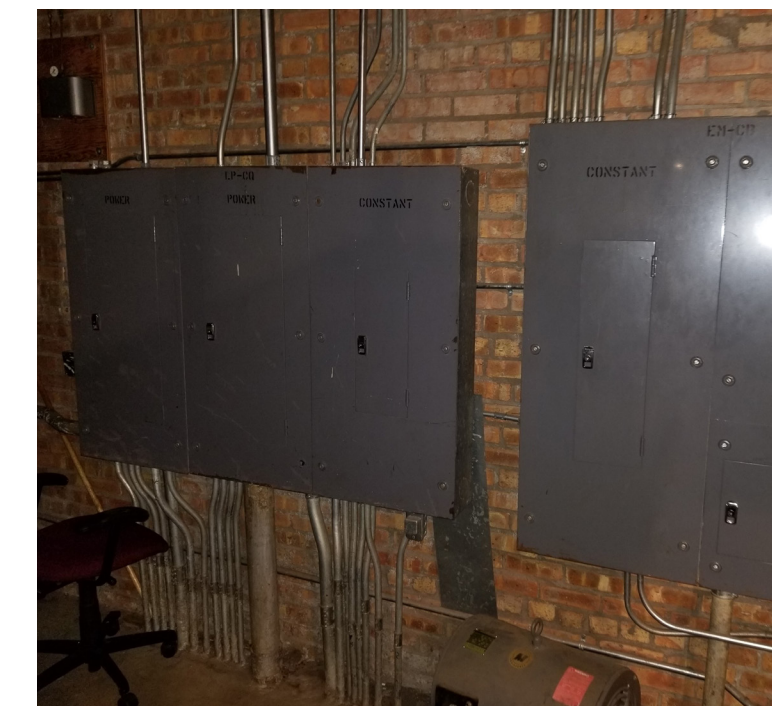
Substation C-2

The first section of the C-2 substation consists of a 4160V load break switch manufactured by I-T-E circuit breaker company, the second section contains a 500 KVA transformer to step the voltage down to 120/208V. The third section has a 1600A circuit breaker for the building's distribution load, as well as a 100A circuit breaker emergency panelboard. The fourth section has a board containing normal power distribution circuit breakers. The entire board is manufactured by I-T-E circuit breaker company. The substation is original to the building, and the equipment is past its expected lifespan.

Any panelboards fed via cloth-insulated wiring should be re-fed with equivalent thermoplastic-insulated wire as replacements occur.

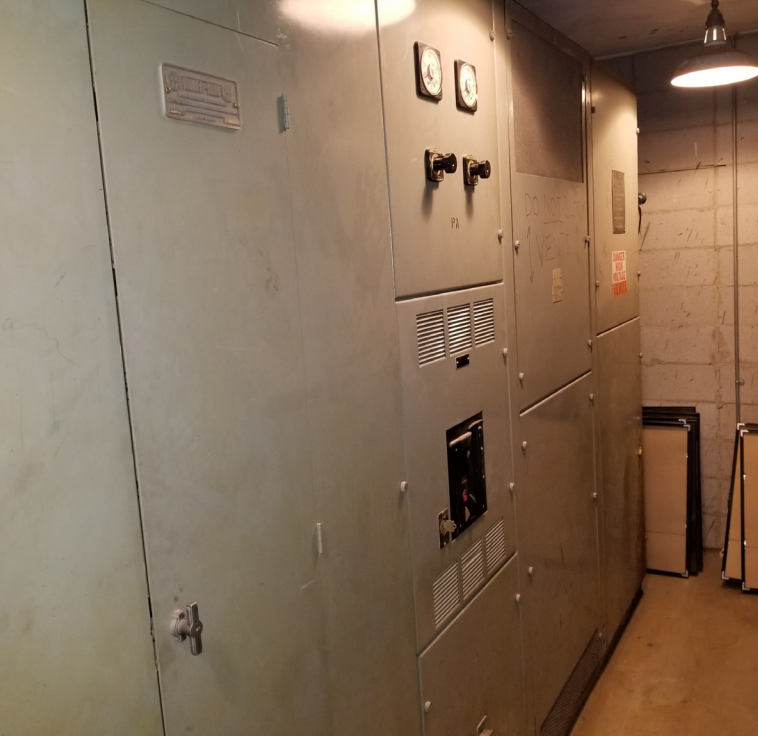
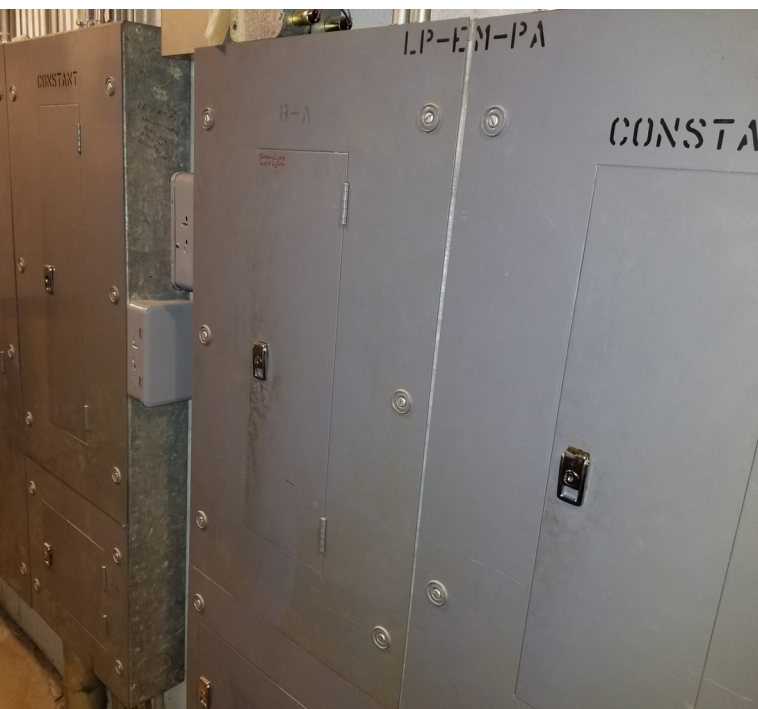
Substation PA

The first section of the PA-2 substation consists of a 4160V load break switch manufactured by I-T-E circuit breaker company, the second section contains a 500 KVA transformer to step the voltage down to 120/208V. The third section has a 1600A circuit breaker for the building’s distribution load, as well as a 150A circuit breaker emergency panelboard. The fourth section has a board containing normal power distribution circuit breakers. The entire board is manufactured by I-T-E circuit breaker company. The substation is original to the building, and the equipment is past its expected lifespan.

Any panelboards fed via cloth-insulated wiring should be re-fed with equivalent thermoplastic-insulated wire as replacements occur.

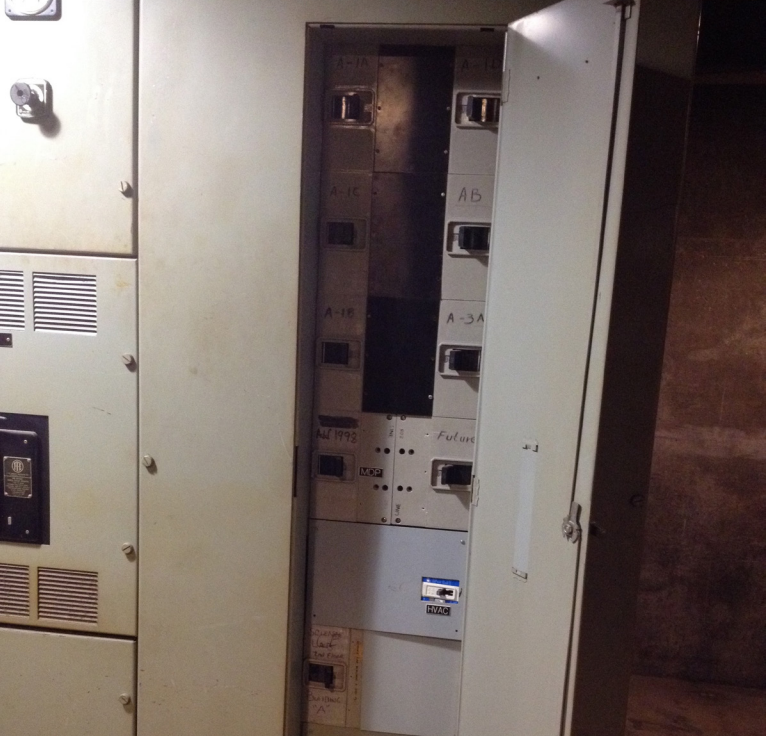
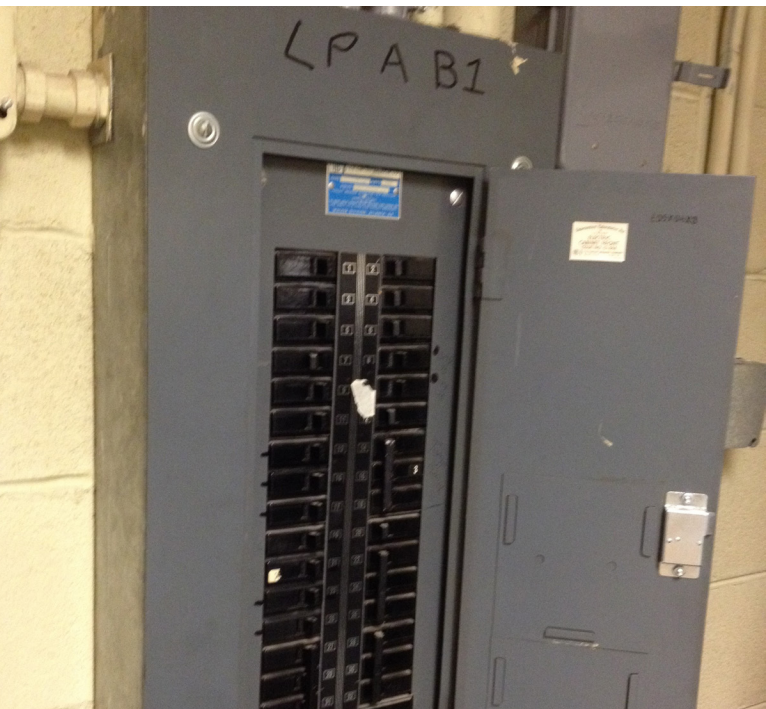
Substation A

The first section of the A substation consists of a 4160V load break switch manufactured by I-T-E circuit breaker company, the second section contains a 500 KVA transformer to step the voltage down to 120/208V. The third section has a 1600A circuit breaker for the building’s distribution load, as well as a 100A circuit breaker emergency panelboard. The fourth section has a board containing normal power distribution circuit breakers. The entire board is manufactured by I-T-E circuit breaker company. The substation is original to the building, and the equipment is past its expected lifespan.

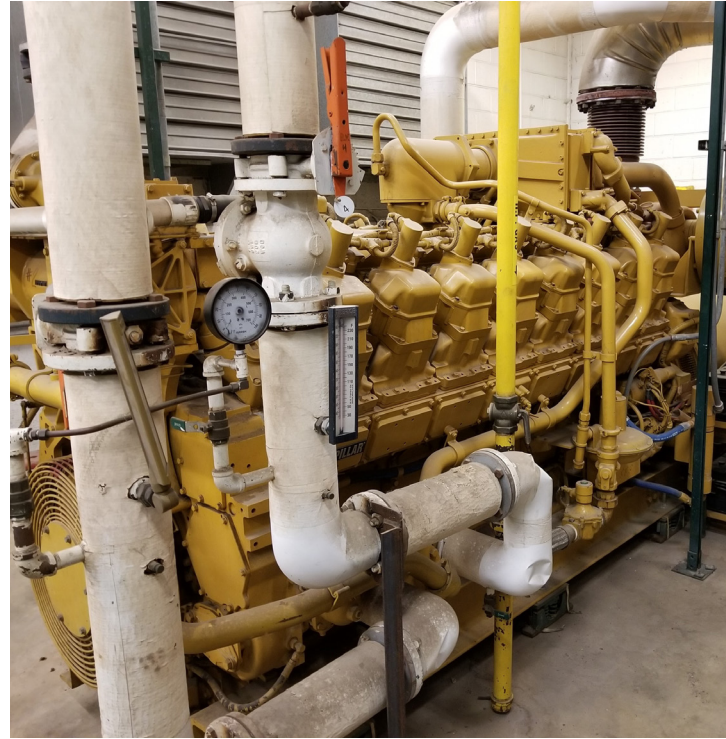
Cogeneration Unit

The existing (2) cogeneration units are Caterpillar natural gas machines capable of supplying up to 800kW when they are used simultaneously. The output is at 4160V. The generator outputs connect to a three-section board, two sections are for input of power to the board from each generator, the final section is used for a tie breaker to output the combined power from the units and feed power back to the grid via outdoor switchgear, located where the electrical service lands at the building. The generators are capable of powering the entire school upon loss of utility power.

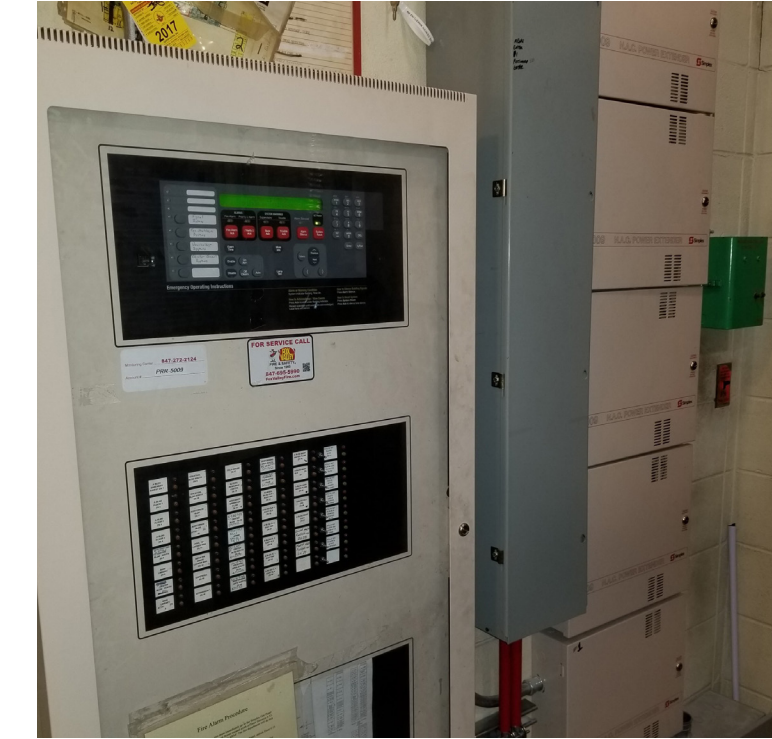
Fire Alarm Panel

The building contains a Simplex fire alarm system, consisting of audio, visual, heat detector, smoke detector, duct smoke detectors, and pull station devices. The system is heavily outdated, and the equipment is beyond its typical life expectancy. In addition, the building is not sprinklered, with the exception of a portion of the A wing building.

The design process is underway for a complete replacement of the existing fire alarm system, to be implemented in 2018. This replacement serves as a modernization project, as the existing fire alarm control panel is outdated and incompatible with certain newer fire alarm technologies that are beneficial in a school setting such as voice communication.
